**COLORADO DIVISION OF RECLAMATION, MINING AND SAFETY**  
**MINERALS PROGRAM INSPECTION REPORT**  
**PHONE: (303) 866-3567**

| <b>MINE NAME:</b><br>Iverson Mine | <b>MINE/PROSPECTING ID#:</b><br>M-2011-001 | <b>MINERAL:</b><br>Gravel and Sand | <b>COUNTY:</b><br>Weld |
| <b>INSPECTION TYPE:</b><br>Monitoring | <b>INSPECTOR(S):</b><br>Peter S. Hays | <b>INSP. DATE:</b><br>March 17, 2016 | <b>INSP. TIME:</b><br>14:00 |

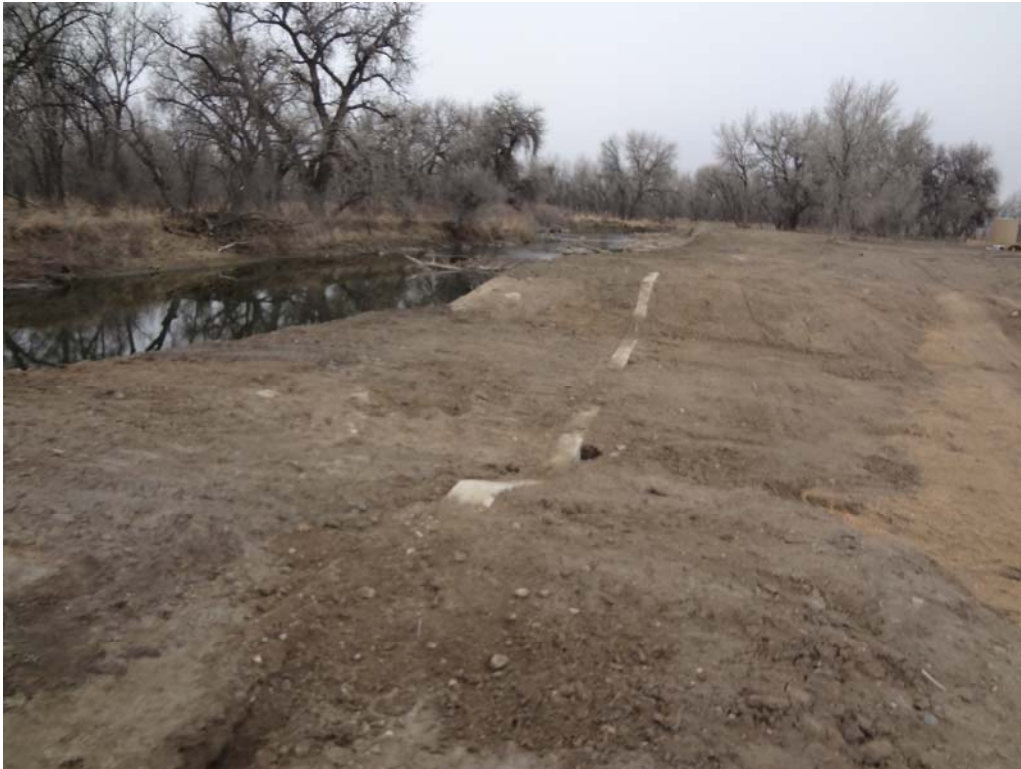
Looking north at west end of west diversion structure

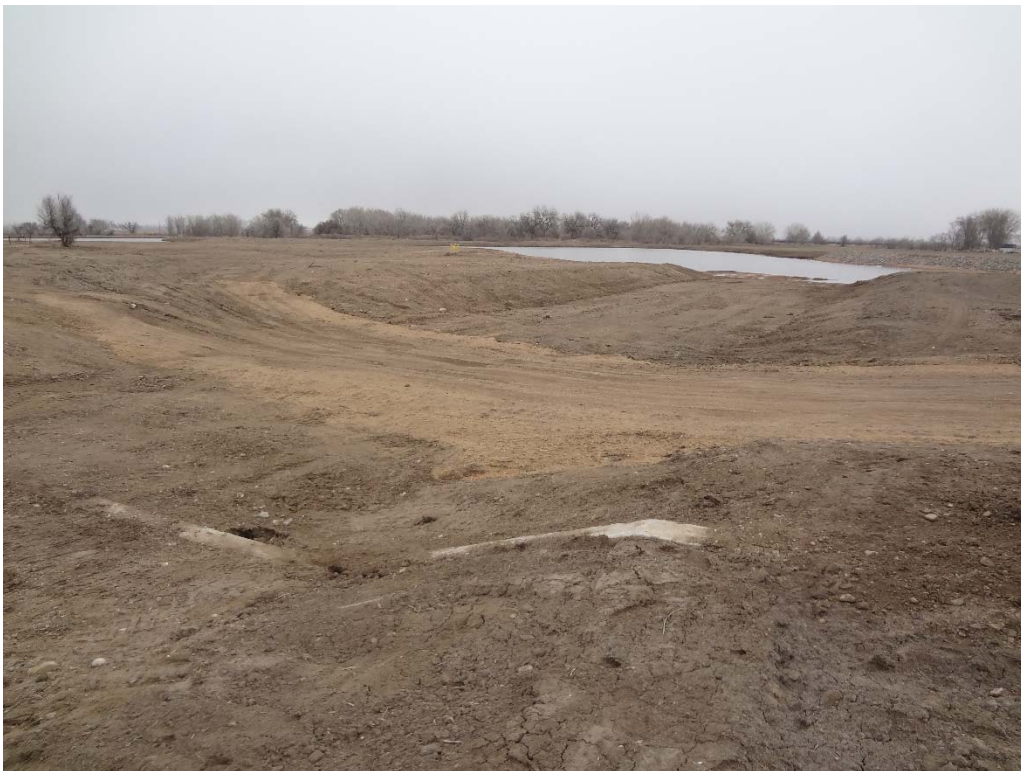
Looking east from west end of west diversion structure

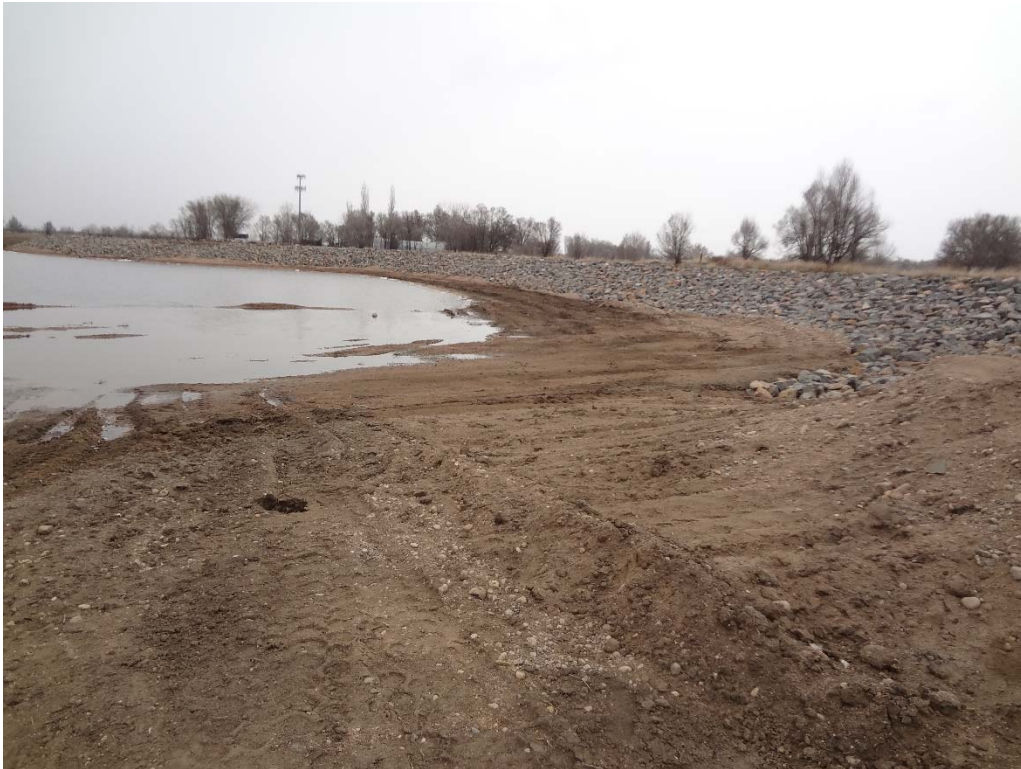
Looking east from east end of west diversion structure

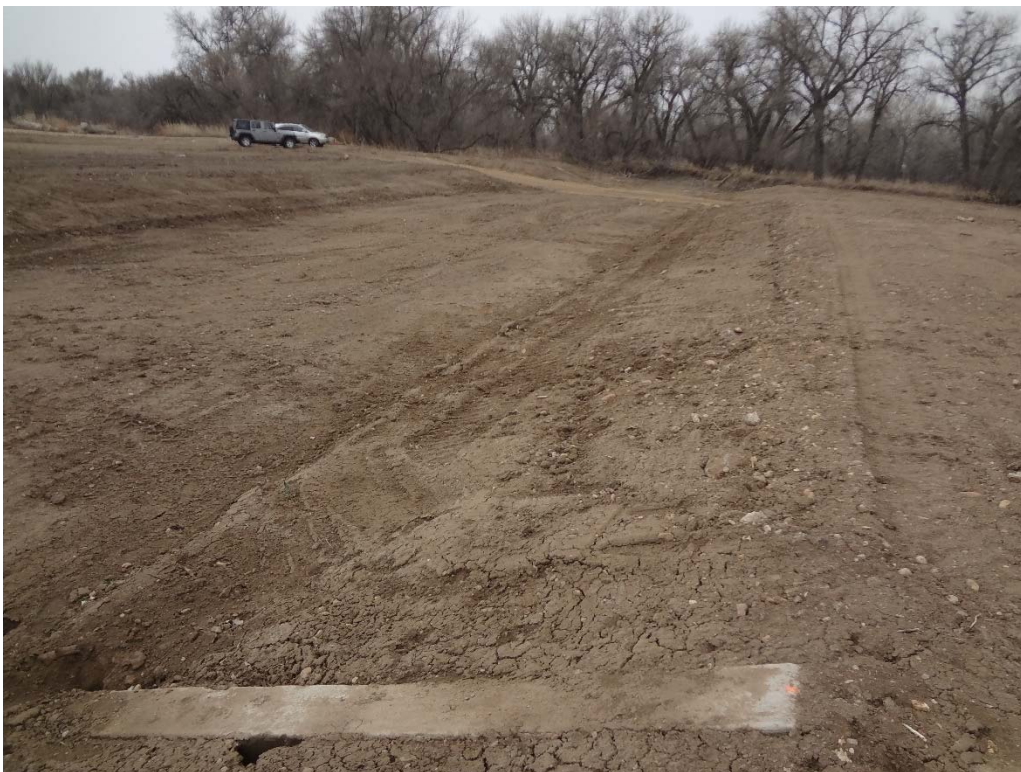
Looking west from east end of west diversion structure

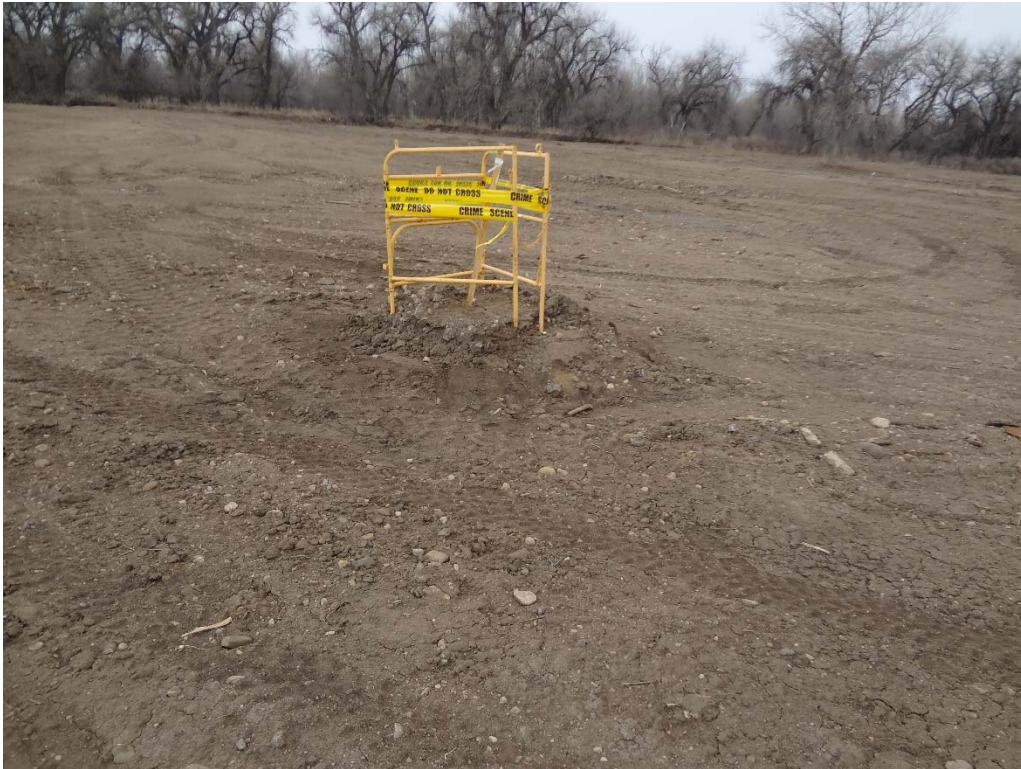
During the inspection, Mr. Iverson was concerned the overall site grade has been reduced to provide fill material for the breaches and diversion structures repairs. Survey stakes indicating cuts from the existing grade were observed during the inspection. The Division is concerned the required minimum of six (6) inches of topsoil is not being salvaged in advance of the grading work.

Looking at grade stake in the southwest corner of the site

**CORRECTIVE ACTIONS:** The Operator must document the required minimum of six (6) inches of topsoil depth is present following the completion of grading work at the site.

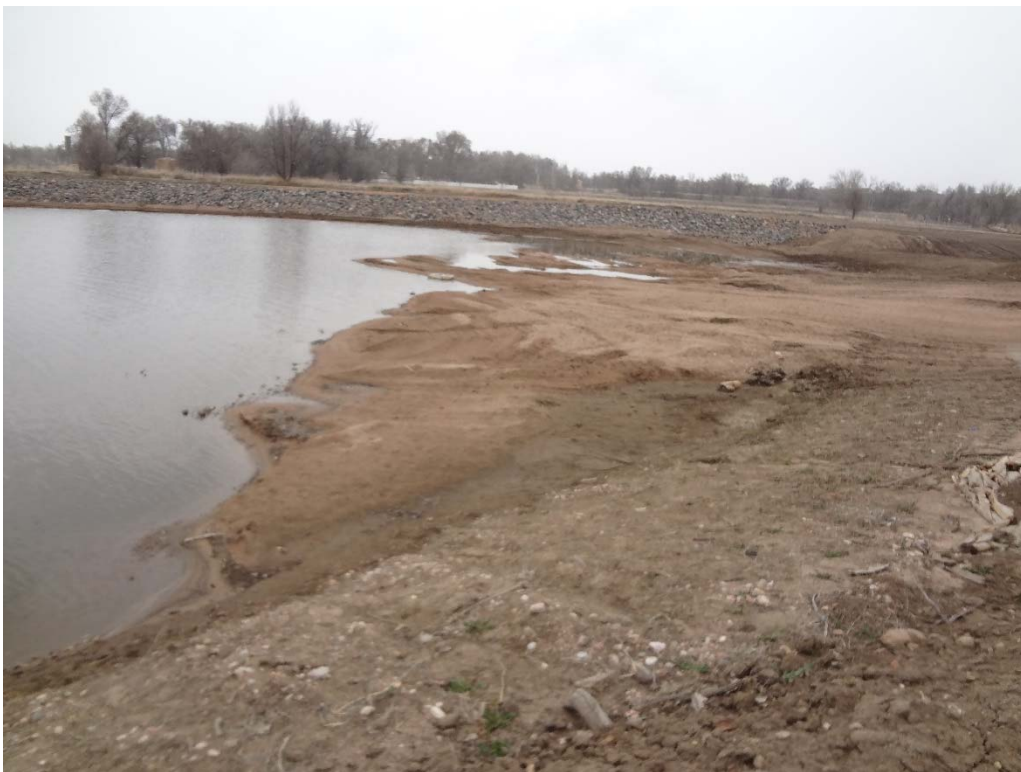
An alluvial fan was observed east of the west diversion structure. No other evidence of debris in the pit was observed during the inspection. The Division is unable to verify Mr. Iverson's statement that the debris caused hundreds of thousands of dollars in damage. Mr. Iverson mailed the Division a letter following the inspection dated March 21, 2016 with pictures taken during the 2015 flood event at the site. The pictures show portions of the diversion structure, trees and deposited alluvial material in the pit. The pictures also show the breached diversion structures. The portions of the diversion structures and trees were not observed in the pit during the inspection.

Looking at the alluvial fan east of the west diversion structure

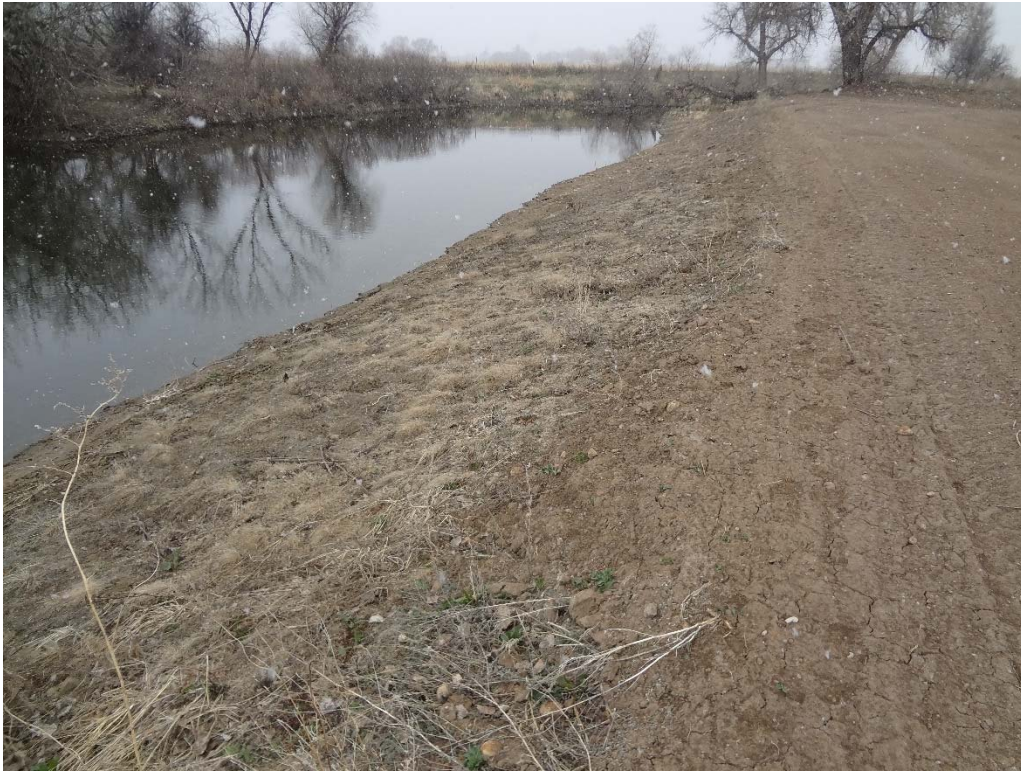
The upper breach, located in the northwest corner of the site, was reported in the 2014 Annual Report received by the Division on July 25, 2014. The breach occurred on May 25, 2014, two months before the Operator notified the Division. The Operator failed to comply with the requirements of Rule 8.1.

Looking north at shoreline of repaired upper breach area

**CORRECTIVE ACTIONS:** The Operator must submit a revised 2014 Annual Report for the Iverson Mine to describe the repair work required to fix the breach with engineering certification and as-built drawings for the repairs, if available, by the corrective action date.

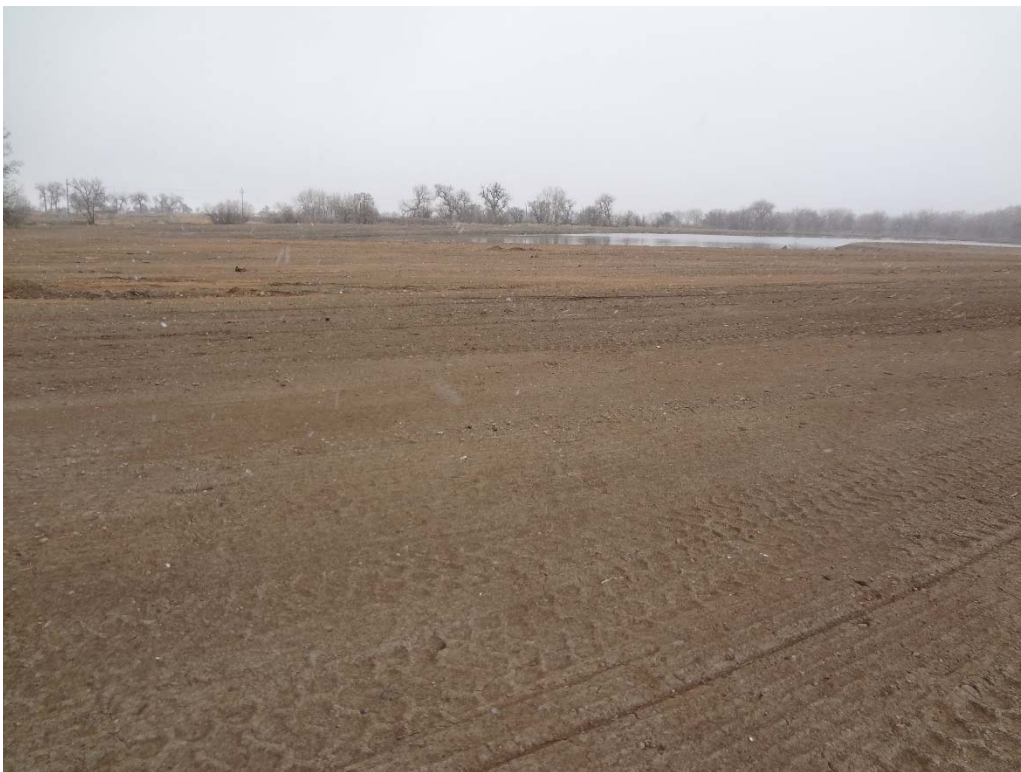
Looking southeast at repaired upper breach area

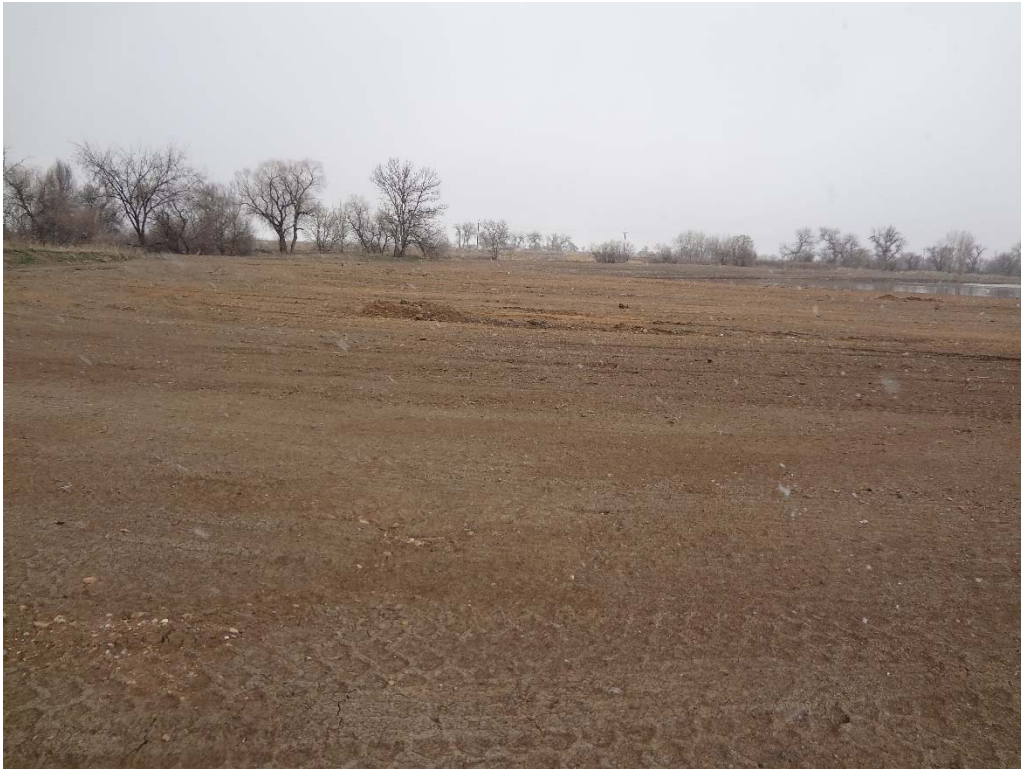
Looking east at repaired upper breach area

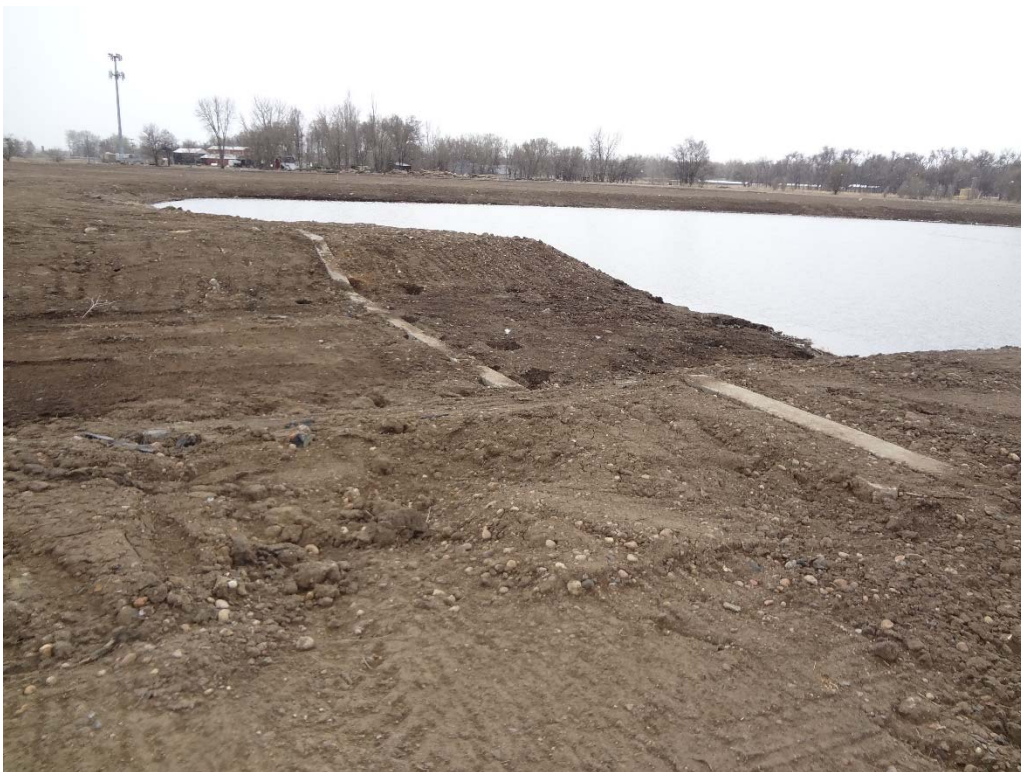
Looking southeast at the west end of east diversion structure

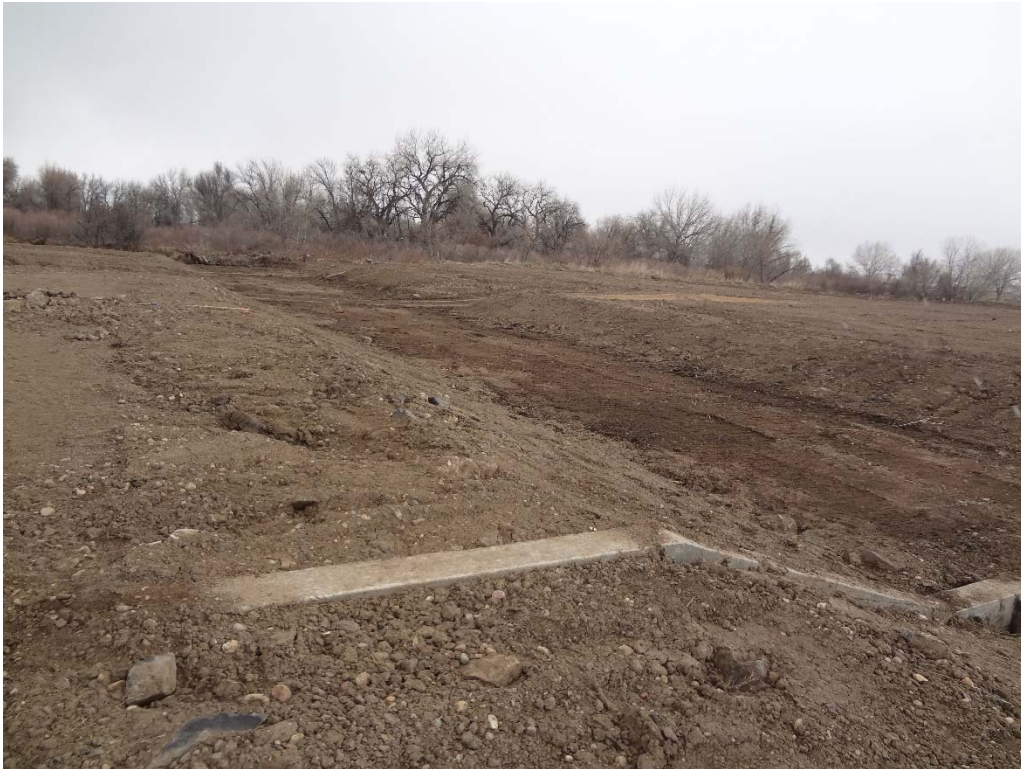
Looking northeast from the west end of the east diversion structure

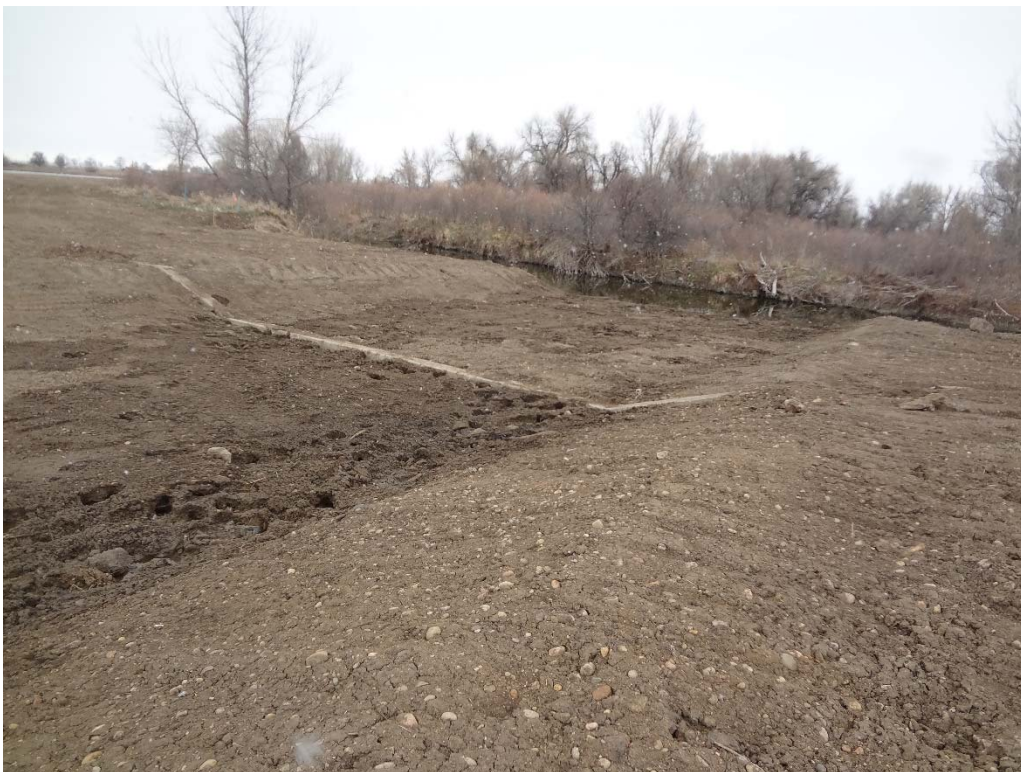
Looking north at the east end of the east diversion structure

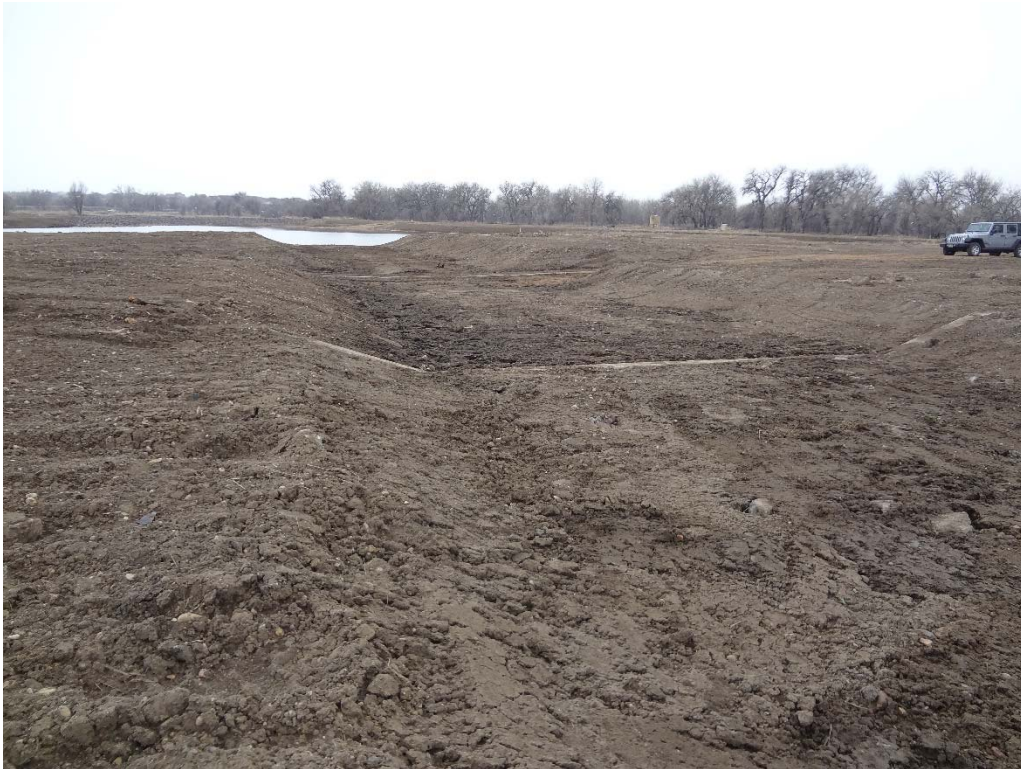
Looking southwest from east end of the east diversion structure

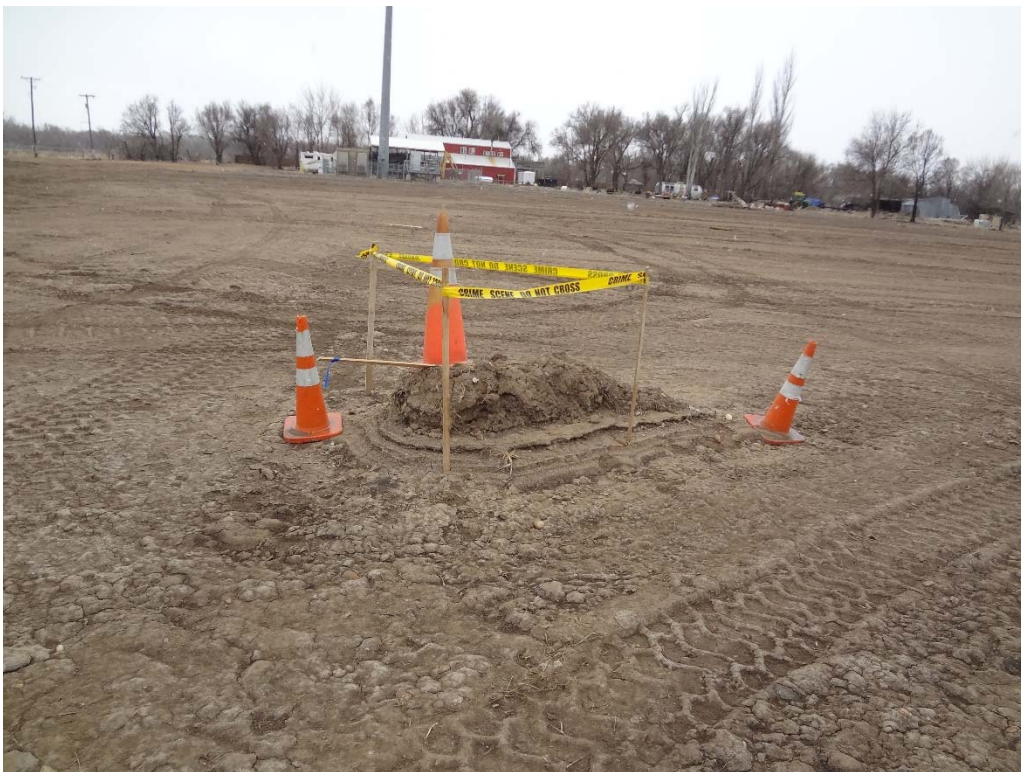
Looking at grade stake in the southeast corner of the site
