U.S. DEPARTMENT OF INTERIOR  
BUREAU OF LAND MANAGEMENT  
ROYAL GORGE FIELD OFFICE  
**3600 INSPECTION REPORT**

MINE NAME:	<u>Iron Mountain</u>
OPERATOR:	<u>Cooper Excavating</u>
MAIN COMMODITY:	<u>Aggregate</u>
TYPE OF OPERATION:	<u>110c</u>
COUNTY:	<u>Fremont</u>
LOCATION:	<u>Glen Vista, CO off Iron Mountain Rd.</u>
INSPECTOR(S)/ OP. REP PRESENT:	<u>William Jenkins – BLM, Shawnee – Rocky Mountain Excavating, Bennie – Rocky Mountain Excavating</u>
INSPECTION DATE:	<u>1/27/2016</u>
DATE OF COMPLAINT, if applicable:	<u>N/A</u>

BLM COC#:	<u>075258</u>
CDRMS PERMIT#:	<u>M-1994-092</u>
MSHA ID #:	<u>Click here to enter text.</u>
CONTRACT ACRES/ AM'T/ LENGTH:	<u>COC-075258</u>
TIME OF DAY:	<u>9:00 – 11:15 AM MT</u>
INSPECTION TYPE:	<u>Other – based on Fremont County's request to update the site's CUP</u>
REASON FOR INSPECTION:	<u>General</u>
WEATHER CONDITION:	<u>Clear</u>

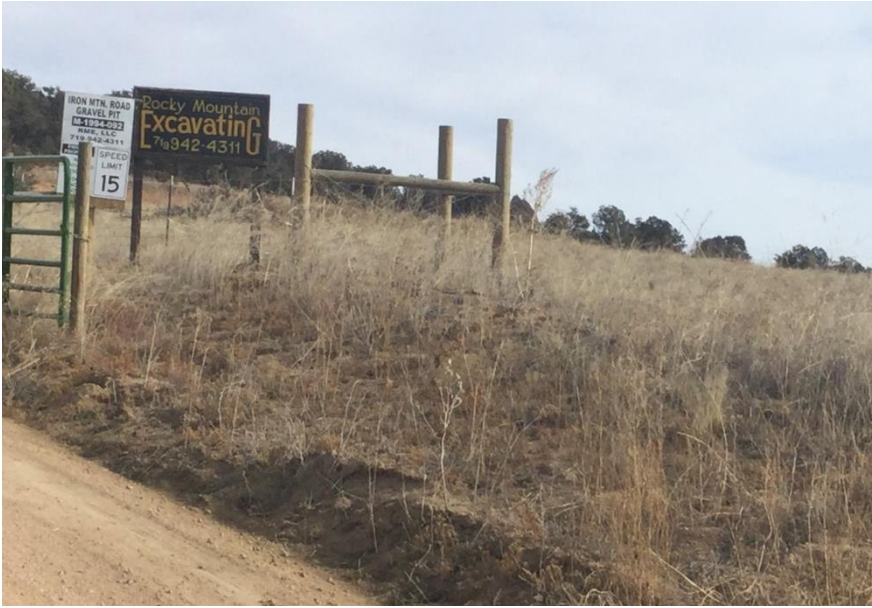
The new sign posted at the entrance to the site

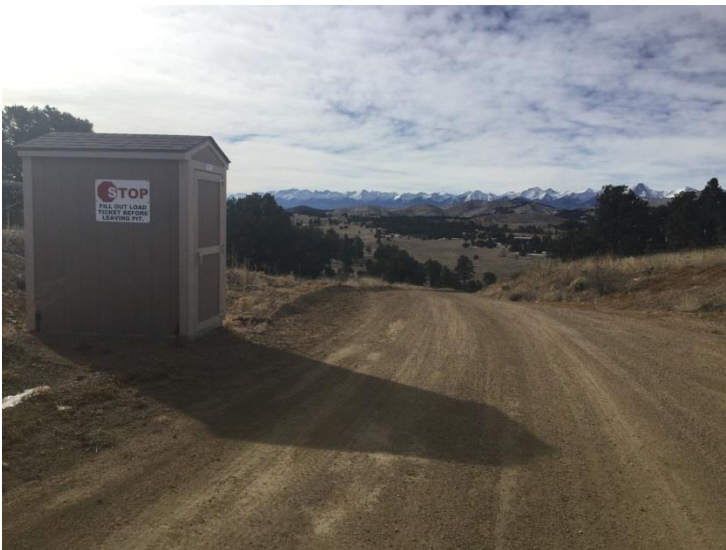
The load-ticket station along the site's access road

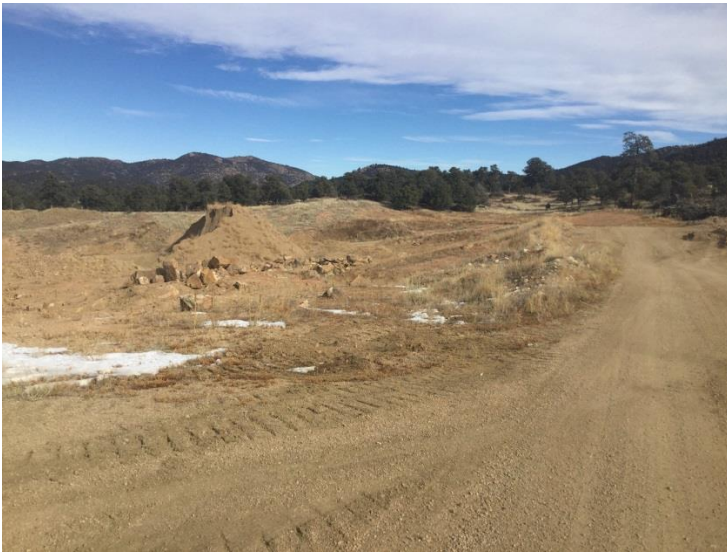
An overview of the active pit from the southeast corner of the site

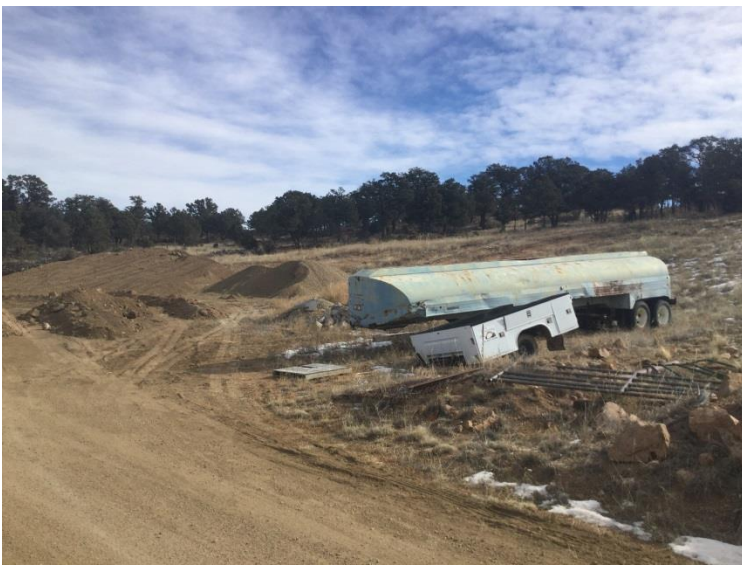
The equipment left by the previous operator, which needs to be removed from the site

SAFETY	No safety hazards were observed during the inspection.
ENGINEERING/ GEOLOGIC & STABILITY CONDITIONS		The site did not appear to have any engineering or geologic stability issues.
OTHER LOCAL/ STATE/ FEDERAL REQ. & COMPLIANCE		The site appears to be in compliance with all state and federal requirements. The DRMS sign was posted at the site's entrance.
OTHER OBSERVATIONS/NOTES		<ul style="list-style-type: none"><li>- I was met onsite by both of the operators at different times during the inspection.</li><li>- While onsite, I conducted a GPS survey of the fenced-in permit boundary and access road.</li><li>- The previous operator still has equipment onsite (water truck, and trailer) as well as some trash (scrap metal, chair, and desk) that need to be removed.</li></ul>

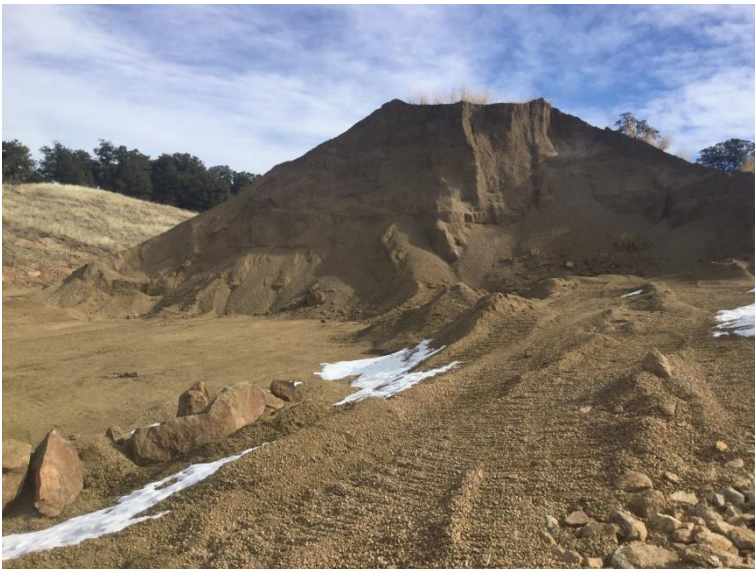
The site's stockpile of fine/fill material

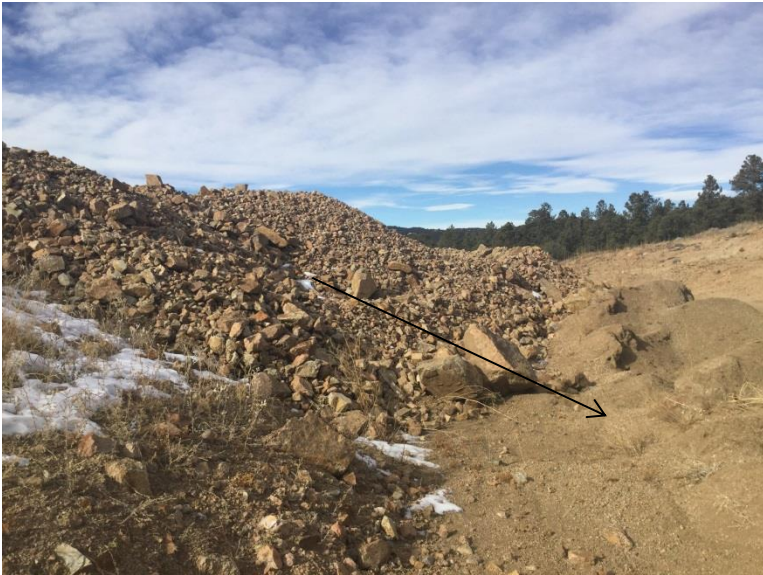
The site's material before and after it has been crushed and screened

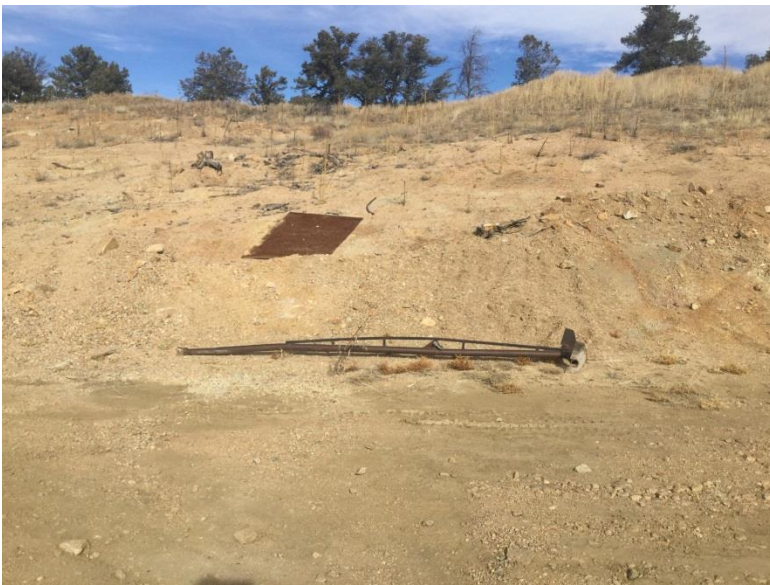
Scrap metal and machine equipment onsite, that was left by the previous operator

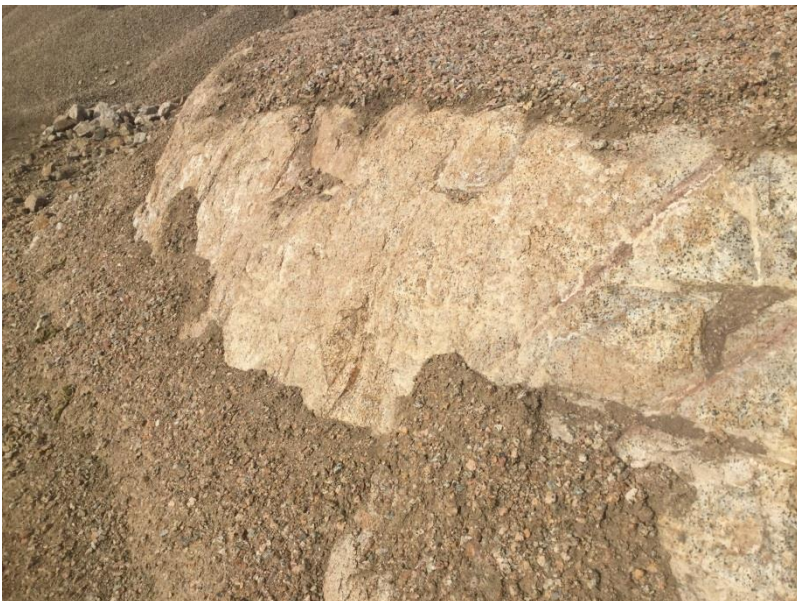
An outcrop of bedrock material on the northern end of the mine floor

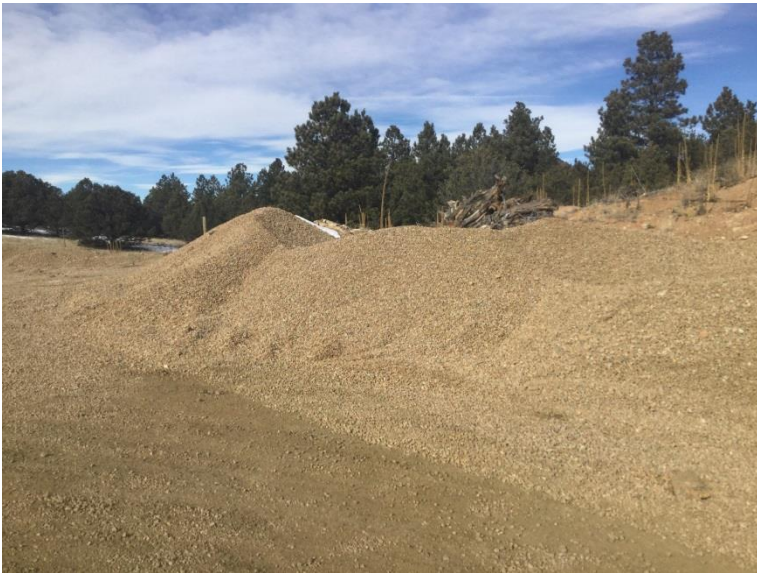
Stockpiled material in the northwestern corner of the site

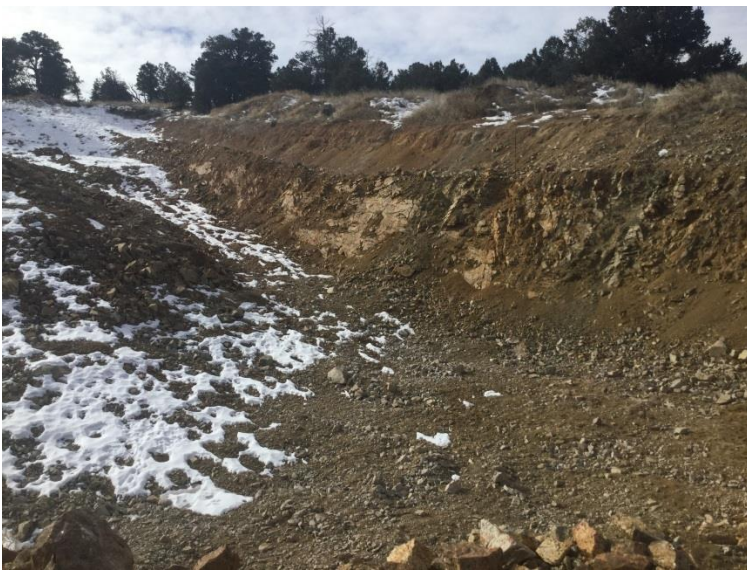
The site's highwall on the southwestern side of the pit, where blasting will likely occur when the operator has depleted their current stockpiles.

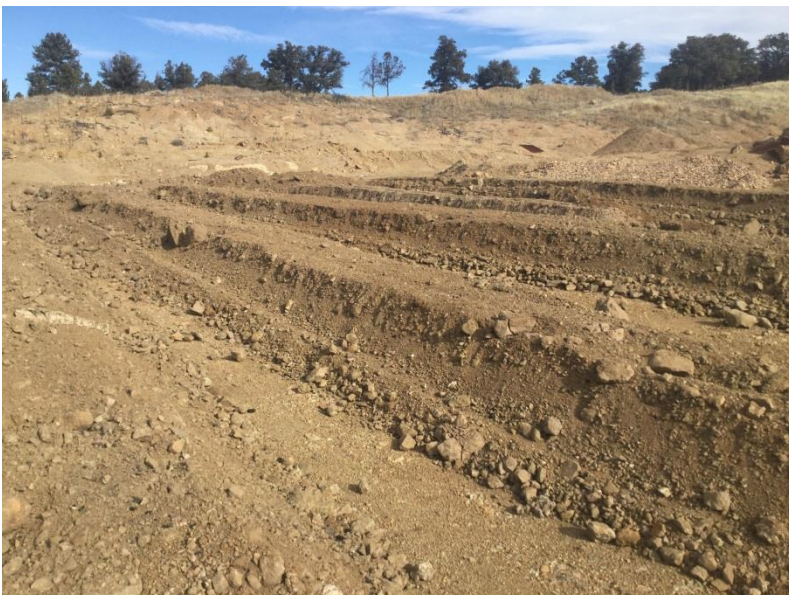
What appears to be overburden, or fine material, that has been organized into North-South oriented rows.
