COLORADO DIVISION OF RECLAMATION, MINING AND SAFETY
MINERALS PROGRAM INSPECTION REPORT
PHONE: (303) 866-3567

MINE NAME: Rock Dog #1	MINE/PROSPECTING ID#: M-2005-045	MINERAL: Sand and gravel	COUNTY: La Plata
INSPECTION TYPE: Monitoring	INSPECTOR(S): Lucas J. West	INSP. DATE: March 29, 2016	INSP. TIME: 11:45
OPERATOR: Oldcastle SW Group, Inc. dba Four Corners M	OPERATOR REPRESENTATIVE: Chris Gray	TYPE OF OPERATION: 112c - Construction Regular Operation	
REASON FOR INSPECTION: Normal I&E Program	BOND CALCULATION TYPE: Complete Bond	BOND AMOUNT: \$137,842.00	
DATE OF COMPLAINT: NA	POST INSP. CONTACTS: None	JOINT INSP. AGENCY: None	
WEATHER: Cloudy	INSPECTOR'S SIGNATURE:

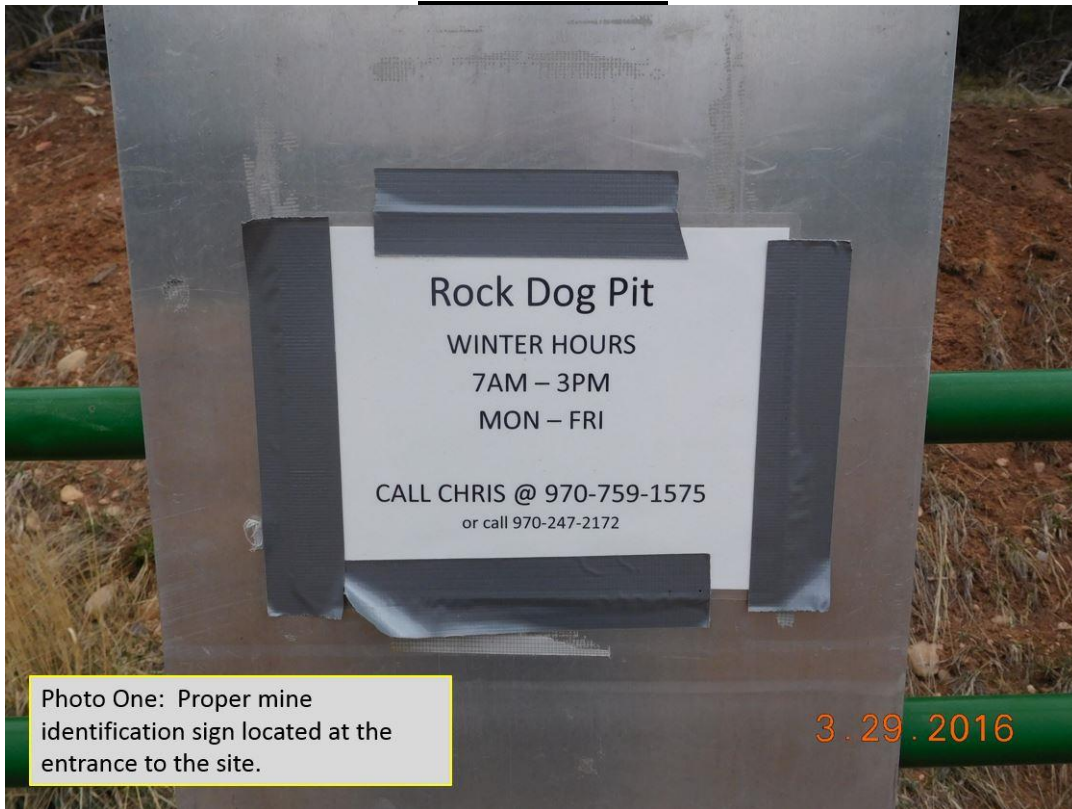
Proper Mine identification signage is posted on the front gate, shown in Photo One, and the permit boundaries were clearly outlined with berms, fence lines and T-Posts. The site was not active during the inspection. The current mining activity is concentrated in the area identified as Phase B in the mine plan maps. Phase B has been stripped, as seen in Photos Two and Three with the overburden stockpiled. All mining activities were contained within the permit boundaries. The site consists of 210.9 Acres and currently has approximately 38 Acres disturbed. On site conversations with the site foreman indicate that mining activities will not proceed west of the Florida, as originally planned and approved. Storm water control features were observed and appeared to be functioning properly in response to snow melt and recent precipitation events.

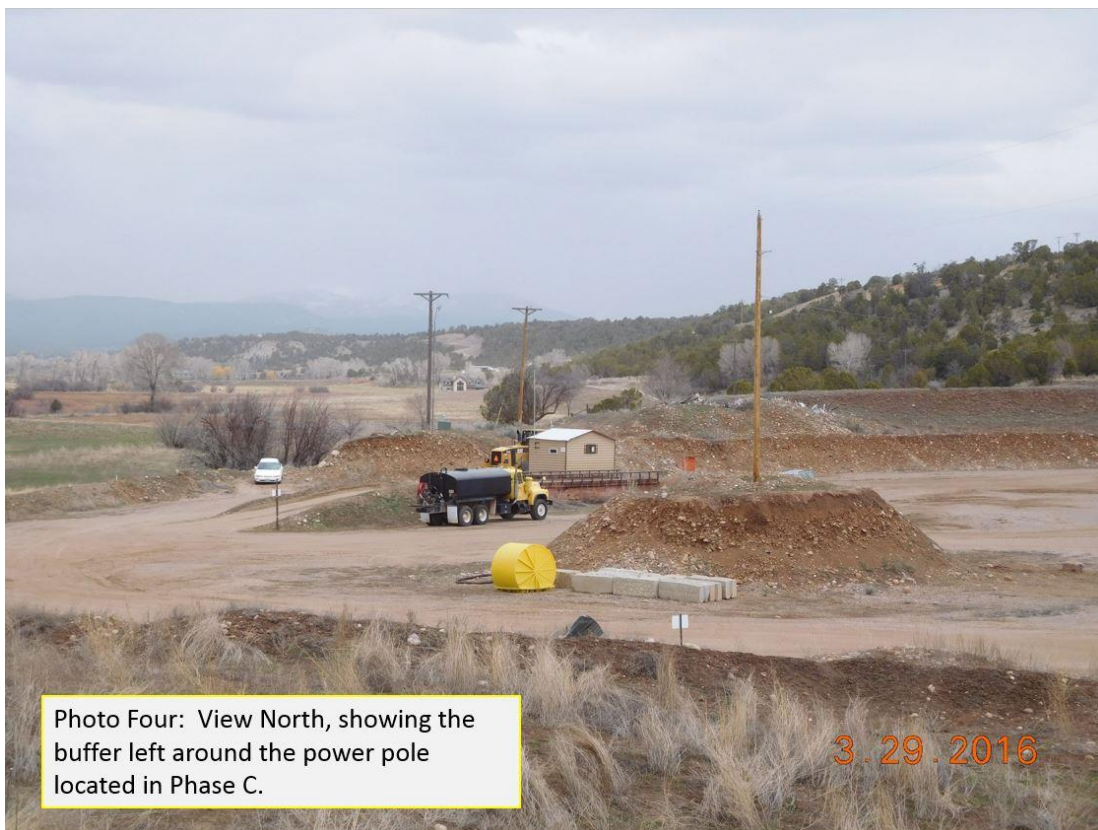
Various equipment, including a water truck and front end loader, was observed during the inspection. All fuel tanks had appropriate secondary containment and was in good condition. A power line owned and operated by the La Plata Electric Association cuts through the permitted area. Photo Four shows one of the poles that has been mined around. The mining activities left a sufficient buffer around the pole and appears to be stable. Some debris was located on site, however it was consolidated and stored in an orderly fashion and are not a problem at this time.

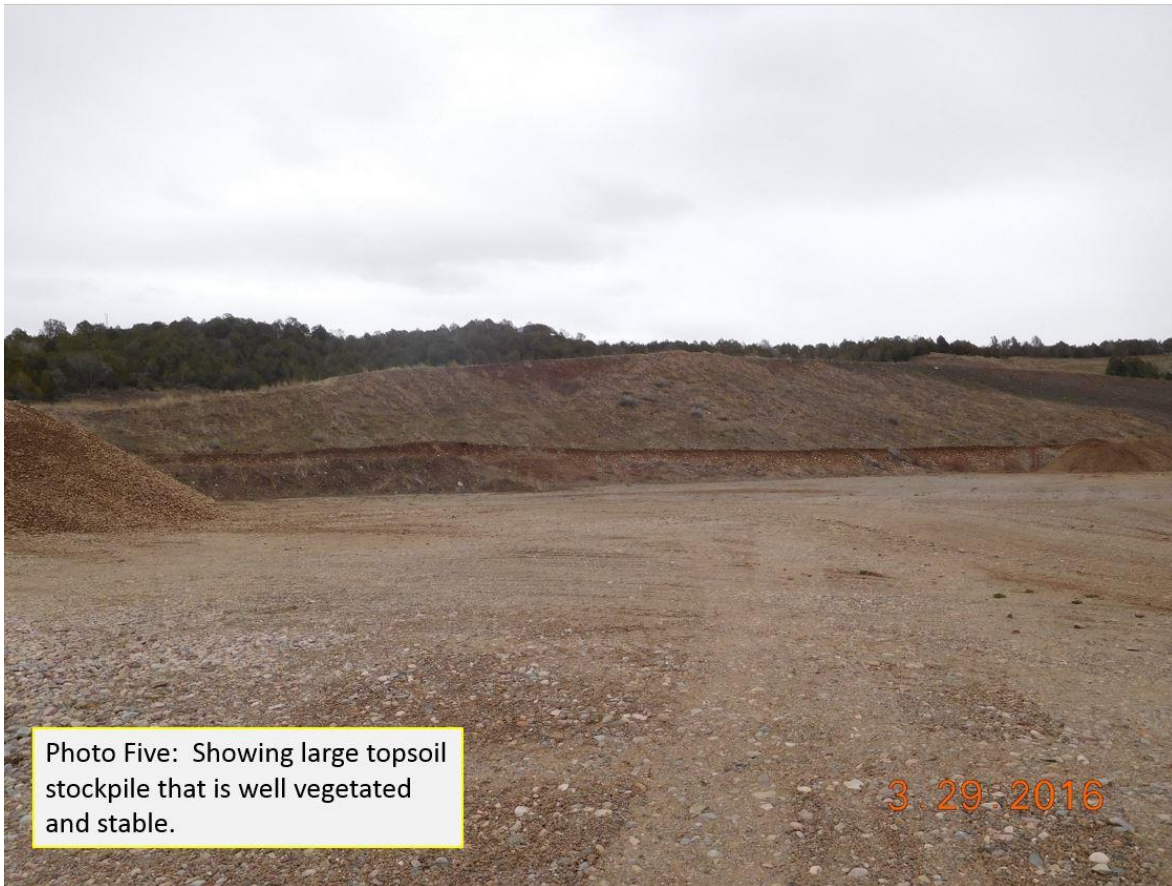
Several Stockpiles were observed throughout the site of various sized materials. All stockpiles appeared to be stable and in good condition. Photo Five shows the Topsoil stockpile that was observed on the East side of the site. The pile is large and well vegetated, showing no signs of erosion. No signs of erosion were identified on the entire site. Evidence of last years weed treatment was observed on a patch of thistle located south of the scale house. Some minor areas of new growth was observed, and conversations with the operator indicate that the site is scheduled to be treated soon. The overall footprint of the site was in good condition and no problems or possible violations were observed.
