COLORADO DIVISION OF RECLAMATION, MINING AND SAFETY
MINERALS PROGRAM INSPECTION REPORT
PHONE: (303) 866-3567

| MINE NAME: North Clear Creek Construction Materials Mi | MINE/PROSPECTING ID#: M-2006-039 | MINERAL: Sand & Gravel | COUNTY: Garfield |
| INSPECTION TYPE: Monitoring | INSPECTOR(S): Amy C. Yeldell | INSP. DATE: April 13, 2016 | INSP. TIME: 14:00 |

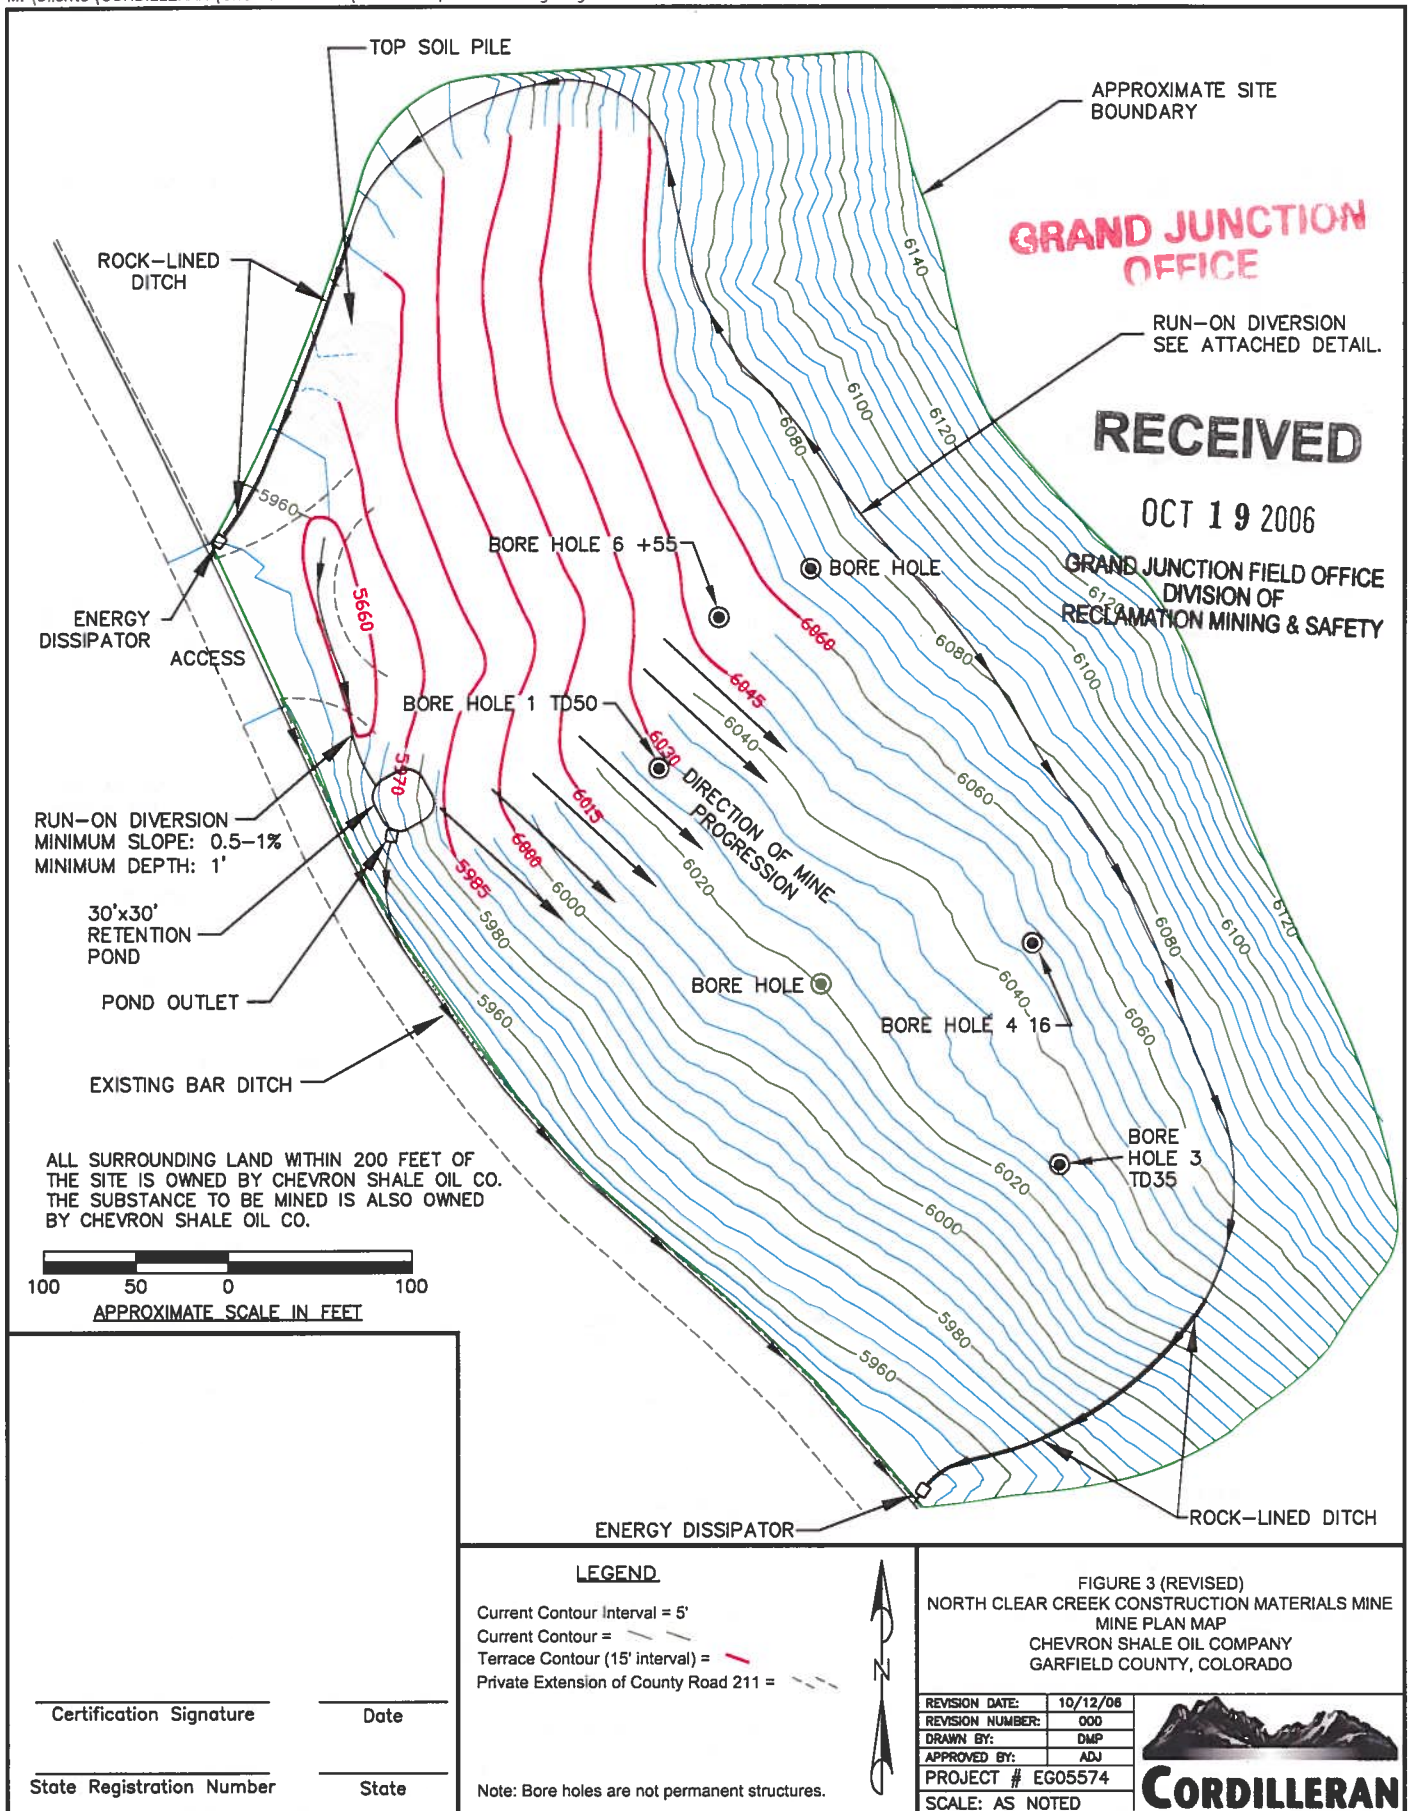
Staff digitized the permit boundary depicted in the 2015 annual report using google earth images which

coincides to the striped land. This permit boundary does not match the boundary delineated in the permit application (map attached). The site appears to be approximately 11 acres which is larger than the approved 8 acres. Depending on the extent in which land has been affected outside of the permit boundary this could be a possible violation of mining without a permit or failure to protect lands from off-site damages. The Division is requesting that the operator survey the current disturbance to clarify the total affected acreage to date. Then the operator shall provide the Division with documentation of their findings within 90 days of this inspection report including an updated map. Upon receipt of this information the Division will make its determination of how to proceed forward and rectify the situation.

CORRECTIVE ACTIONS: The operator shall, survey the current disturbance to clarify the total affected acreage to date. The operator shall provide the Division with documentation of their findings, including updated maps by the corrective action date. Upon receipt of this information the Division will make its determination of how to proceed forward and rectify the situation.
