COLORADO DIVISION OF RECLAMATION, MINING AND SAFETY
MINERALS PROGRAM INSPECTION REPORT
PHONE: (303) 866-3567

MINE NAME: Texas Creek Gravel Pit	MINE/PROSPECTING ID#: M-1980-143	MINERAL: Sand and gravel	COUNTY: La Plata
INSPECTION TYPE: Monitoring	INSPECTOR(S): Lucas J. West	INSP. DATE: March 29, 2016	INSP. TIME: 14:50
OPERATOR: Neil's Excavation	OPERATOR REPRESENTATIVE: None	TYPE OF OPERATION: 110c - Construction Limited Impact

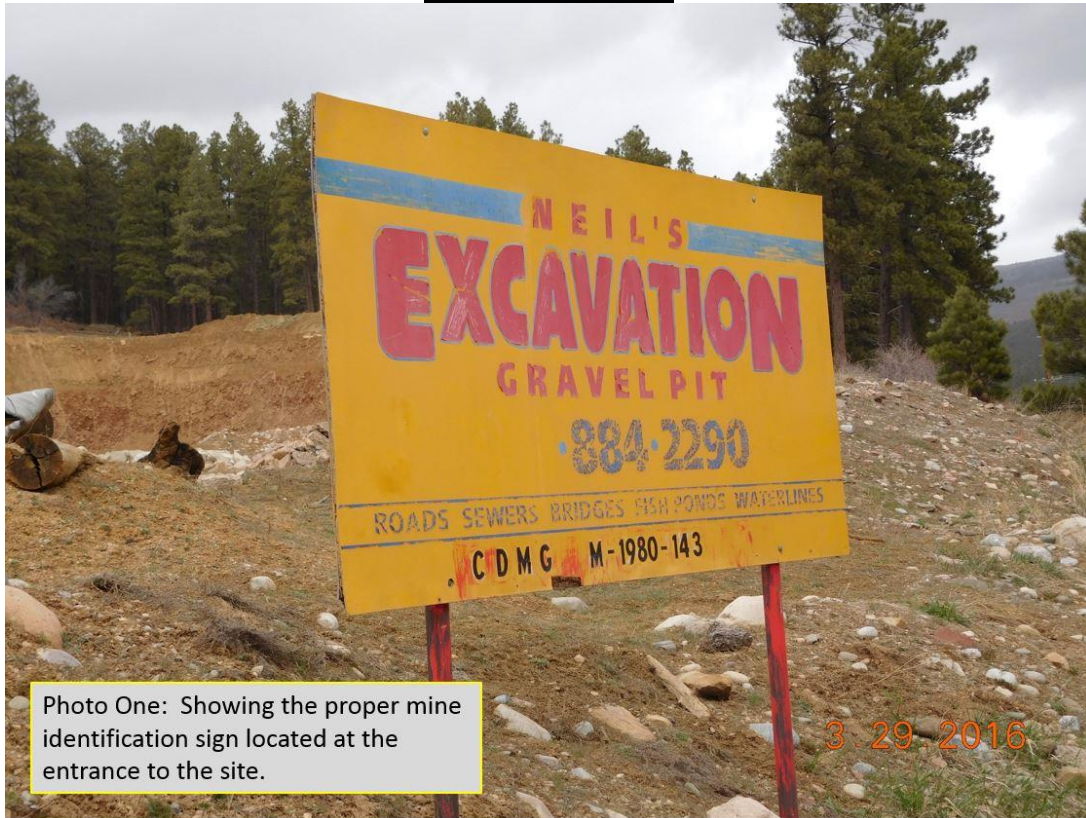
Proper Mine identification signage was observed, shown in Photo One, and the permit boundaries were clearly marked with berms and T-Posts. The site was not active during the time of the inspection. All mining activities are contained within the permit boundaries. The activity is contained to a small section of highwall located to in the North corner of the pit and is approximately 60 to 70 feet tall as seen in Photo Two. Various stockpiles of material were located on the pit floor as well as a topsoil stockpile located to the North of the highwall. All stockpiles appear to be stable and in good condition.

Photo One: Showing the proper mine identification sign located at the entrance to the site.

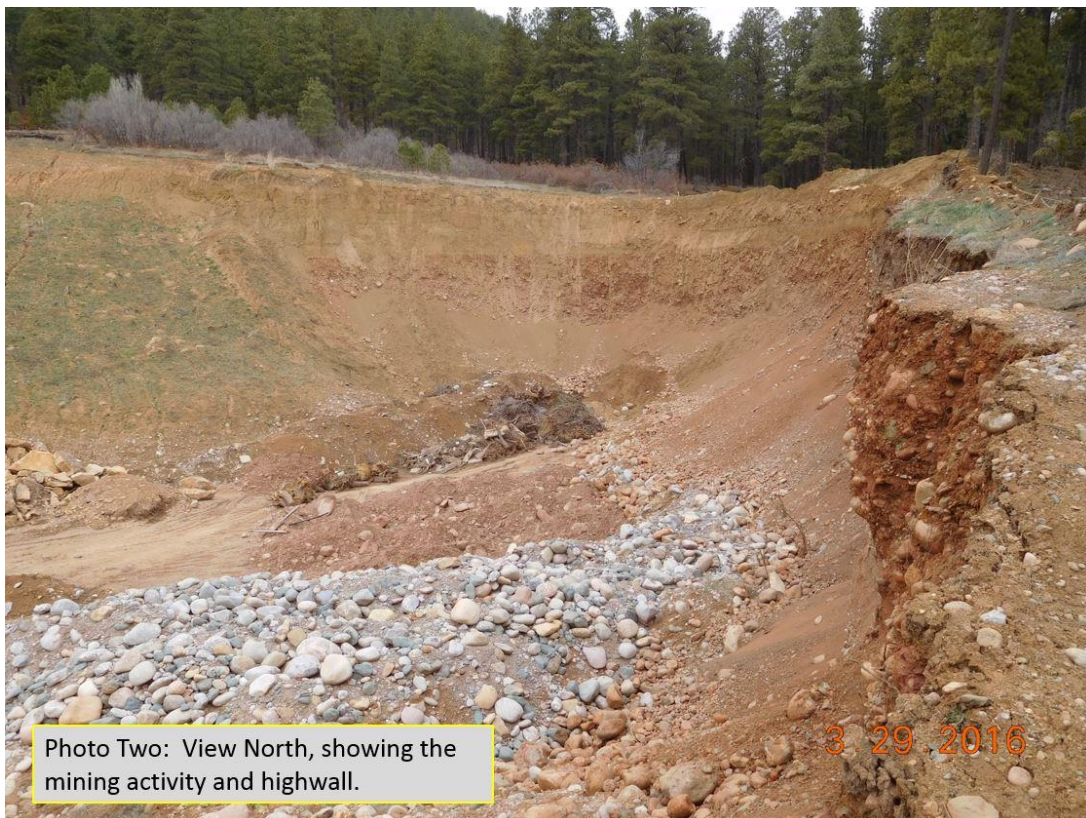
Photo Two: View North, showing the mining activity and highwall.

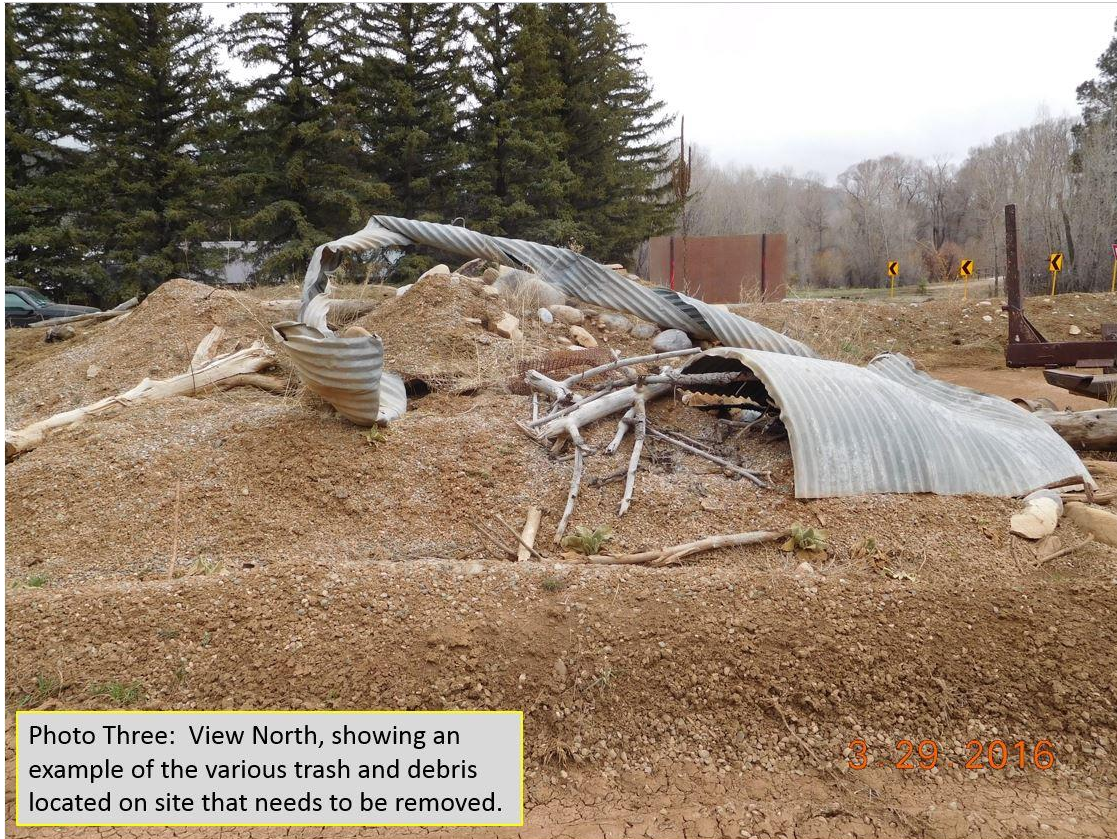
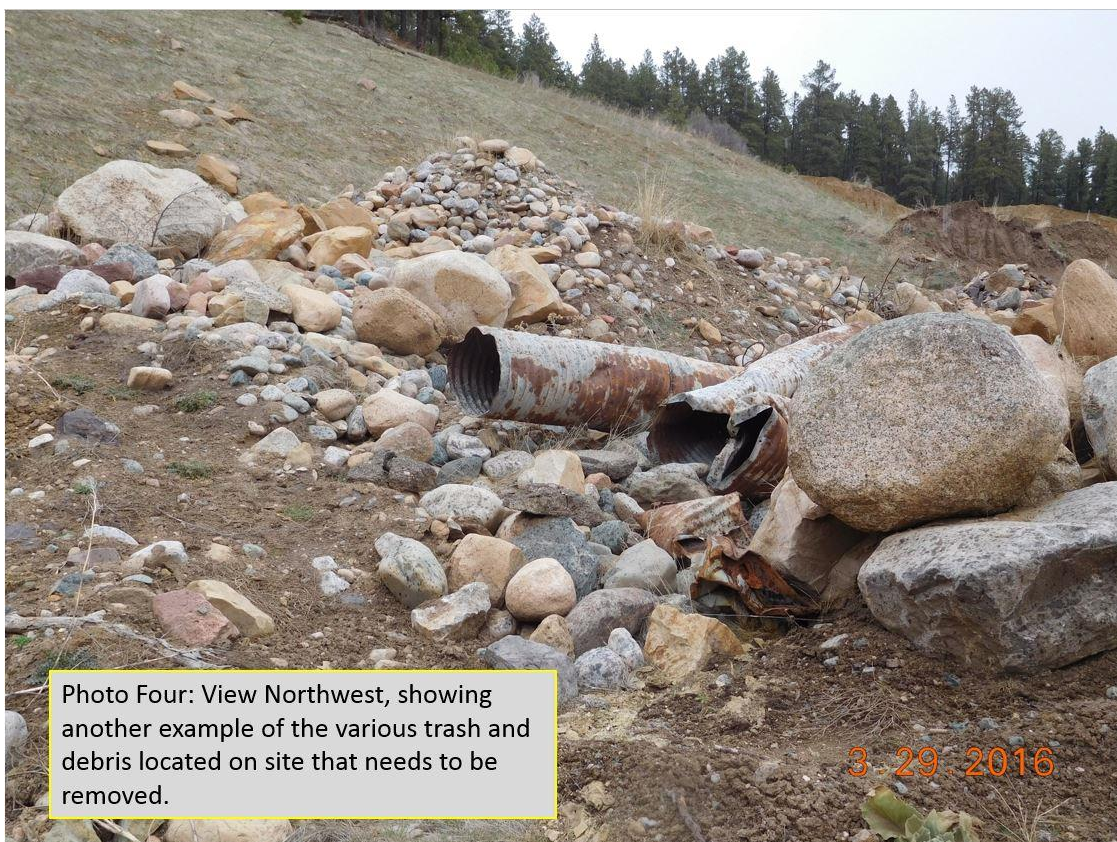
Intermingled with some of the overburden stockpiles that were observed, and in other areas of the site was various trash including pieces of culverts, springs and other debris shown in Photos Three and Four. The Operator needs to remove these from the site and continue to keep the site free from trash and debris. If the items are not removed by the time the Division does its next routine monitoring inspection, then removal of the debris will need to be included in the next reclamation cost update.

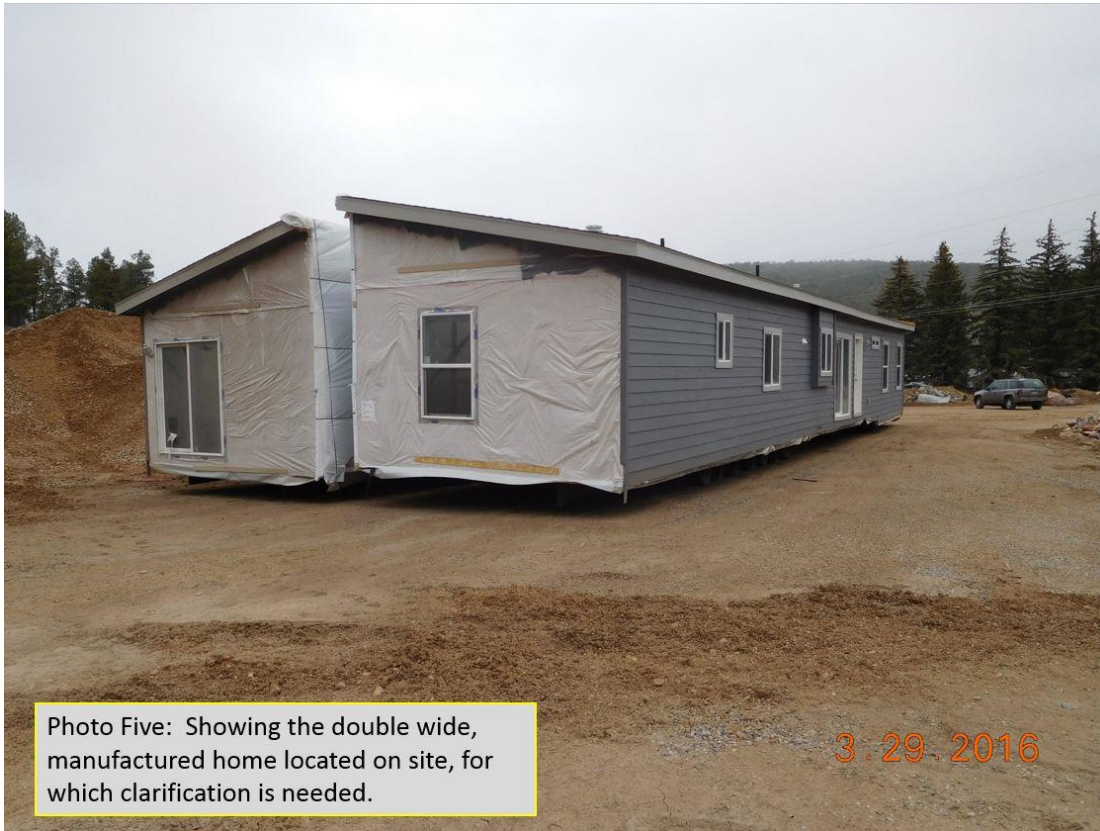
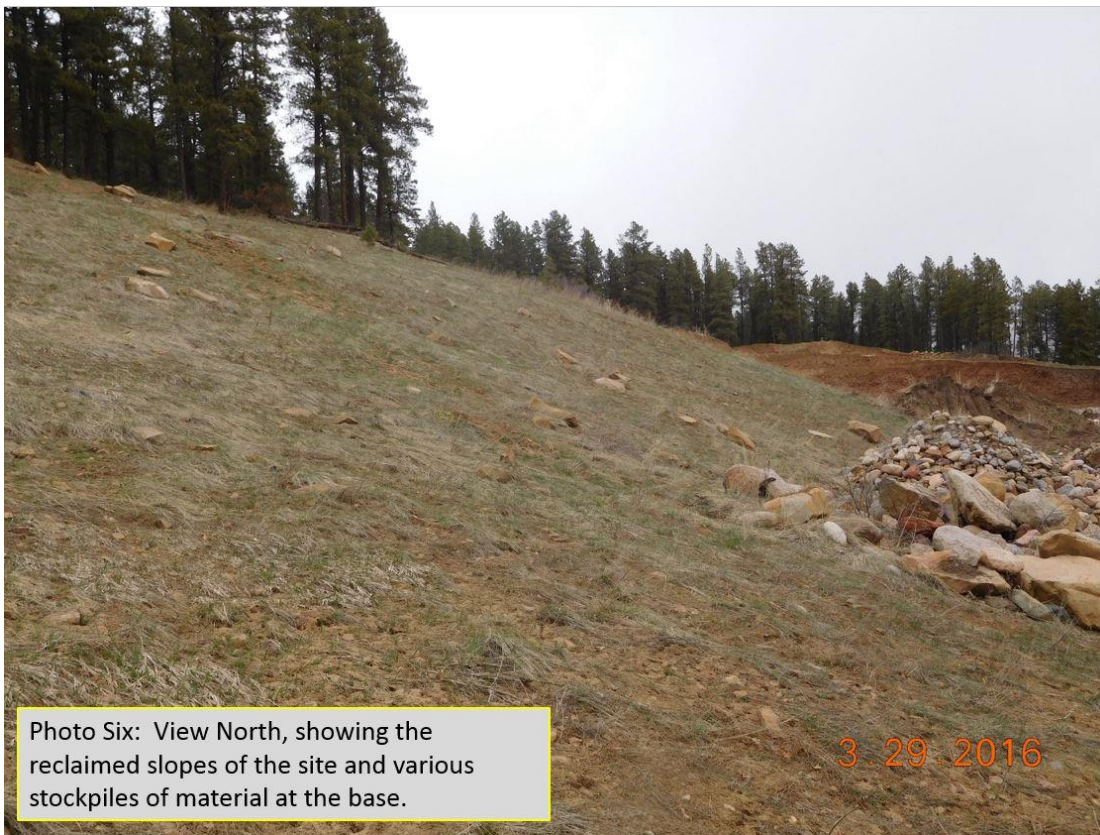
Photo Five shows both halves of a double wide manufactured home, on trailers, were observed onsite. The intended post mining land use for the site is industrial / commercial and was identified in the original application as a building site. However, no permanent structures are identified in the permit file. It is unclear if the home is to remain on site as part of the post mining land use. If the home is intended to be placed on site, then clarification as to the exact location of the home will need to be addressed through the Technical Revision process. If the home is being temporarily stored on site, it will need to be kept in good order or removed prior to the Division's next routine monitoring inspection. Failure to remove the home prior to then will result in including the removal and disposal of the home from the site in the next reclamation cost update. Please contact the Division for clarification on this matter.

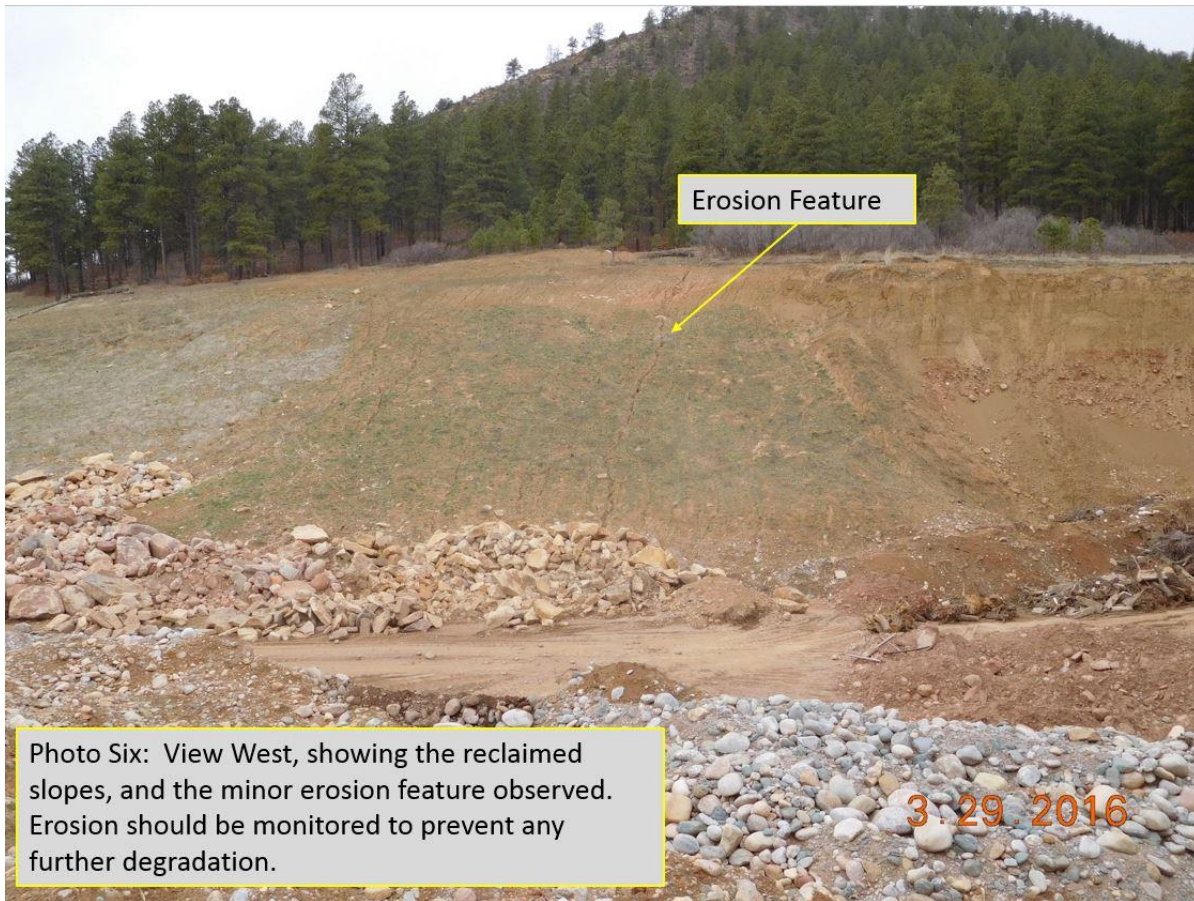
The Operator has begun contemporaneous reclamation by backfilling and reseeding sections as the highwall has advances. Photo Six shows the reclaimed areas. Minor erosion was observed on the reclaimed slope shown in Photo Seven, and the vegetation aiding in the stability. The Operator is advised to observe the minor erosion, and if necessary, take action should the erosion begin to worsen. Evidence of weed treatment was observed, and no new growth of noxious weeds were noted. Storm water control devices were observed and appeared to be functioning properly. No problems or possible violations were observed during this inspection.

Photo Six: View West, showing the reclaimed slopes, and the minor erosion feature observed. Erosion should be monitored to prevent any further degradation.
