COLORADO DIVISION OF RECLAMATION, MINING AND SAFETY
MINERALS PROGRAM INSPECTION REPORT
PHONE: (303) 866-3567

MINE NAME: Monument View Gravel Pit	MINE/PROSPECTING ID#: M-2000-032	MINERAL: Sand and gravel	COUNTY: Mesa
INSPECTION TYPE: Monitoring	INSPECTOR(S): Stephanie J. Mitchell	INSP. DATE: February 18, 2016	INSP. TIME: 10:00
OPERATOR: M.A. Concrete Construction, Inc.	OPERATOR REPRESENTATIVE: Martin Azcarraga	TYPE OF OPERATION: 112c - Construction Regular Operation

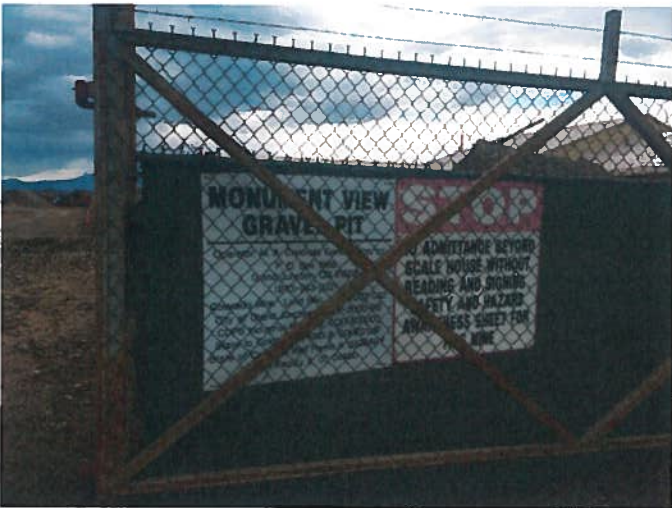
Adequate mine identification signage was noted at the entrance to the site. The affected area was adequately marked with fencing. The North and West permit boundaries were protected by a berm.

Mine ID Sign

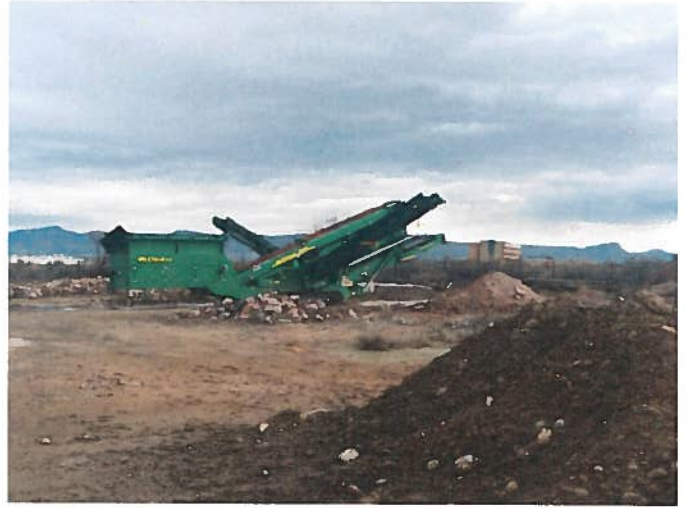
Mining was taking place during this inspection. Materials stockpiles were located at various locations throughout the pit floor. An office and scale had been constructed near the west permit boundary. An asphalt plant was located in the northeast part of the permit area. A portable crusher and screener were on site.

Crusher on site

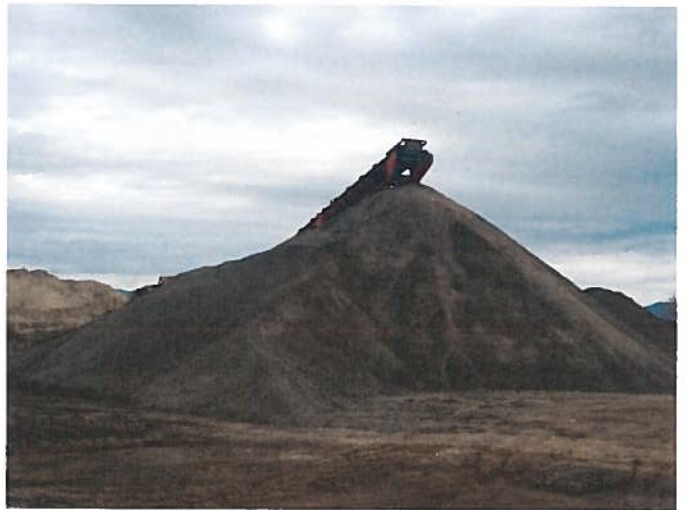
Material Stockpile

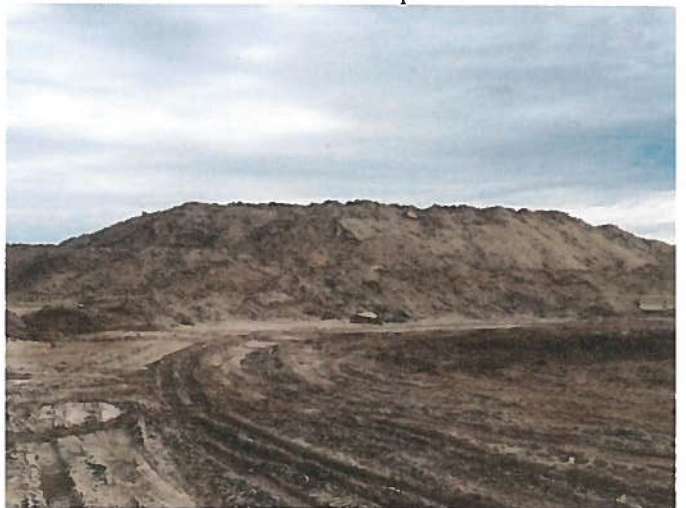
Overburden

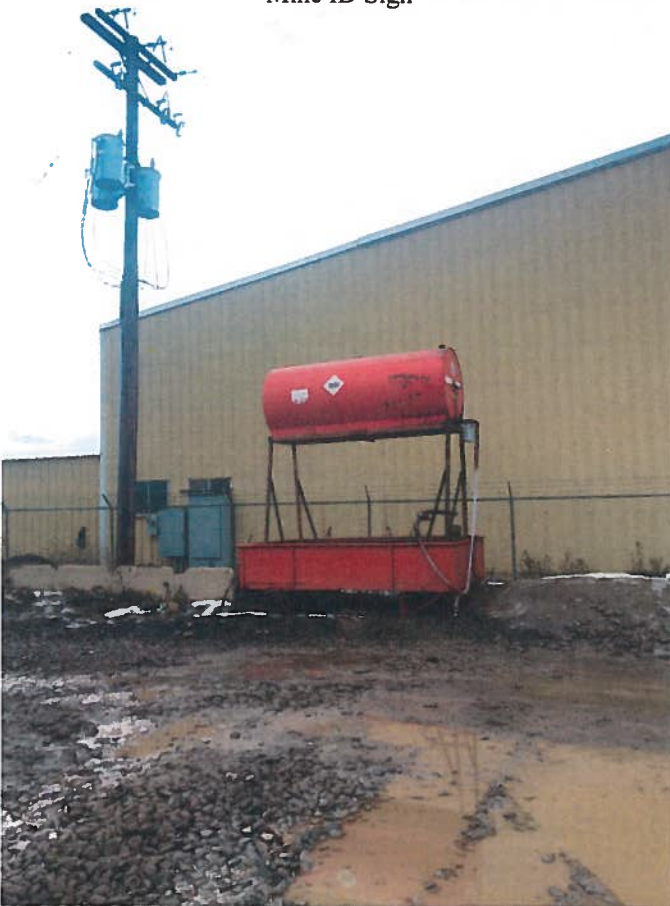
Topsoil stockpiles are protected with adequate vegetation. Fuel containers observed on site were stored in adequate secondary containment structures.

Fuel Tank with Secondary containment

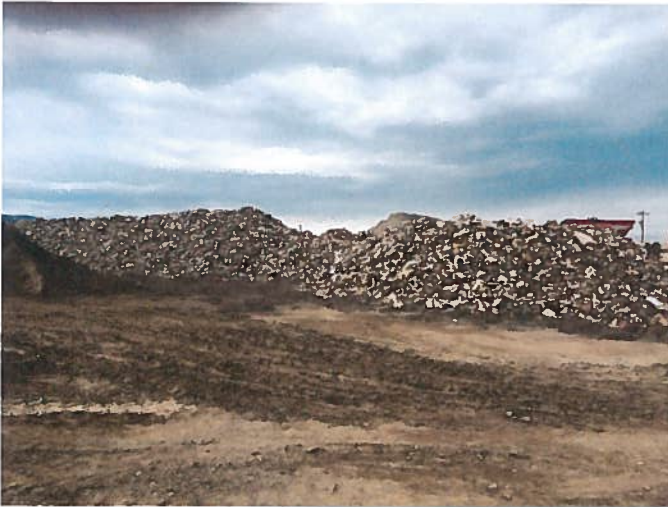
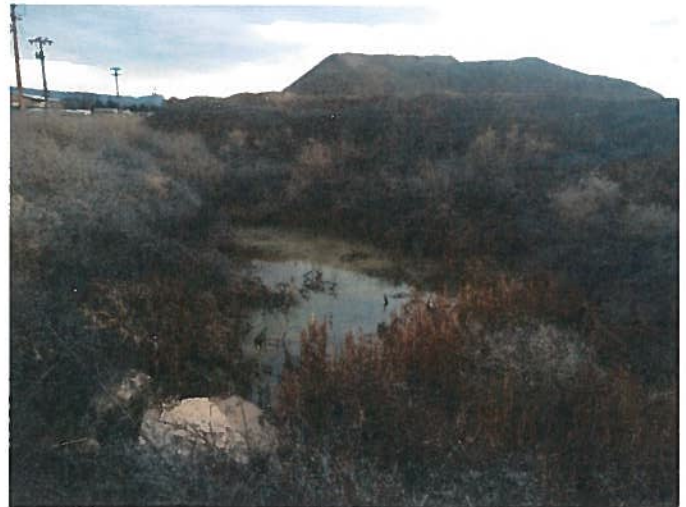
Retention Pond

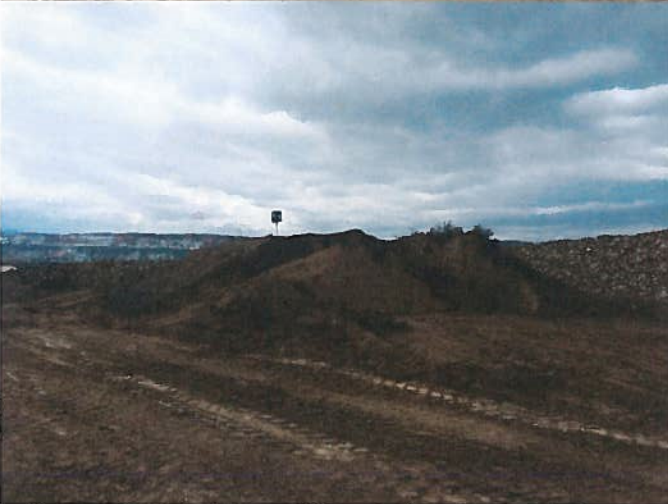
Topsoil Stockpile

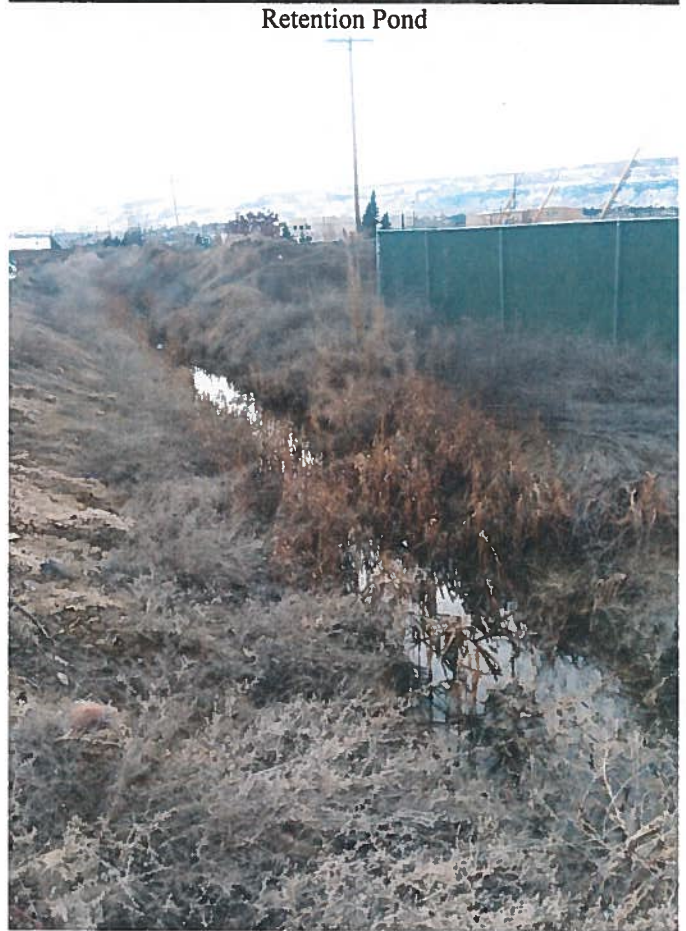
Noxious weeds were not observed onsite. A ditch is located along the western boundary of the permit area.

Ditch along west boundary
