COLORADO DIVISION OF RECLAMATION, MINING AND SAFETY
MINERALS PROGRAM INSPECTION REPORT
PHONE: (303) 866-3567

MINE NAME: Orchard Grove Industrial Pit	MINE/PROSPECTING ID#: M-1990-094	MINERAL: Gravel	COUNTY: Mesa
INSPECTION TYPE: Monitoring	INSPECTOR(S): Stephanie J. Mitchell	INSP. DATE: February 18, 2016	INSP. TIME: 13:00
OPERATOR: Parkerson Construction, Inc.	OPERATOR REPRESENTATIVE: Ivan Geer	TYPE OF OPERATION: 112c - Construction Regular Operation

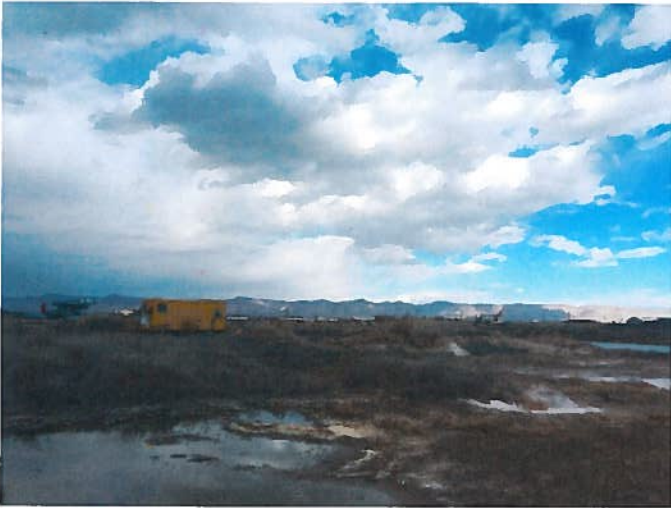
Some standing water- less than 72 hour retention

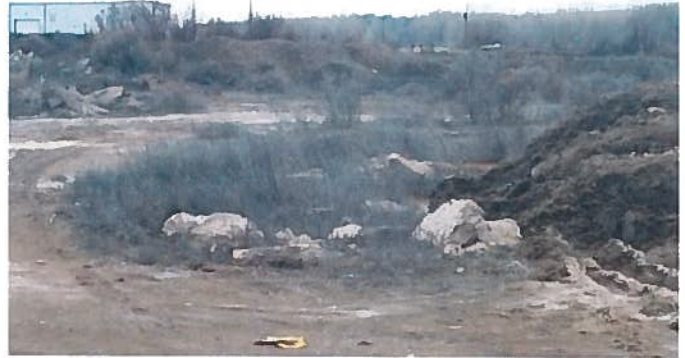
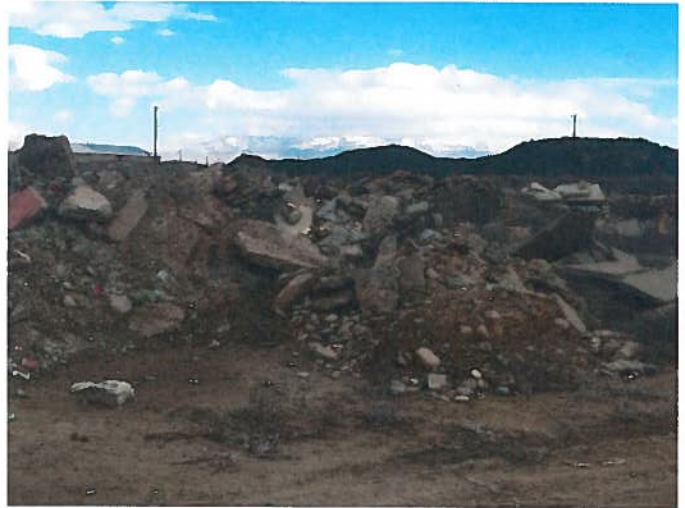
Offsite material (inert) is being stored on site, but has been allowed since 1998.

Offsite material

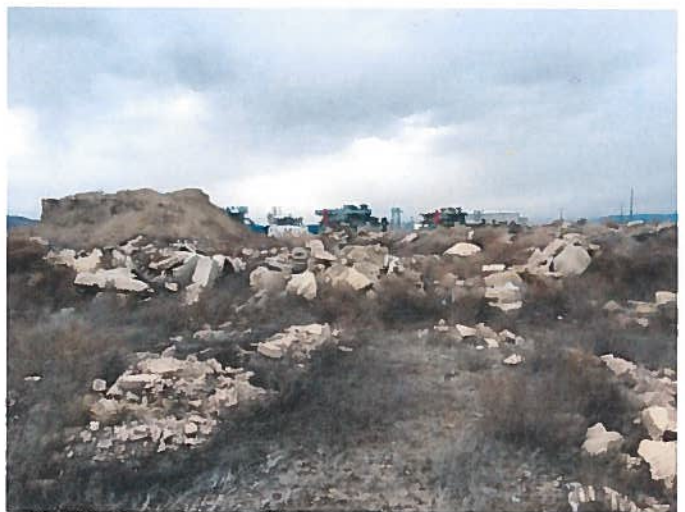
Offsite material
