COLORADO DIVISION OF RECLAMATION, MINING AND SAFETY
MINERALS PROGRAM INSPECTION REPORT
PHONE: (303) 866-3567

MINE NAME: Craig Pit	MINE/PROSPECTING ID#: M-1976-027	MINERAL: Sand and gravel	COUNTY: La Plata
INSPECTION TYPE: Surety-Related Inspection	INSPECTOR(S): Lucas J. West	INSP. DATE: April 8, 2016	INSP. TIME: 11:15
OPERATOR: Skanska USA Civil West R.M.D. Inc.	OPERATOR REPRESENTATIVE: Joe Schluter	TYPE OF OPERATION: 112c - Construction Regular Operation

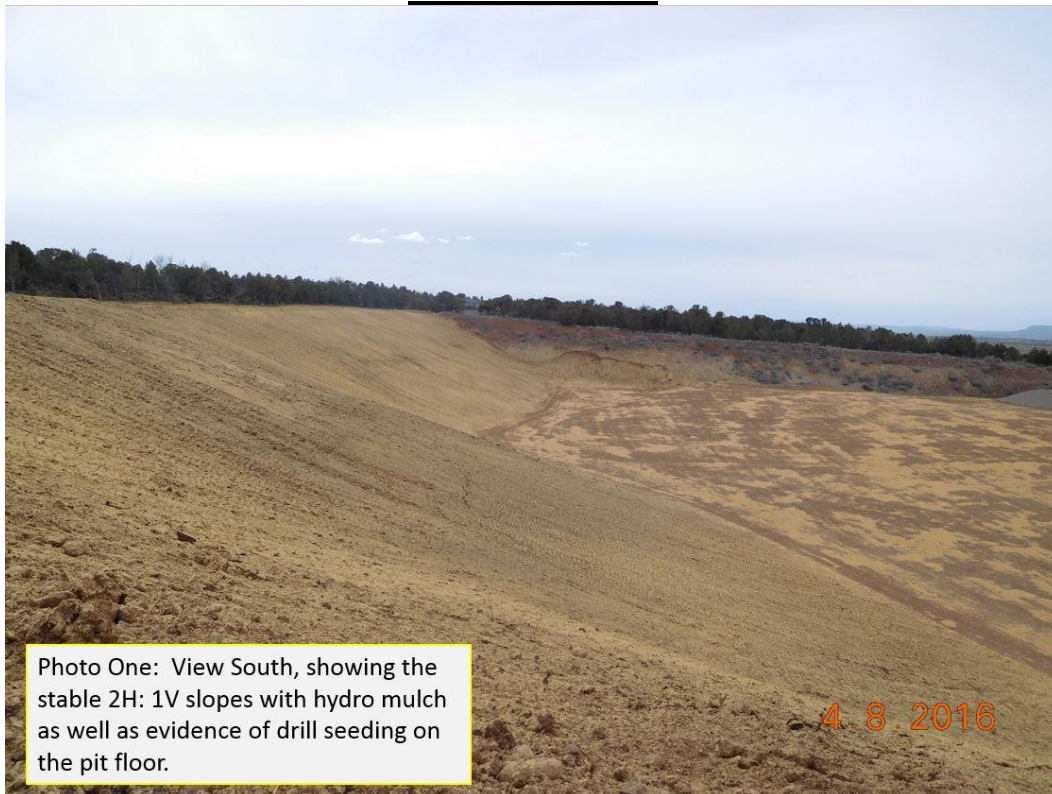
The grading outlined in the TR03 directly reflects the conditions of the site. The side slopes Shown in Photo One, around the pit floor were graded to the approved 2H: 1V, and appear stable. No signs of erosion were observed on the site. The pit floor, Photo Two, has been graded to approximately a 5H: 1V sloping to a small catchment basin to convey storm water runoff. The pit floor also appears to be stable and shows no signs of erosion. The entire site was revegetated in March of 2016 with the updated seed mix identified in TR04. The side slopes were broadcast and hydro mulched, while the pit floor was drill seeded, and mulched. Evidence of drill seeding and the hydro mulch on the slopes can be seen in Photo Three.
