COLORADO DIVISION OF RECLAMATION, MINING AND SAFETY
MINERALS PROGRAM INSPECTION REPORT
PHONE: (303) 866-3567

MINE NAME: The Pride of America Mine	MINE/PROSPECTING ID#: M-1999-058	MINERAL: Marble	COUNTY: Gunnison
INSPECTION TYPE: Pre-operation Inspection	INSPECTOR(S): Dustin Czapla, Amy Yeldell	INSP. DATE: April 27, 2016	INSP. TIME: 11:00
OPERATOR: Colorado Stone Quarries, Inc.	OPERATOR REPRESENTATIVE:	TYPE OF OPERATION: 112c - Construction Regular Operation

REASON FOR INSPECTION: Pre-operation Inspection	BOND CALCULATION TYPE: None	BOND AMOUNT: \$402,631.00
DATE OF COMPLAINT: NA	POST INSP. CONTACTS: None	JOINT INSP. AGENCY: None
WEATHER: Clear	INSPECTOR'S SIGNATURE:

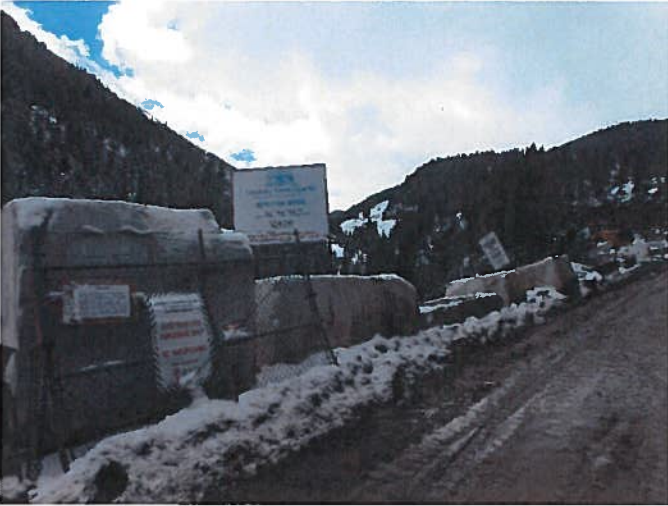
Adequate mine identification signage was noted at the entrance to the site.

Figure 1: CN-1 notice posted at entrance

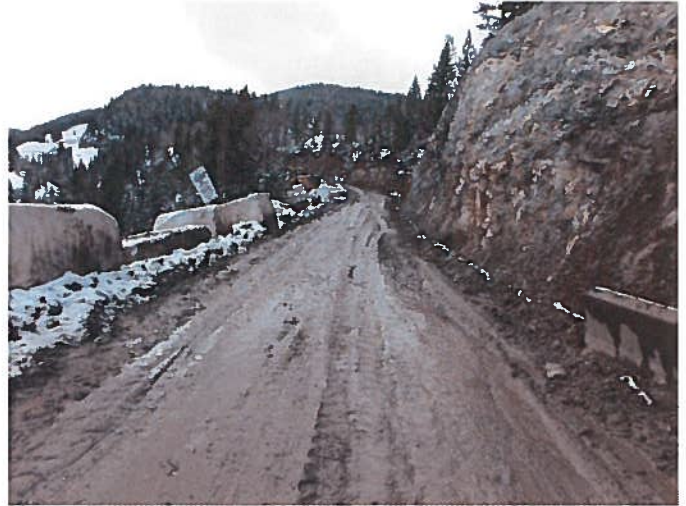
Figure 2: View up access road from gate

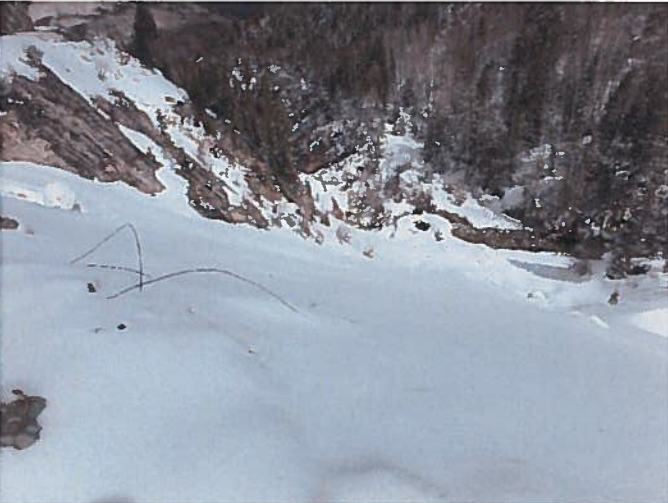
Figure 3: Washington waste rock landform

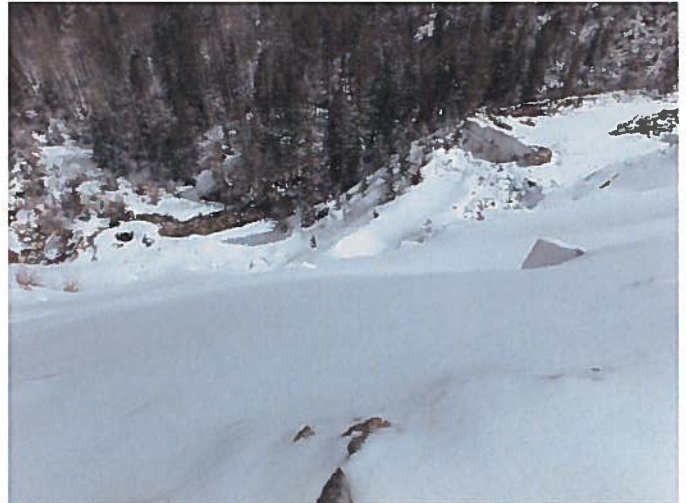
Figure 4: Washington waste rock landform

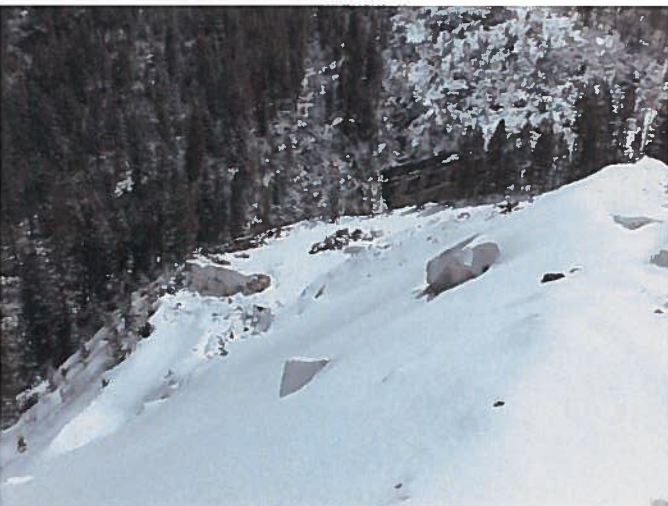
Figure 5: Washington waste rock landform

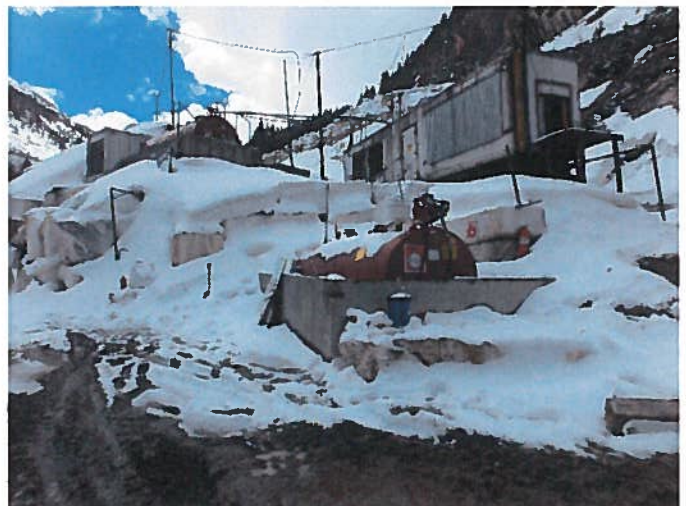
Fuel is stored on site in double wall tanks and concrete containment structures.

Figure 6: Fuel storage and generator located on the bench above the Washington waste rock, near Portal 4

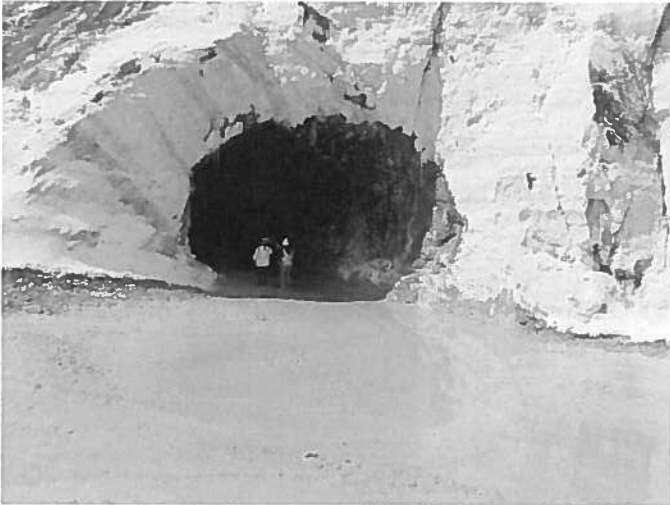
Portals 2 and 3 were barricaded with waste blocks. Portal 4 was still open during the inspection. Stormwater and process water are now directed to the lower part of the Washington Gallery.

Figure 7: Portal 4 and Washington gallery now utilized for stormwater collection

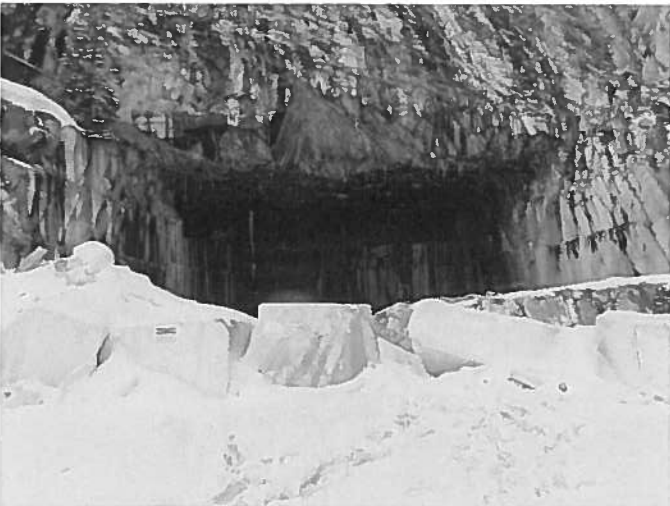
Figure 9: Portal 3 barricaded

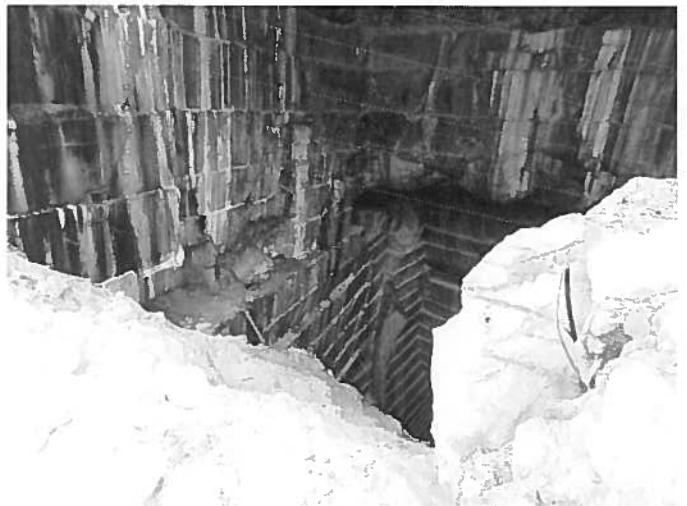
Figure 10: Portal 3 barricaded

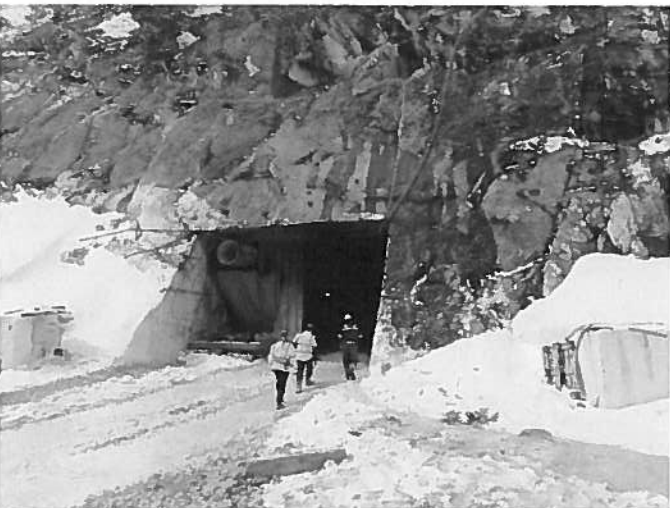
Figure 11: Portal 5

Portals 5, 6 and 7 are currently utilized for access to the active mining areas. Portal 7 was opened in June 2015. The portals appeared stable. Mining was occurring during this inspection. The office trailer and support facilities are located near Portals 5 and 6.

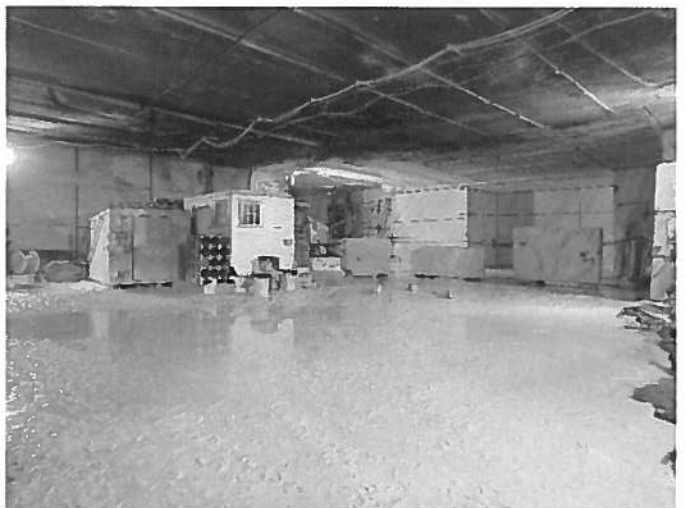
Figure 12: Mining level accessed through Portal 5

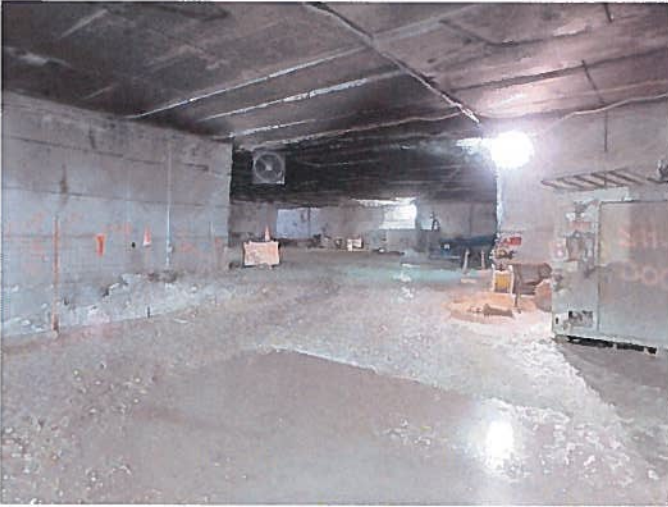
Figure 13: Mining level accessed through Portal 5

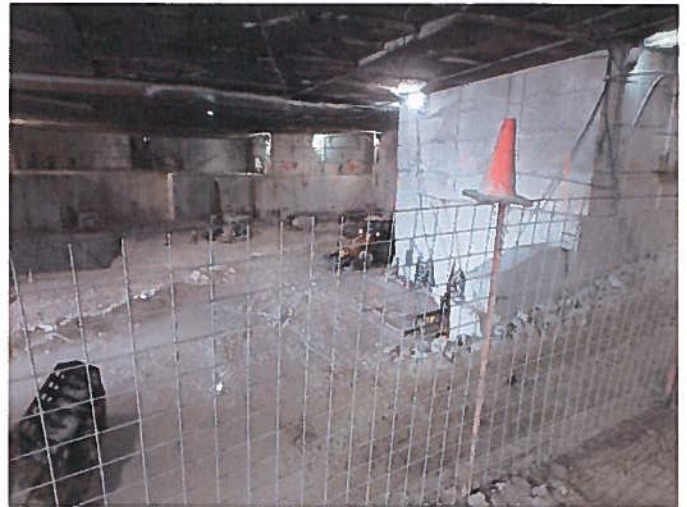
Figure 14: Mining level accessed through Portal 6

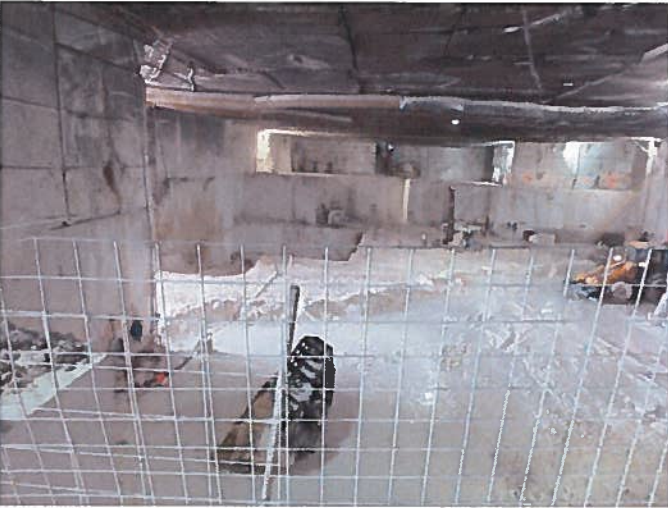
Figure 15: Mining level accessed through Portal 6
