# COLORADO DIVISION OF RECLAMATION, MINING AND SAFETY MINERALS PROGRAM INSPECTION REPORT

MINE NAME:	MINE/PROSPECTING ID#:	MINERAL:	COUNTY:
Platte Valley Operation	M-1989-120	Sand and gravel	Weld
INSPECTION TYPE:	INSPECTOR(S):	INSP. DATE:	INSP. TIME:
Monitoring	Peter S. Hays	May 5, 2016	09:45
OPERATOR:	OPERATOR REPRESENTATIVE:	TYPE OF OPERATION:	
Aggregate Industries - WCR, Inc.	Connie Davis, Jason Anderson	112c - Construction Regular Operation

This inspection was a follow-up to the inspection conducted on February 24, 2016 to verify the completed Platte River breach repair was performed in compliance with Technical Revision No. 5 (TR-05). This inspection was limited to the breach repair only.

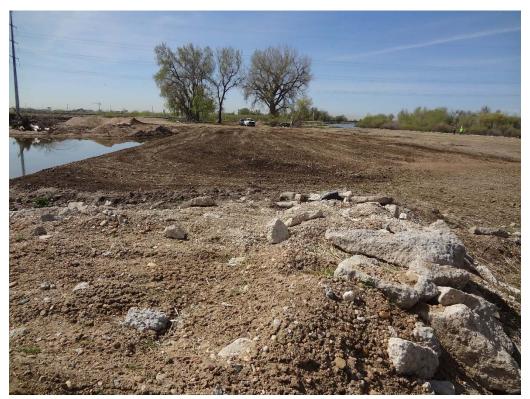
Looking south from NW AI property corner

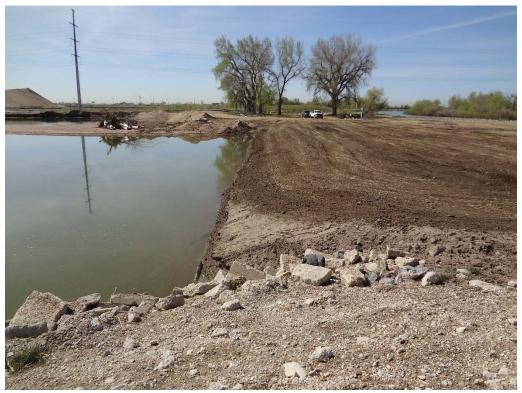
Looking south from NW AI property corner

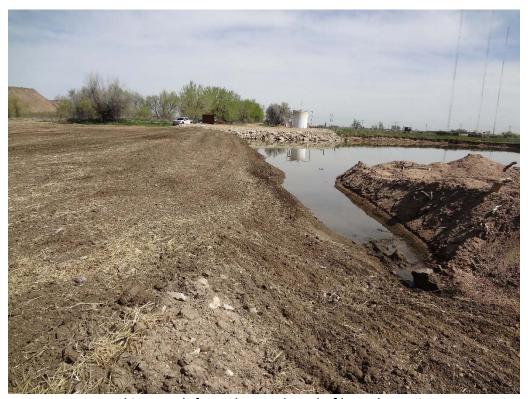
Looking north from the south end of breach repair

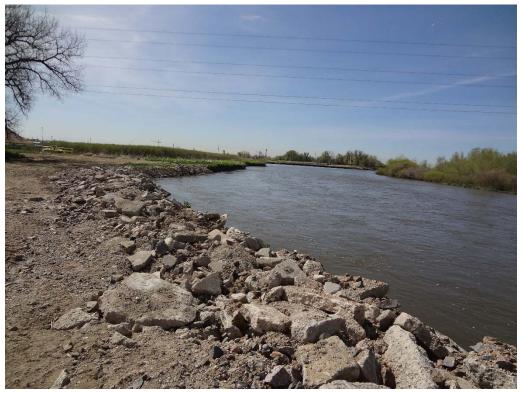
Looking south at Platte River
