COLORADO DIVISION OF RECLAMATION, MINING AND SAFETY
MINERALS PROGRAM INSPECTION REPORT
PHONE: (303) 866-3567

MINE NAME: Cresson Project	MINE/PROSPECTING ID#: M-1980-244	MINERAL: Gold	COUNTY: Teller
INSPECTION TYPE: Monitoring	INSPECTOR(S): Elliott R. Russell	INSP. DATE: April 28, 2016	INSP. TIME: 10:30
OPERATOR: Cripple Creek & Victor Gold Mining Company	OPERATOR REPRESENTATIVE: Marc Tidquist	TYPE OF OPERATION: 112d-3 - Designated Mining Operation

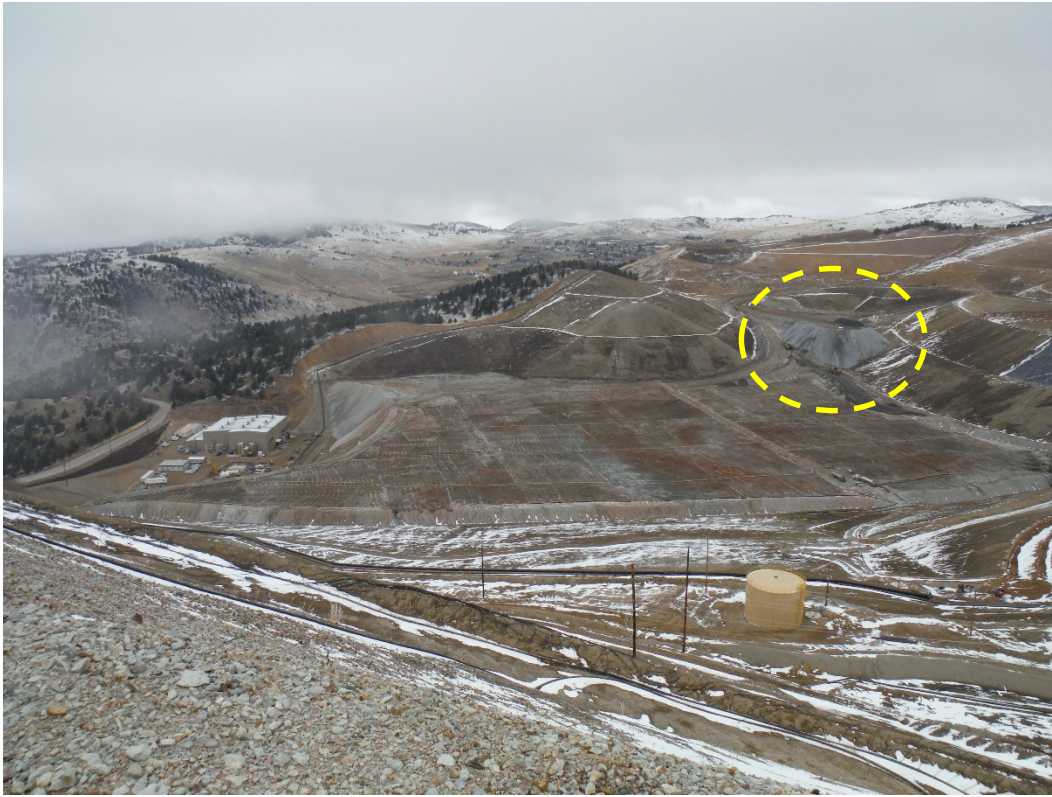
The Division and Mr. Tidquist were accompanied by Mr. Jeff Gaul into the SGVLF. The first lift of ore within the SGVLF was completed and the new 9650-foot lift was actively being stacked at the time of the inspection (**Photo 1**). Mr. Gaul stated that the Squaw Gulch Adsorption Desorption and Recovery facility (SGADR) was in testing and at approximately 50% operational capacity with a projected commissioning later this fall. CC&V was currently having three new level indicators installed near the Pregnant Solution Storage Area (PSSA) pumps because the indicators on the casings had been compromised (**Photo 2**). CC&V also plans on installing a forth indicator near the toe of the first heap leach lift to acquire data of the pregnant solution level outside of the pumps' cone of influence. The Division inspected an area of Drain Cover Fill (DCF) that had recently been repaired in the southwest corner of the SGVLF (**Photo 3**). Runoff from the south perimeter road drained down to the 9550-foot bench, crossed onto the pad, and washed out DCF beneath the barren solution line (**Photo 4**). Repairs to this area should take future mitigation of similar runoff events into consideration.

Photo 1. Overview of the SGVLF, 9650-foot lift circled; looking northwest.

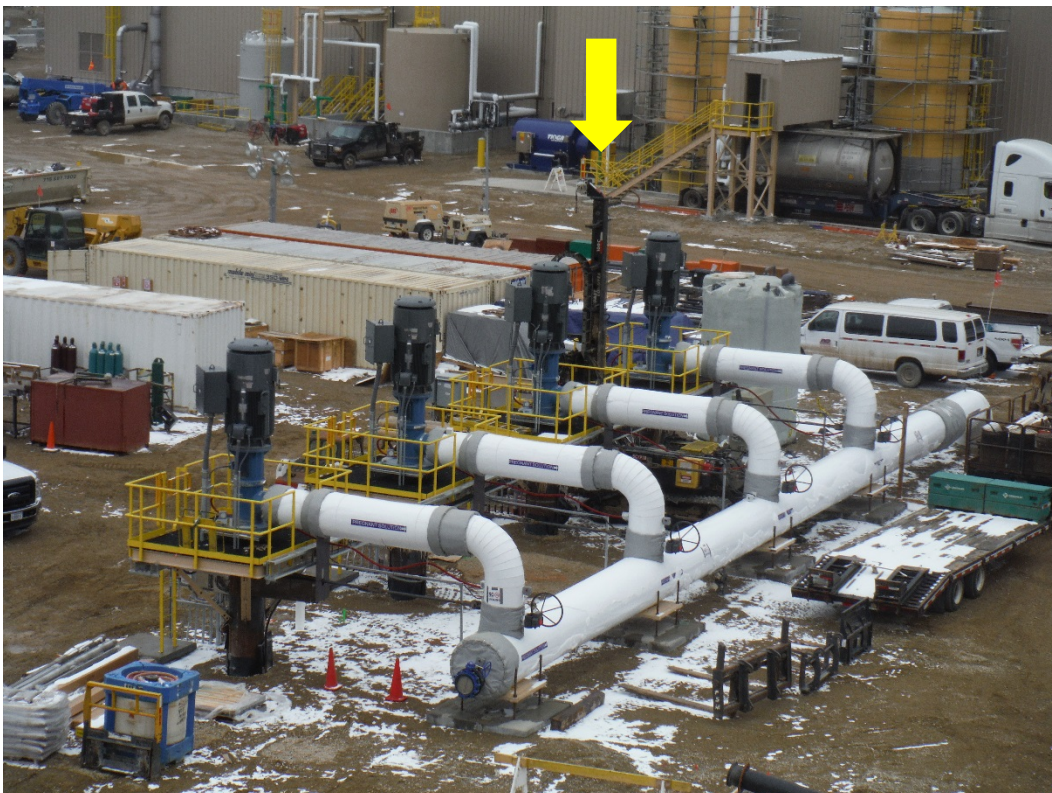
Photo 2. A small drill rig installing a level indicator between the northern two PSSA pumps adjacent to the SGADR; looking northwest.

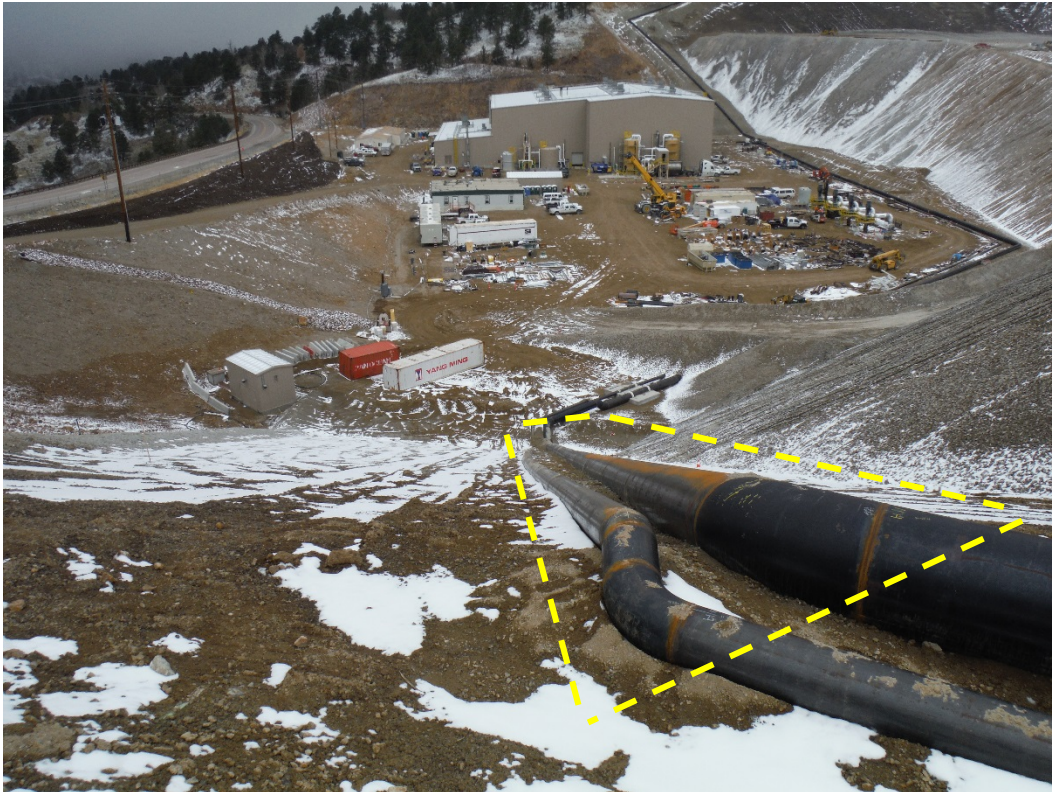
Photo 3. Area of repaired DCF under the barren solution line; looking northwest toward the SGADR.

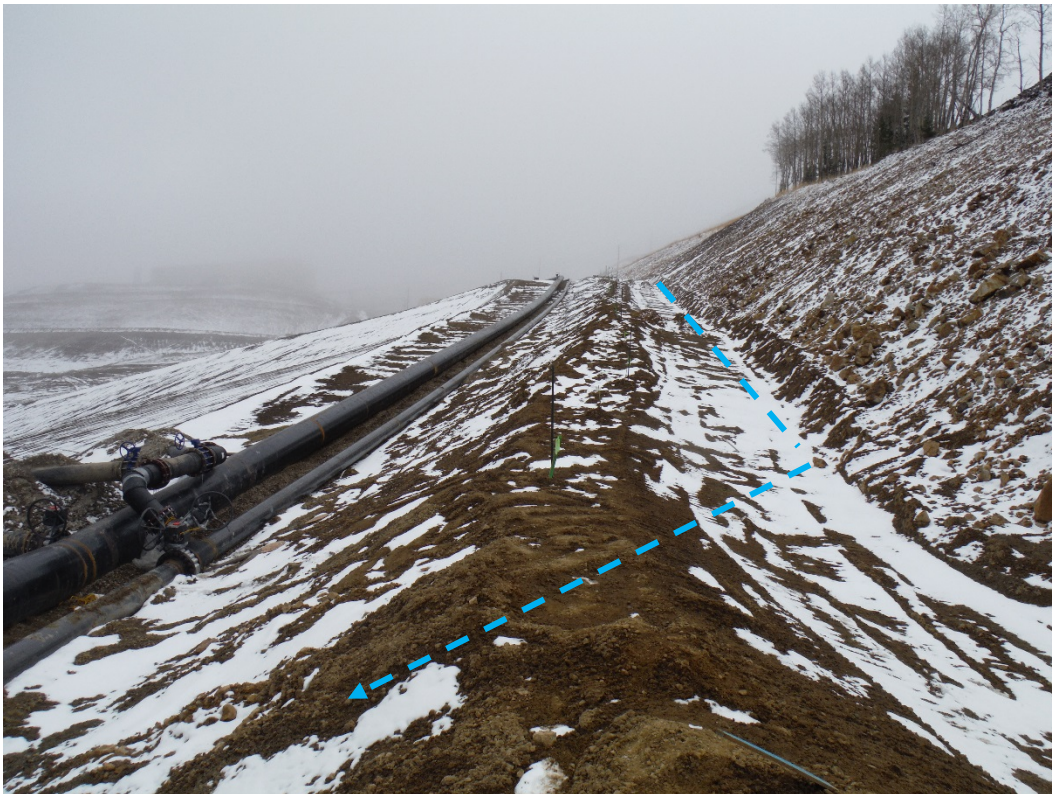
Photos 4. SGVLF south perimeter road, showing approximate storm water flow that caused DCF erosion; looking east.

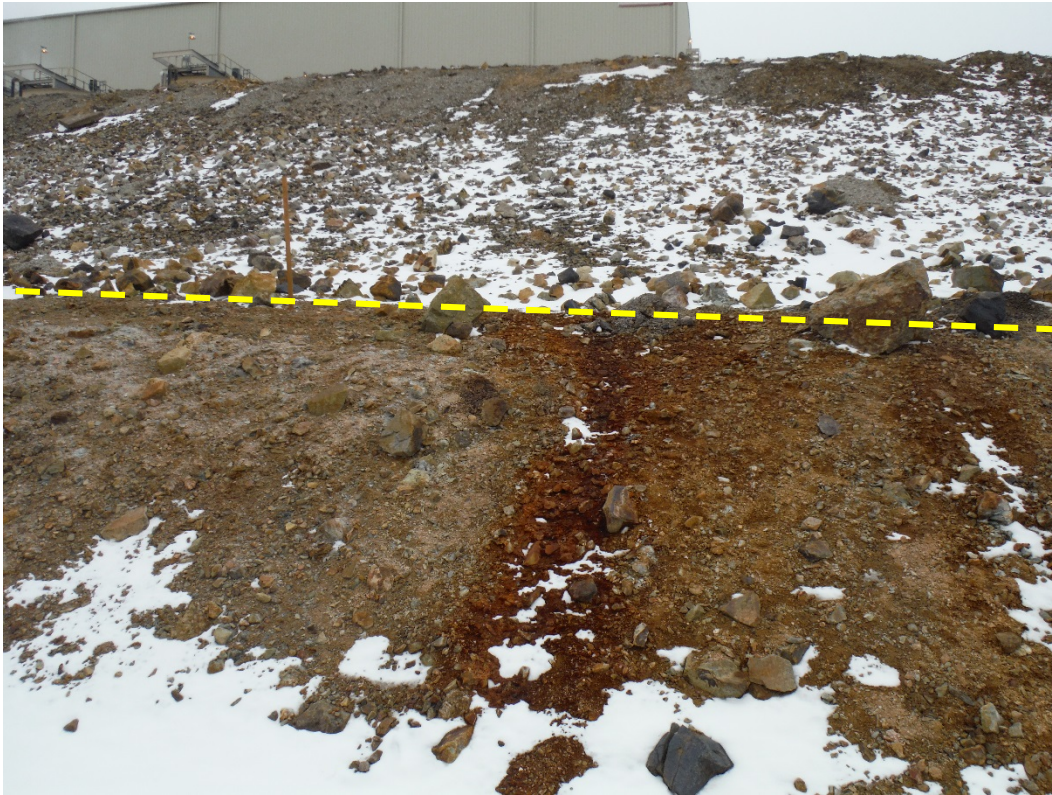
Following up with previous observations, the Division inspected the southwest corner of the HGM pad where a seep/possible discharge was observed coming from the edge of the HGM pad liner. These areas of concern were dry at the time of the inspection (**Photo 5**). The Division observed gray staining on the surface grate of the western most sump (sump CB-3) of the HGM pad liner and a corroded metal pipe (**Photos 6 & 7**). It appears that metallurgical processing solution was possibly drained into the HGM sump. The Division observed gray staining on the sides of cyanidation vat leach tank #1 and the side of the nearby building located on the west side of the HGM (**Photo 8**); it appears this tank was overtopped with process slurry and splattered on the adjacent building. Evidence of splatter on the entire height of the adjacent building, approximately 30 feet tall, was observed. The Division observed a large amount of processed material inside the curbed concrete foundation, consuming the capacity of the secondary containment of the cyanide vat leach tanks. This solid material was dark gray in color and consistent with the characteristics of the mill's process slurry. The approved permit discusses that the process slurry associated with the vat leach process is comprised of a dilute sodium cyanide solution, lime, and the fine concentrate slurry which had been floated through the mill's froth floatation process. There are six vat leach tanks, each are approximately 173,000 gallons in size and the curbed concrete foundation has the capacity of 75% of one vat leach tank. The Division observed that the secondary containment was filled to within approximately 6 inches of the top of the curbed foundation (**Photo 9**). A large amount of this material was heaped up in the southern end of the secondary containment, between the foundation for future leach tank #7 and the leach area sump #2; it appears the sump as well as multiple electrical junction boxes had been cleared of the slurry residue (**Photo 10**). Observations made during the inspection and recorded in this report indicate the Operator has failed to maintain the secondary containment capacity of the vat leach tanks. This is cited as a part of a Possible Violation, additional details are provided on page two of this report.

Photo 5. One of the sweeps near the southwest corner of the HGM pad, surveyed edge of liner approximated by yellow line; looking southeast.

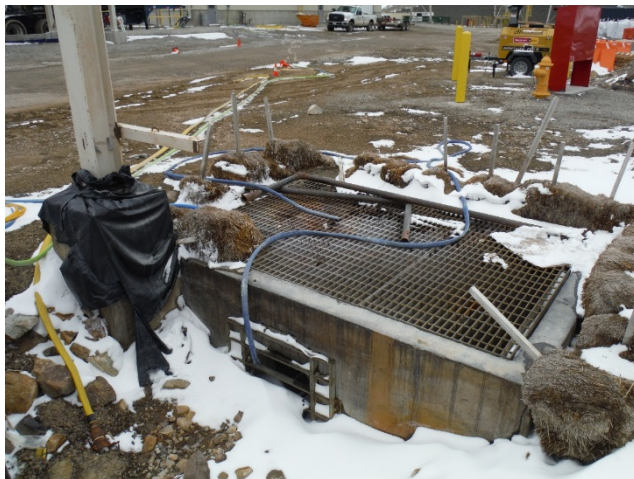
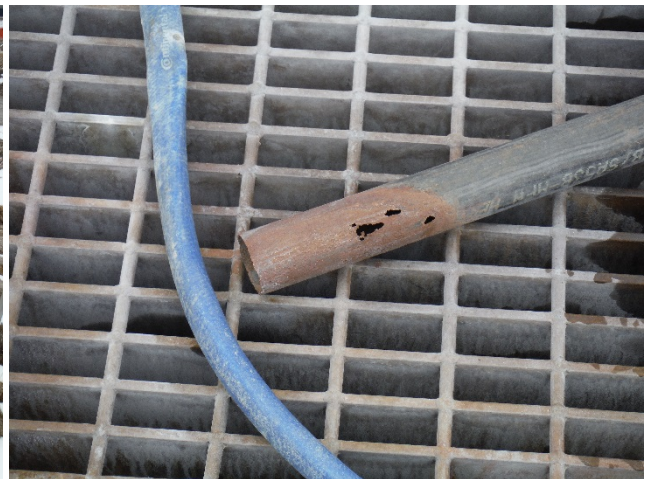
Photos 6 & 7. Surface grate to the southwest HGM pad liner sump, gray staining and corroded still pipe.

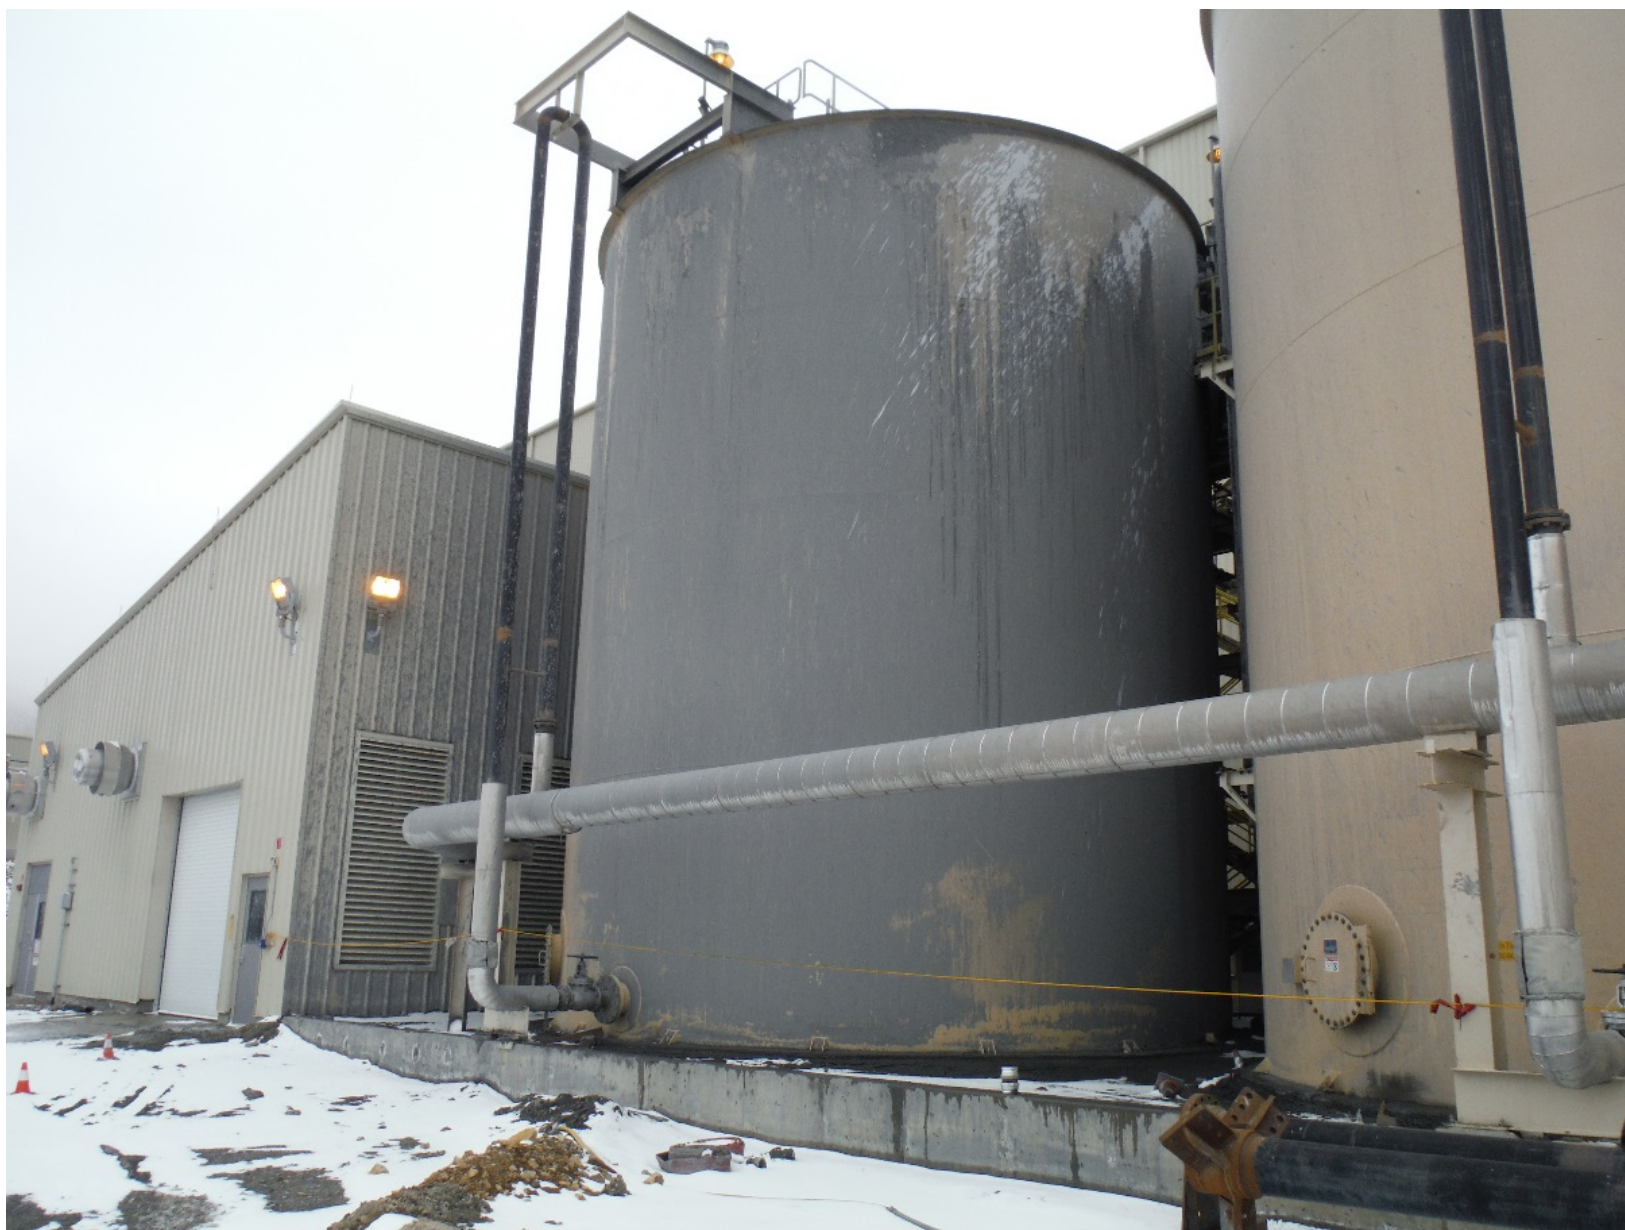
POSSIBLE VIOLATION: Vat Leach Tank #1 of the High Grade Mill has overtopped with process slurry. The Operator failed to maintain the approved capacity of the secondary containment for the cyanidation leach tanks. The Operator failed to notify the Division of this situation, a possible violation of C.R.S. 34-32-121.5 and Rule 8.1(b). Pursuant to C.R.S. 34-32-124(1), this is a possible violation for failure to comply with conditions of an order, permit, or regulation.

Photo 8. Gray staining on the sides of vat leach tank #1, adjacent building with splatter located to the left; looking northeast.

CORRECTIVE ACTIONS: This possible violation has been scheduled to be considered by the Mined Land Reclamation Board, during the June 22-23, 2016 Board meeting. Official notice of the schedule and other details for the MLRB hearing will be provided under a separate document to be sent via certified mail to the operator. The Operator shall also reestablish the approved secondary containment capacity for the cyanidation leach tanks by the corrective action due date.

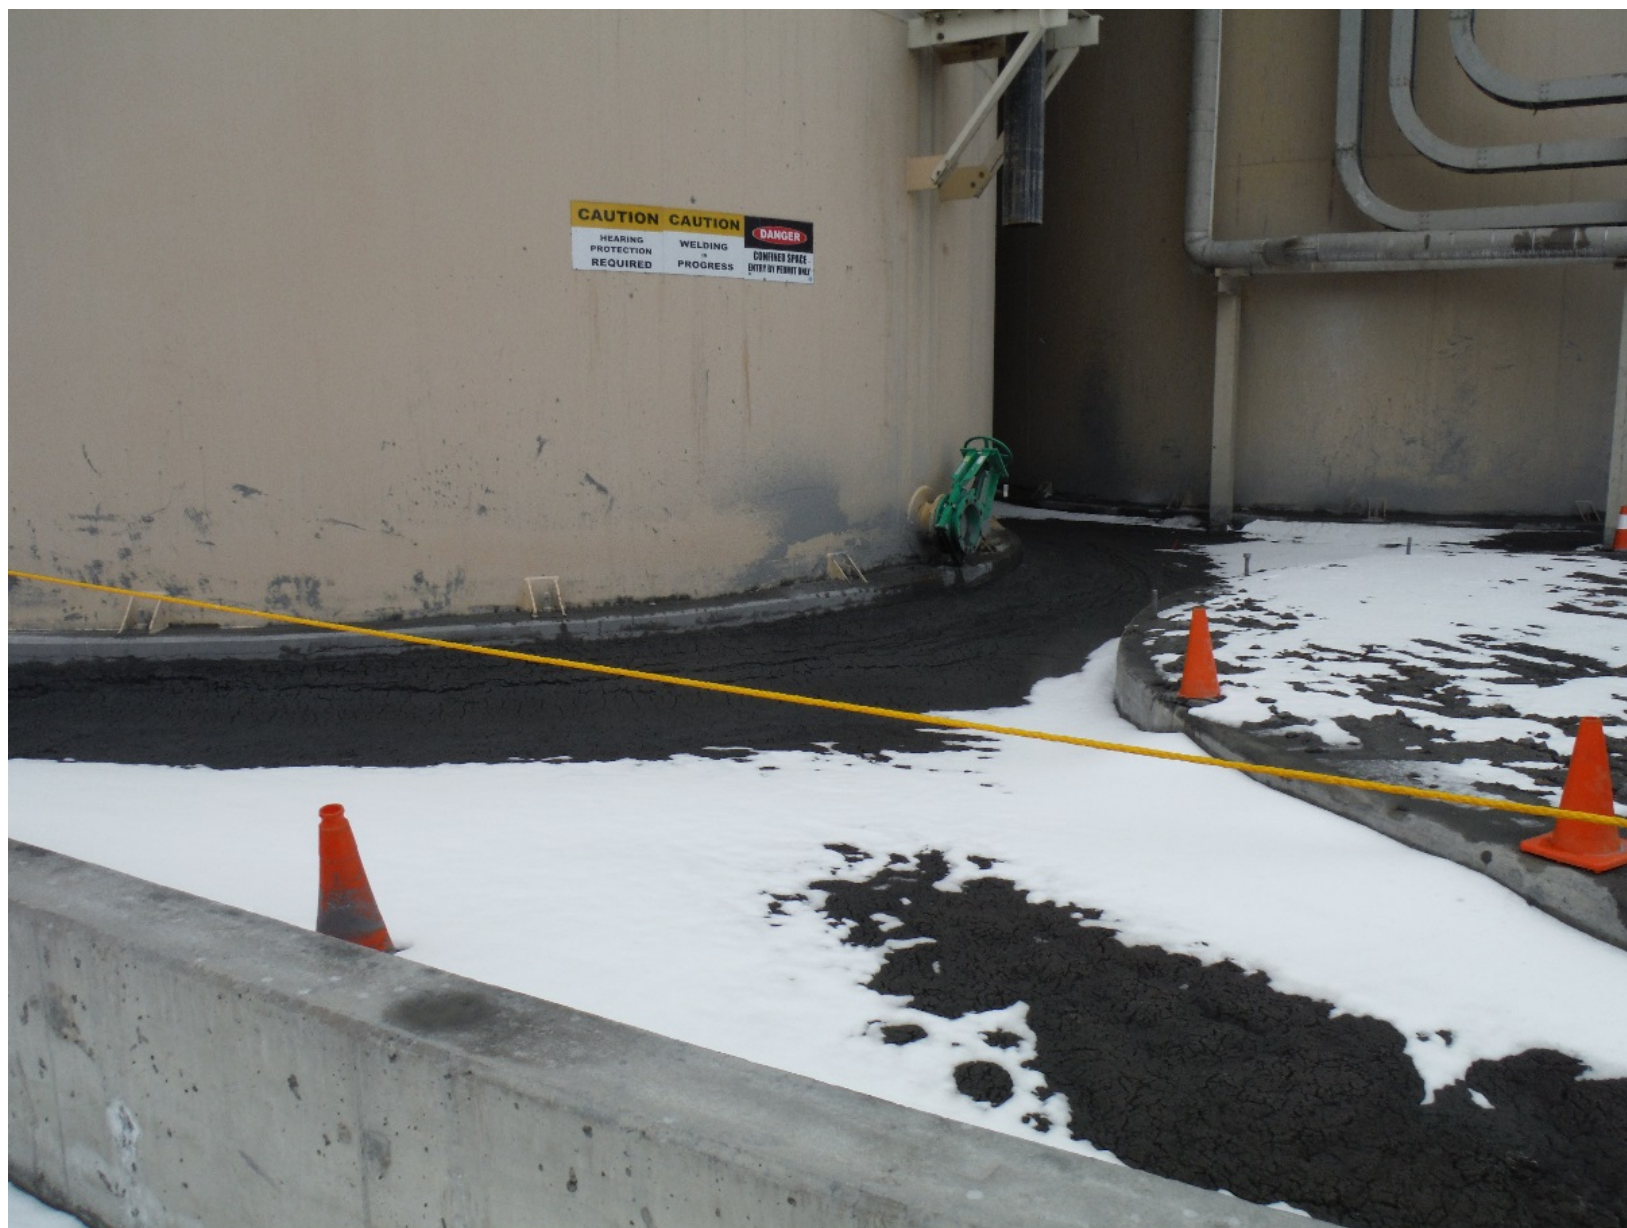
Photo 9. Significant amount of process slurry material within the secondary containment concrete foundation; looking northeast.

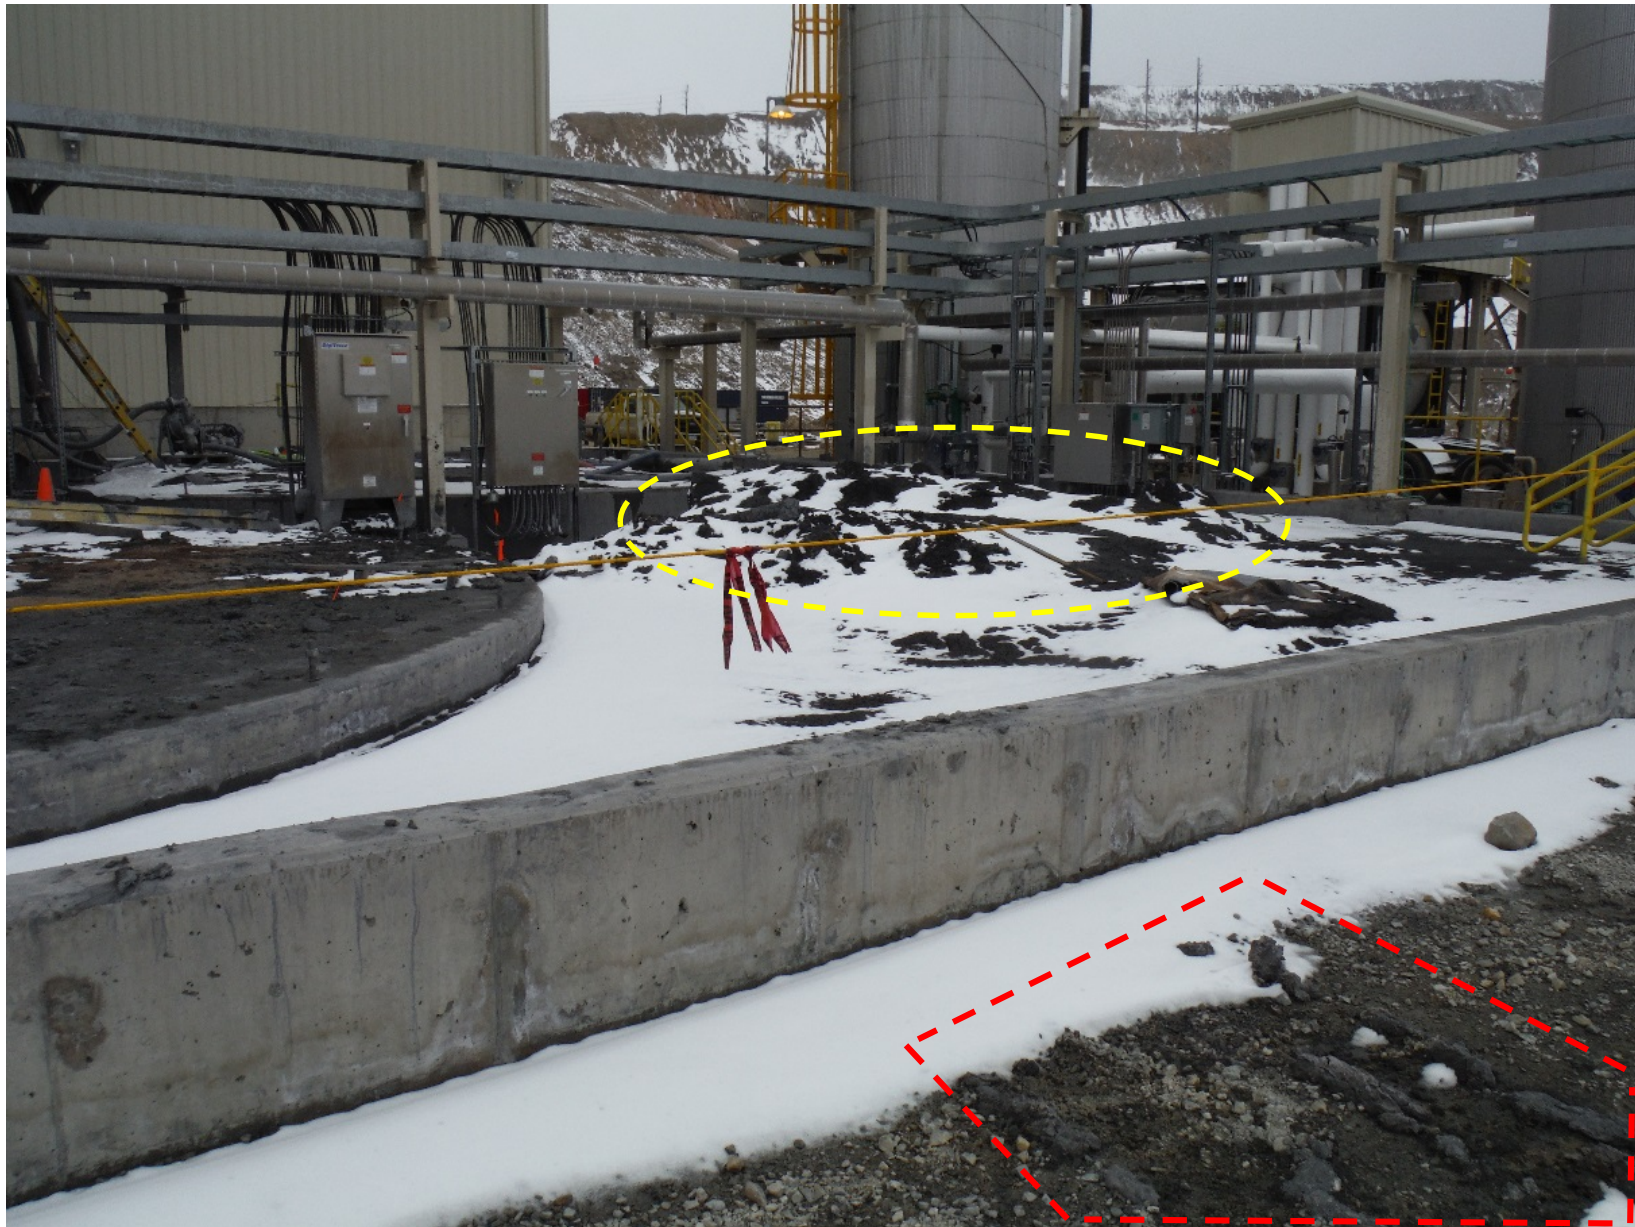
The Division observed traces of material outside of the secondary containment structure, which appears similar to the material consuming the capacity of the secondary containment. This material, located outside of the secondary containment vessel, could be related to the cleanout of the sump and electric boxes discussed above. Given the height of the tank and relatively short height of the curbing, the pattern of splatter observed on the adjacent building indicates material from vat leach tank #1 was broadcast beyond the secondary containment structure (**Photo 11**). The approved permit states that all spills and leaks from the cyanidation leach tanks will be contained within the curbed concrete foundation. The loss of containment at the secondary structure is cited as part of a Possible Violation, additional details are provided on page two of this report.

Photo 10. Heaped material within secondary containment foundation (yellow), similar material outside of secondary containment (red); looking southeast.

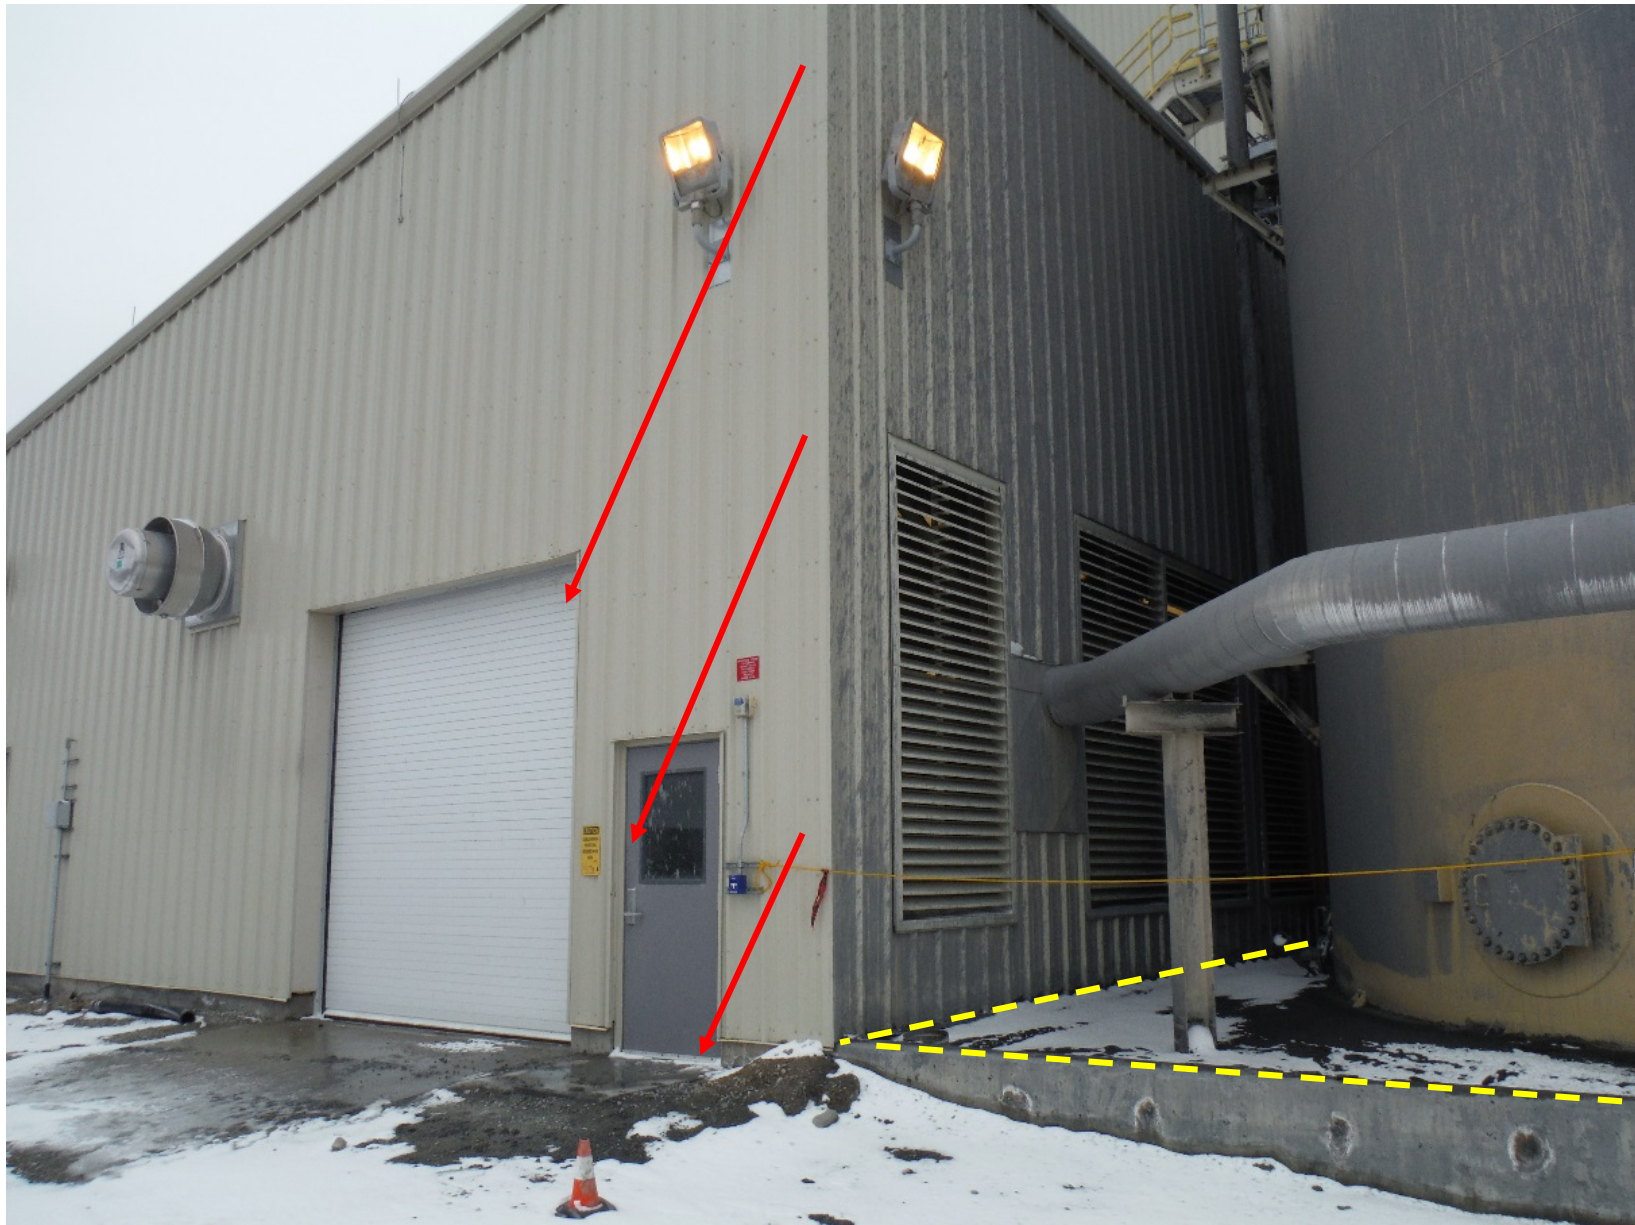
Photo 11. Splatter on the building adjacent to vat leach tank #1, red arrows representing direction of splatter and yellow line shows secondary containment; looking east

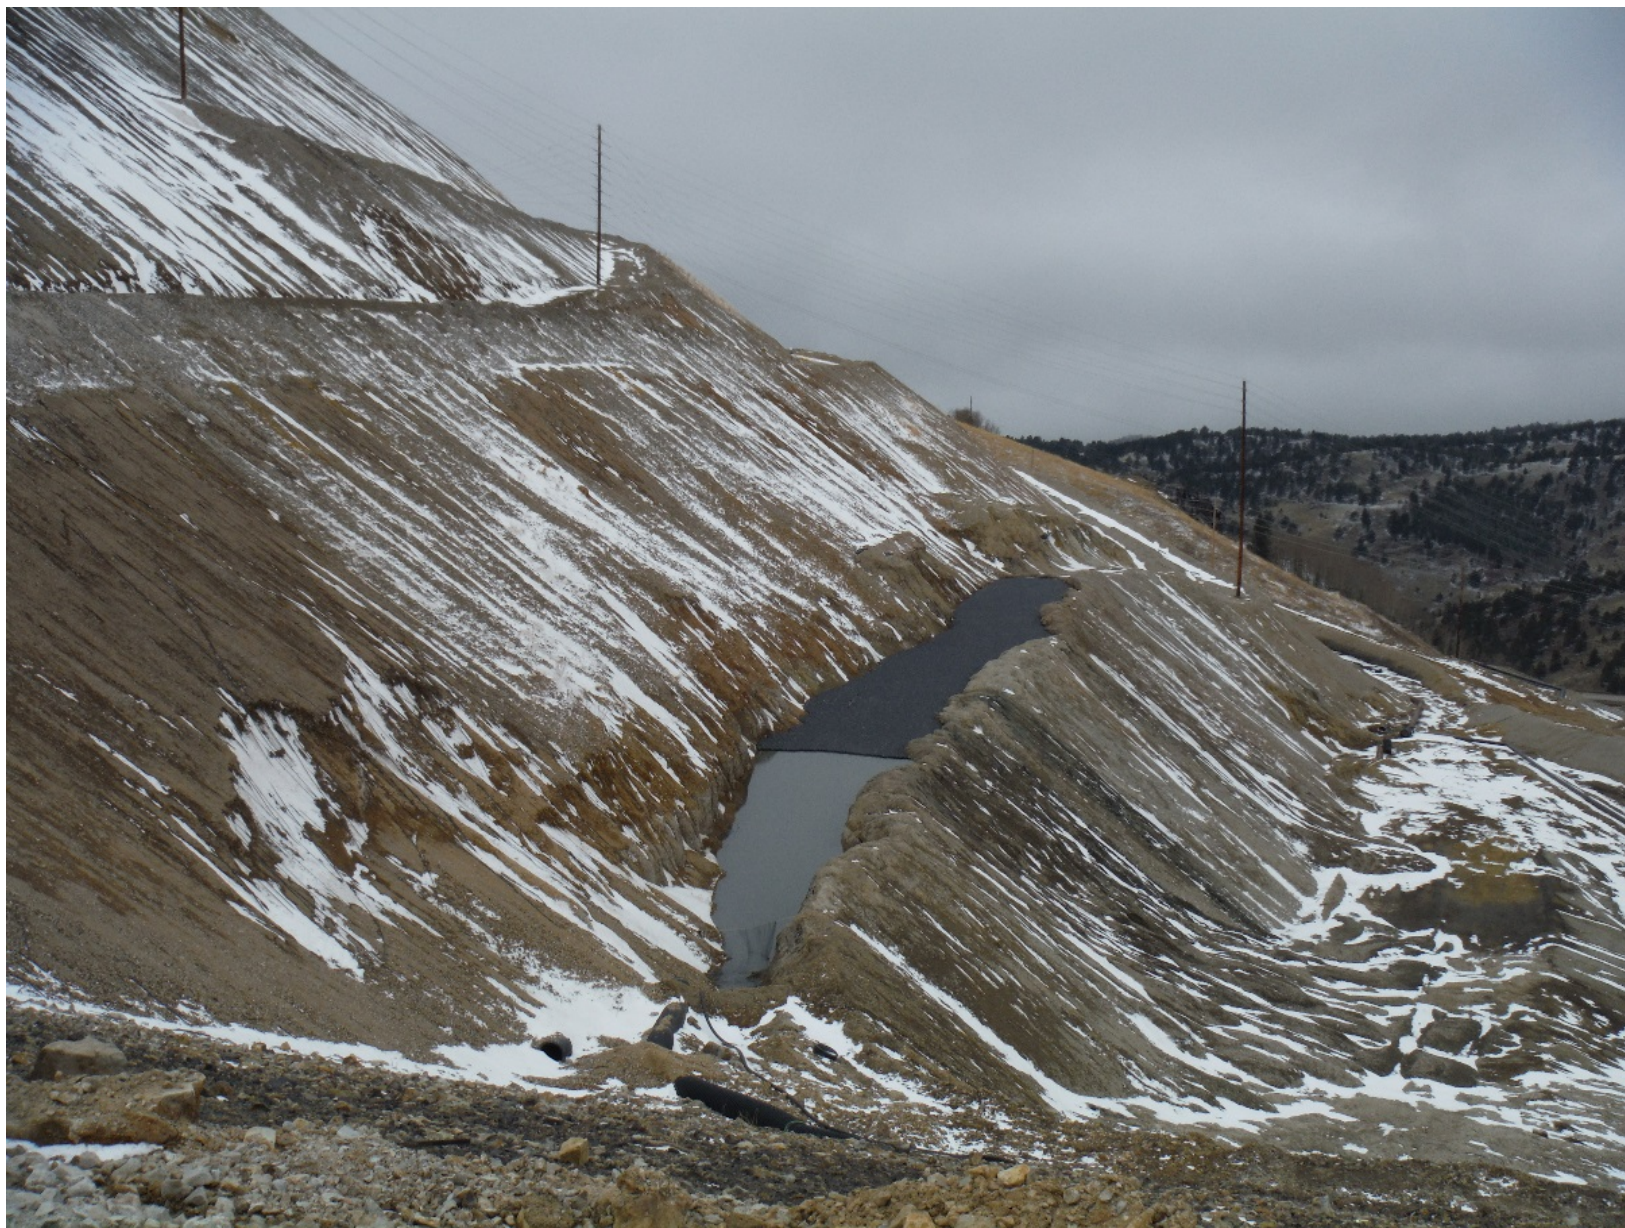
PROBLEM 1: A significant volume of metallurgical processing fluid was exposed in the High Grade Mill infiltration trench. This is a potential attractant to wildlife. The surface area of the exposed fluid exceeded the permit condition (not to exceed 3 feet x 3 feet area).

PROBLEM 2: A significant volume of metallurgical processing fluid was observed in the High Grade Mill infiltration trench. The approved permit states the remainder of the mill leach circuit water balance, not recycled, will be pumped to AGVLF or SGVLF and either injected into the barren pipeline or to a designated drip tube distribution system. As such, the infiltration trench is an unapproved structure and the construction and use of the structure is not authorized by the Permit, the Act and Rules.

Also associated with the High Grade Mill, the infiltration trench that allows the infiltration of mill solution discharge into the AGVLF pad, was inspected. The infiltration trench, constructed on the crest of one of the northern slopes of the AGVLF pad, was near capacity; the amount of solution in the trench had dramatically risen since the last DRMS inspection. This rise in solution level has caused the surface area to increase, causing the amount wildlife mitigation measures, the floating "bird balls", to become inadequate (**Photo 12**). As approved in the permit, the Wildlife Protection Plan states that any area of standing process solution with a surface area larger than 3 feet x 3 feet should be corrected as soon as reasonably possible. The area of the trench lacking "bird balls" is greater than the area allow as identified in the permit; this is cited as Compliance Problem 1 on page two of this report.

Photo 12. HGM solution infiltration trench, the farther dark area are the “bird balls”; looking west.

CORRECTIVE ACTIONS: Provide the Division with photographic evidence that the entire surface area of the solution within the High Grade Mill infiltration trench is covered by "bird balls" or other wildlife mitigation measures.

CORRECTIVE ACTIONS: The Operator shall immediately cease placing fluids within the unapproved infiltration trench. The Operator shall, within one working day of receiving this inspection report, due May 9, 2016, provide the Division a written statement affirming timely compliance with this corrective action.
