COLORADO DIVISION OF RECLAMATION, MINING AND SAFETY
MINERALS PROGRAM INSPECTION REPORT
PHONE: (303) 866-3567

MINE NAME: Highway 50 Borrow Area No. 2	MINE/PROSPECTING ID#: M-1999-076	MINERAL: Borrow material for	COUNTY: Mesa
INSPECTION TYPE: Monitoring	INSPECTOR(S): Stephanie J. Mitchell	INSP. DATE: March 2, 2016	INSP. TIME: 10:30
OPERATOR: Elam Construction, Inc.	OPERATOR REPRESENTATIVE: Jon Mueller	TYPE OF OPERATION: 111 - Construction by Government Agency

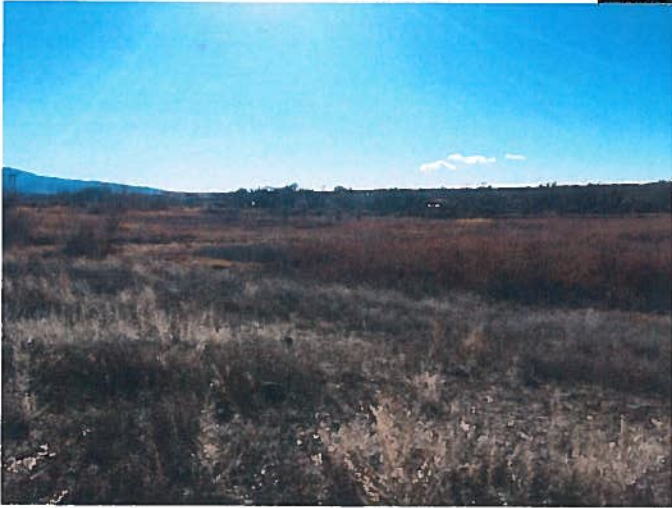
Looking South

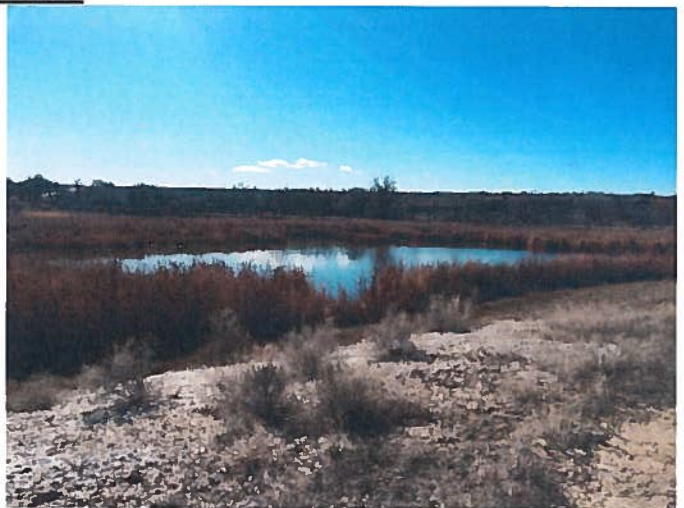
PROBLEM/POSSIBLE VIOLATION: Problem: The site is improperly impounding surface drainage/runoff.

As noted in the previous two inspection reports, the site is impounding water. This is considered a problem at the beginning of the inspection report. A well permit to account for the evaporative losses is required by the Division of Water Resources. Enforcement action will be initiated if an evaporative loss permit or another form of compliance is not received by the Division on or before August 17, 2016. In July of 2013, Elam wrote a letter to the Division ensuring that an approval for augmentation will be filed with the Water Court or plans would be completed to otherwise mitigate the hydrologic balance problem by March 31, 2014. This issue has still not been resolved.

Water Impounded

CORRECTIVE ACTIONS: Submit documentation from the State Engineer's Office demonstrating that the impoundment of water in this pit is authorized by that office. Operator could also remove impediments to proper surface drainage.

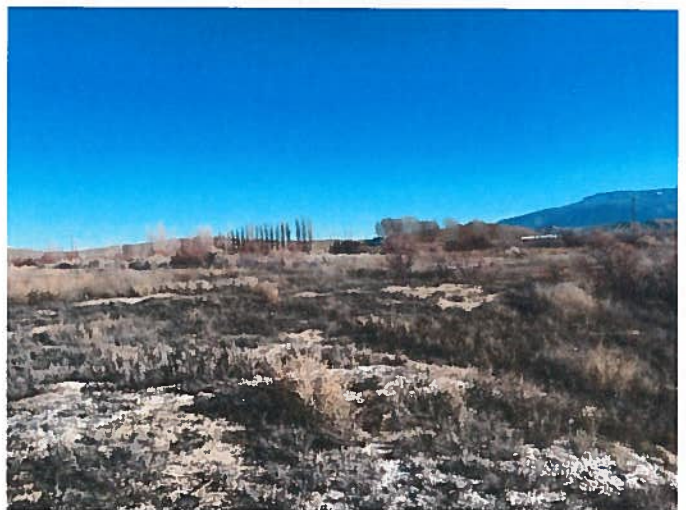
Looking East

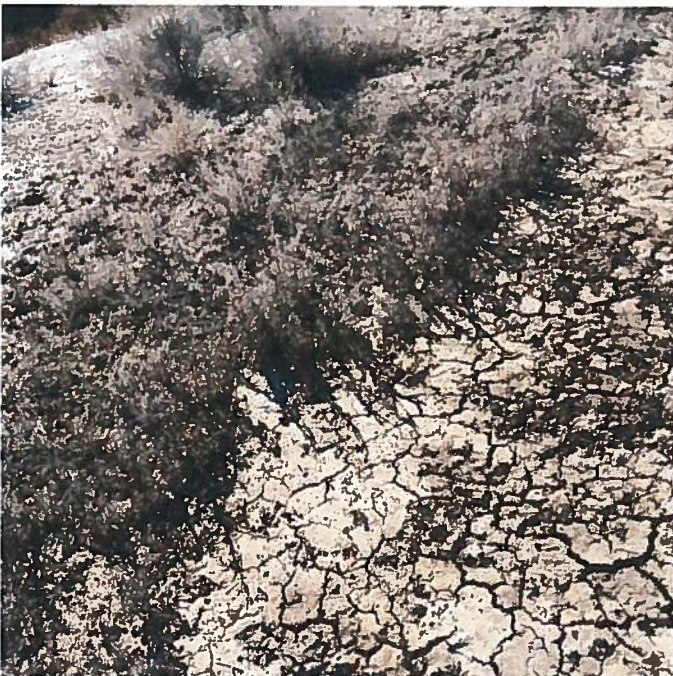
Overall, the site appears to have been graded to match the surrounding topography. No stockpiles are in place at the site. The amount of vegetation is adequate at the site. However, Tamarisk, Russian Olive and Russian Knapweed were all observed. Elam submitted a weed management plan as technical revision in 2005. The Operator ensures that they will be spraying the site in the spring. The Division will be closely monitoring the progress of the weed (Russian Knapweed) management in the future.

Russian Knapweed
