**COLORADO DIVISION OF RECLAMATION, MINING AND SAFETY**  
**MINERALS PROGRAM INSPECTION REPORT**  
**PHONE: (303) 866-3567**

| <b>MINE NAME:</b><br>Cresson Project | <b>MINE/PROSPECTING ID#:</b><br>M-1980-244 | <b>MINERAL:</b><br>Gold | <b>COUNTY:</b><br>Teller |
| <b>INSPECTION TYPE:</b><br>Monitoring | <b>INSPECTOR(S):</b><br>Timothy A. Cazier | <b>INSP. DATE:</b><br>May 12, 2016 | <b>INSP. TIME:</b><br>10:00 |

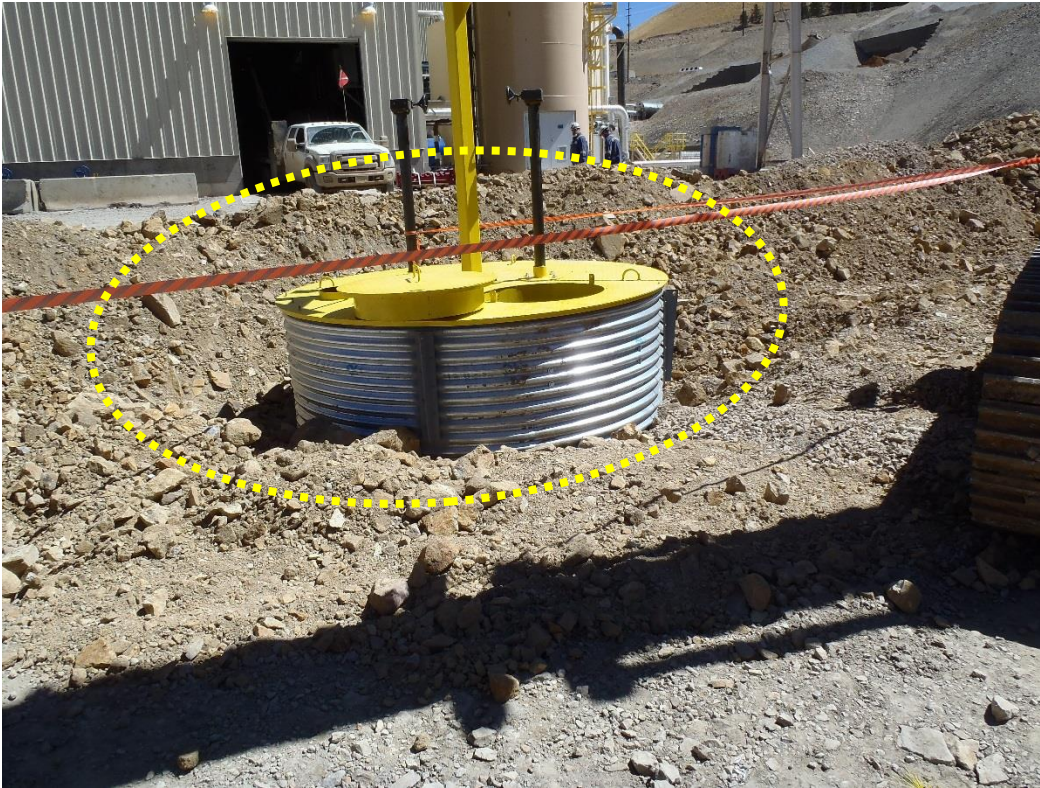
- d) Mill platform seep - Mr. Winterton provided new information regarding the previously observed seep on the southwest corner of the mill platform. CC&V discovered the source of the majority of the water was from significant leaks in the mill's fire suppression system. He stated two joints had been repaired and the mine is considering replacing other joints supplied by the same manufacturer. As such the majority of the water released was fresh water and the staining was due primarily to interaction with the waste rock from which the mill platform was constructed.

Photo 1. Mill platform valve box (looking NE).

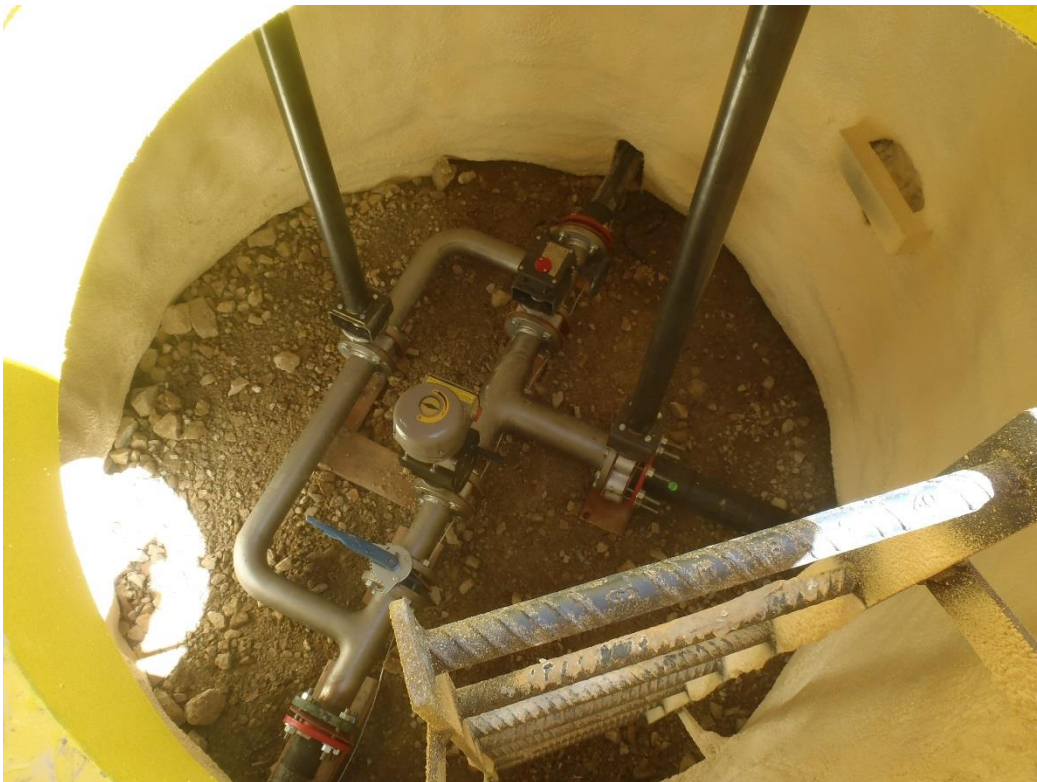
Photo 2. Interior of Mill platform valve box.

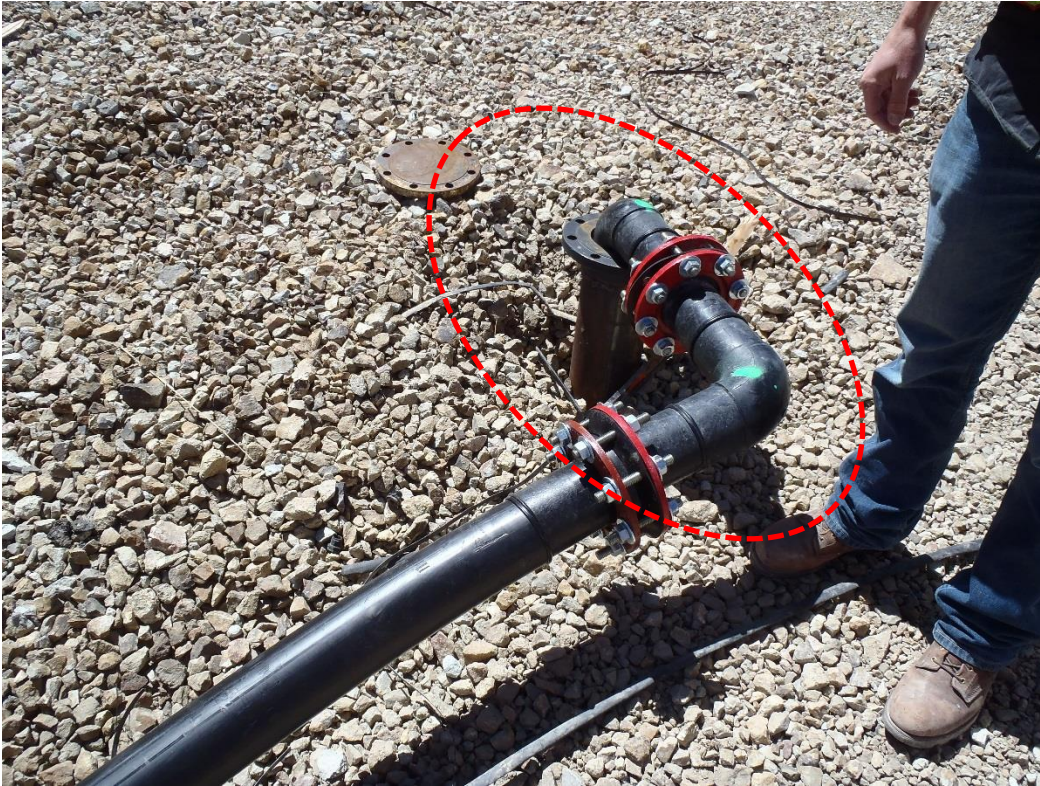
- a) Mill Discharge – This discharge was previously routed to a trench on the north side of the AGVLF Phase IV pad. This practice was cited as a potential problem in the Division's May 6, 2016 report for the April 28, 2016 inspection. Mr. Winterton provided additional information on the mill discharge. The original design was for the middle mill platform sump (Sump #2) to collect both meteoric water and high pH circuit discharge then convey this to either of the VLF drip line systems or the barren solution pipeline. The mix of these waters was causing chemical precipitates which prevented infiltration. Mr. Winterton explained the mine is now diverting the high pH water from Sump #2 via a newly installed "valve box" (see **Photos 1** and **2**), and pumping it to one of two injection wells (see **Photo 3**) above and to the southwest of the aforementioned AGVLF infiltration trench.

Photo 3. One of two injection mill discharge injection well heads on the Phase IV AGVLF.

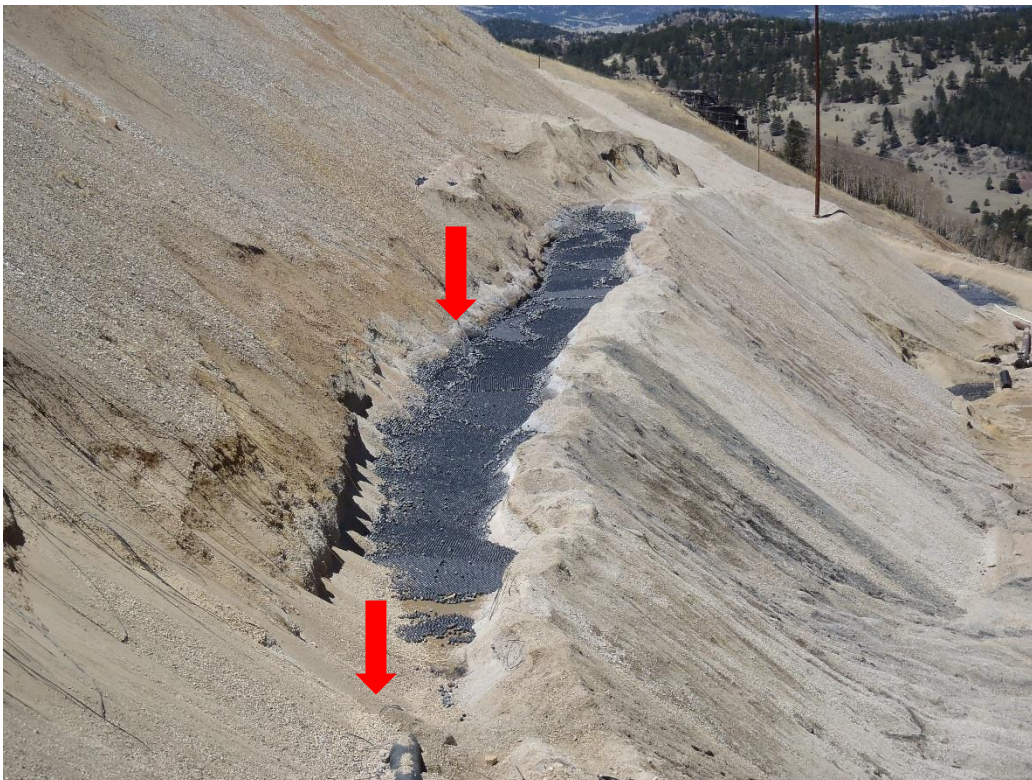
The Division observed no discharge into the infiltration trench and the required extra bird balls appeared to have been placed (see **Photo 4**). With the bird balls in place, the Division could not determine whether any water remained in the infiltration trench. CC&V notified they stopped discharging to this trench on May 6, 2016.

Photo 4. Bird balls observed in dry infiltration trench on north side of Phase IV AGVLF (looking west).  
{Note – no discharge from pipe}

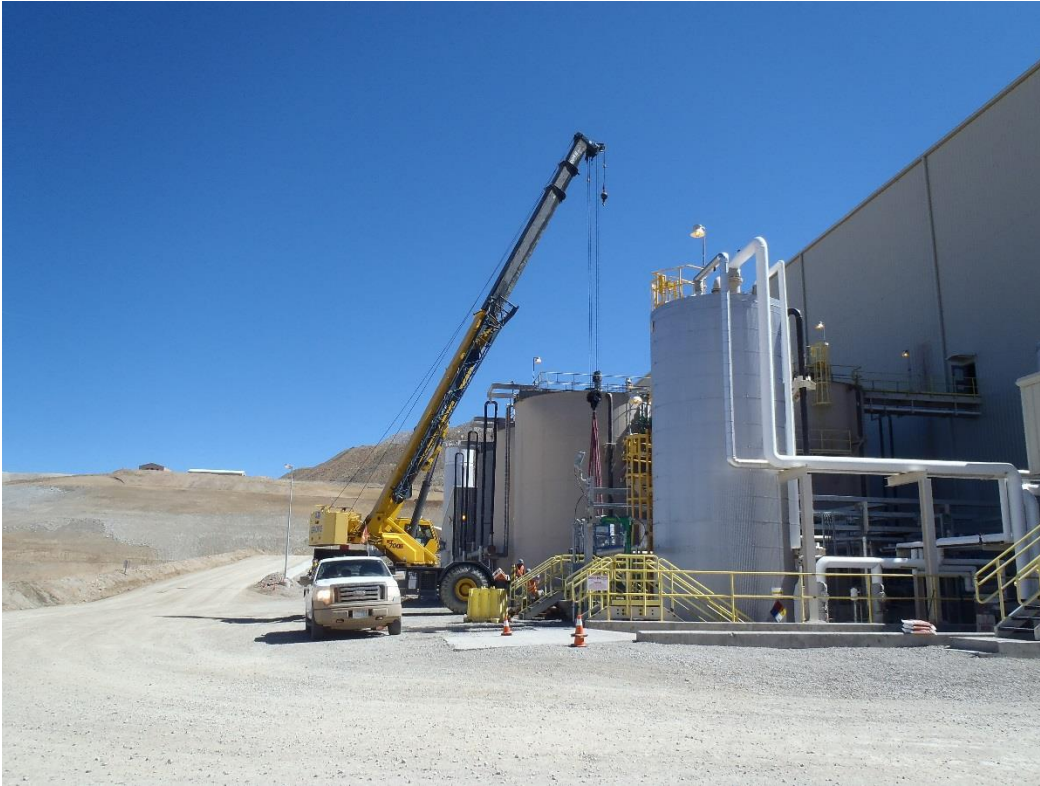
The mine began upgrades to the system beginning in February 2016. The upgrades included the addition of 24-inch diameter pipes to increase the flow capacity as well as replacing the pumps with new larger capacity pumps that he expects to be installed and operational by early June 2016. He expressed confidence that the upgrades would prevent future spills. Mine personnel are using hoses to wash the fine grind into the secondary sump to be pumped back into the leach circuit. They thought the process would take longer than the May 20 corrective action deadline to complete. While onsite the Division observed a crane (see **Photo 5**) placing a manlift in the secondary containment area. Mr. Riley indicated the manlift was needed for the pump replacement effort.

Photo 5. Crane placing a manlift in the secondary containment area.

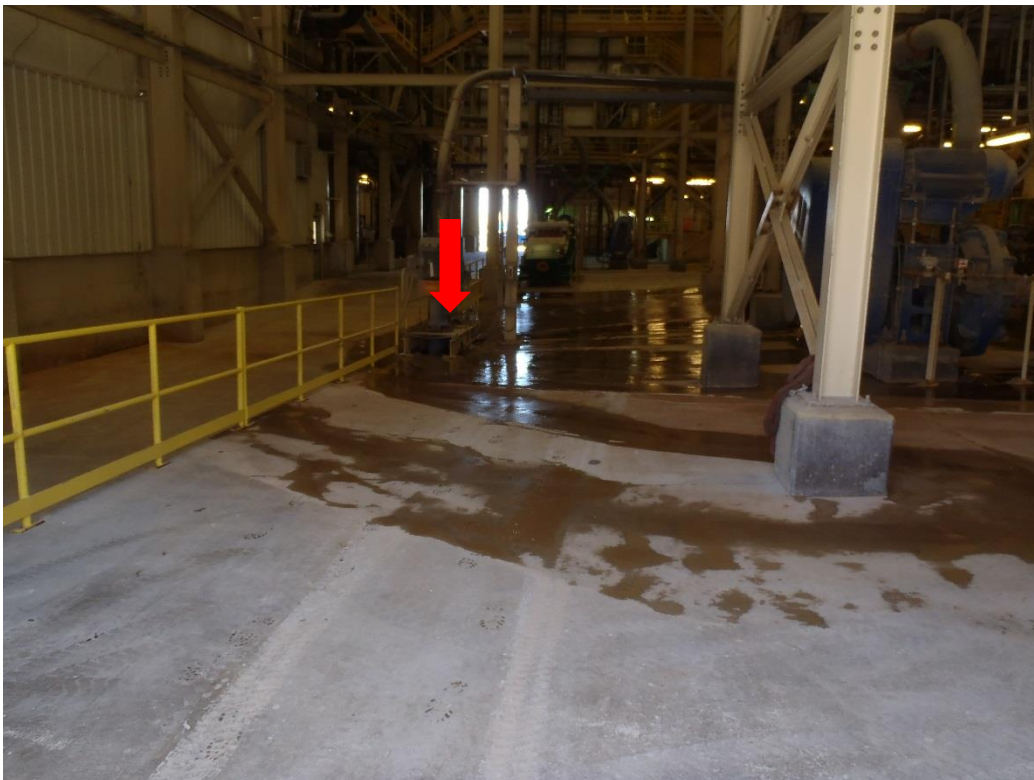
- c) May 11, 2016 spill – On May 11, 2016 CC&V telephoned to notify the Division that Frother Tank #5 backed up and spilled approximately 130,000 gallons of process water (none cyanide containing). The volume of the spill exceeded the capacity of the sumps within the mill building. Mr. Winterton provided some more background during the inspection. Tank #5 was observed where Mr. Winterton explained the failure of both dart valves controlling outflow from the tank. The mill building sumps were observed to be in working order (see **Photo 6**) and no flow was exiting the building (see **Photo 7**).

Photo 6. Mill building sumps.

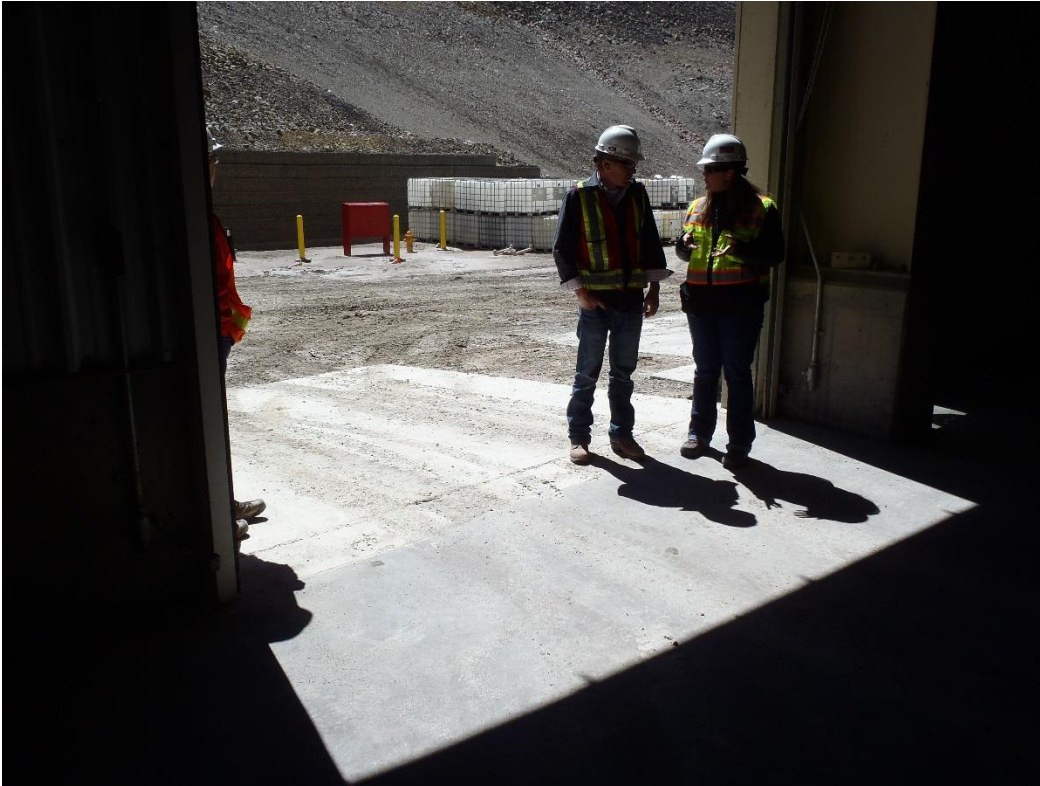
Photo 7. Mill building door through which Tank #5 fluid discharged (looking south).
