COLORADO DIVISION OF RECLAMATION, MINING AND SAFETY
MINERALS PROGRAM INSPECTION REPORT
PHONE: (303) 866-3567

MINE NAME: Triangle One Pit	MINE/PROSPECTING ID#: M-1980-228	MINERAL: Sand and gravel	COUNTY: Archuleta
INSPECTION TYPE: Multi Person Inspection	INSPECTOR(S): Lucas J. West, Amy Yeldell	INSP. DATE: May 5, 2016	INSP. TIME: 08:00
OPERATOR: Oldcastle SW Group, Inc. dba Four Corners M	OPERATOR REPRESENTATIVE: Matt Canrahan	TYPE OF OPERATION: 112c - Construction Regular Operation

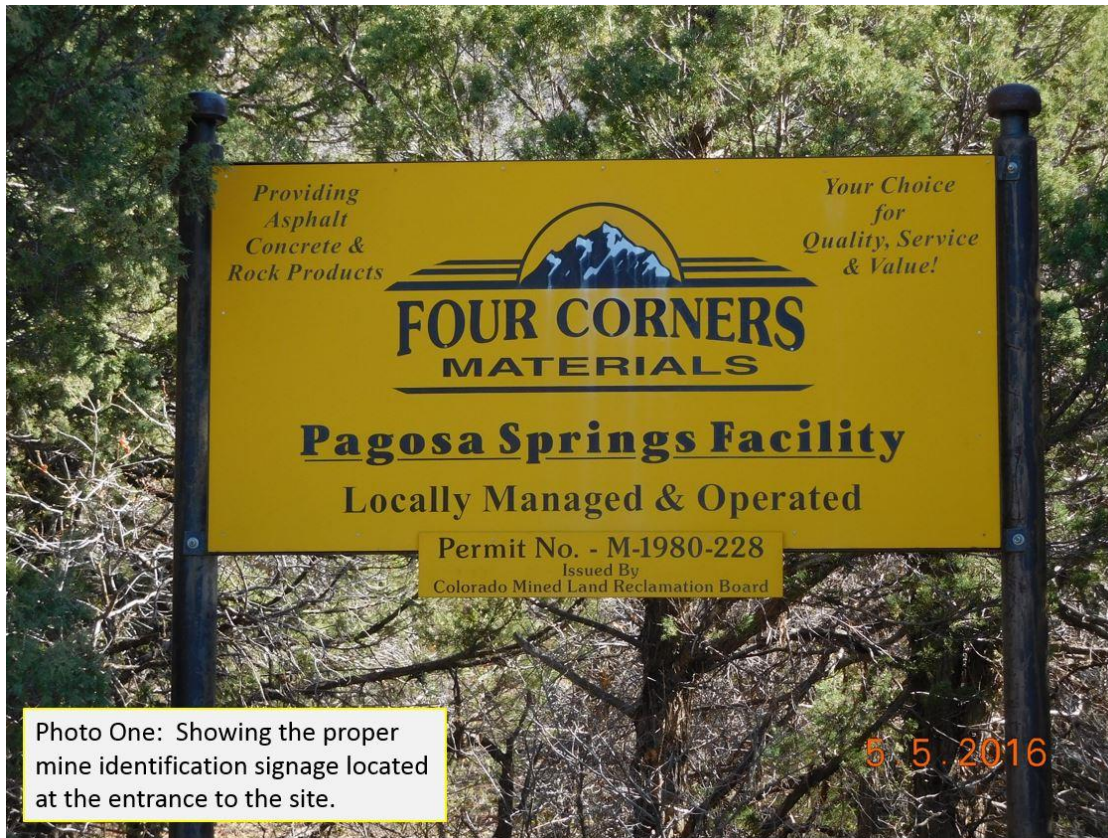
Proper mine identification signage is posted at the entrance to the site, shown in Photo One. The permit boundaries were clearly marked with signs and berms around the perimeter of the site. The site was not active during the time of the inspection. Active mining operations have not taken place at the site since the late 1990's. The site has become a processing facility and hot plant location for materials that have been mined at other permitted sites in accordance with the approved reclamation plan. Photo Two shows the hot plant in good condition. Materials are imported and stockpiled on site while awaiting processing. Several stockpiles are currently located within the permit boundaries shown in Photo Three. All stockpiles appear to be stable and are in good condition. All fuel storage located on site is kept within proper secondary containment devices. Storm water control devices were observed, and appear to be functioning as designed. The sediment ponds located on site are in good condition and are stabilized with vegetation. The pit floor exhibits positive drainage and no erosional issues were noted during the time of the inspection. All slopes around the perimeter of the site appear to be stable and are approximately 3H: 1V or shallower seen in Photo Four. The slopes are well vegetated. Despite the imminent rerelease of the reclamation permit, the operator indicated that the site would still receive regular treatment for noxious weeds. No problems or possible violations were noted during this inspection.

Photo One: Showing the proper mine identification signage located at the entrance to the site.

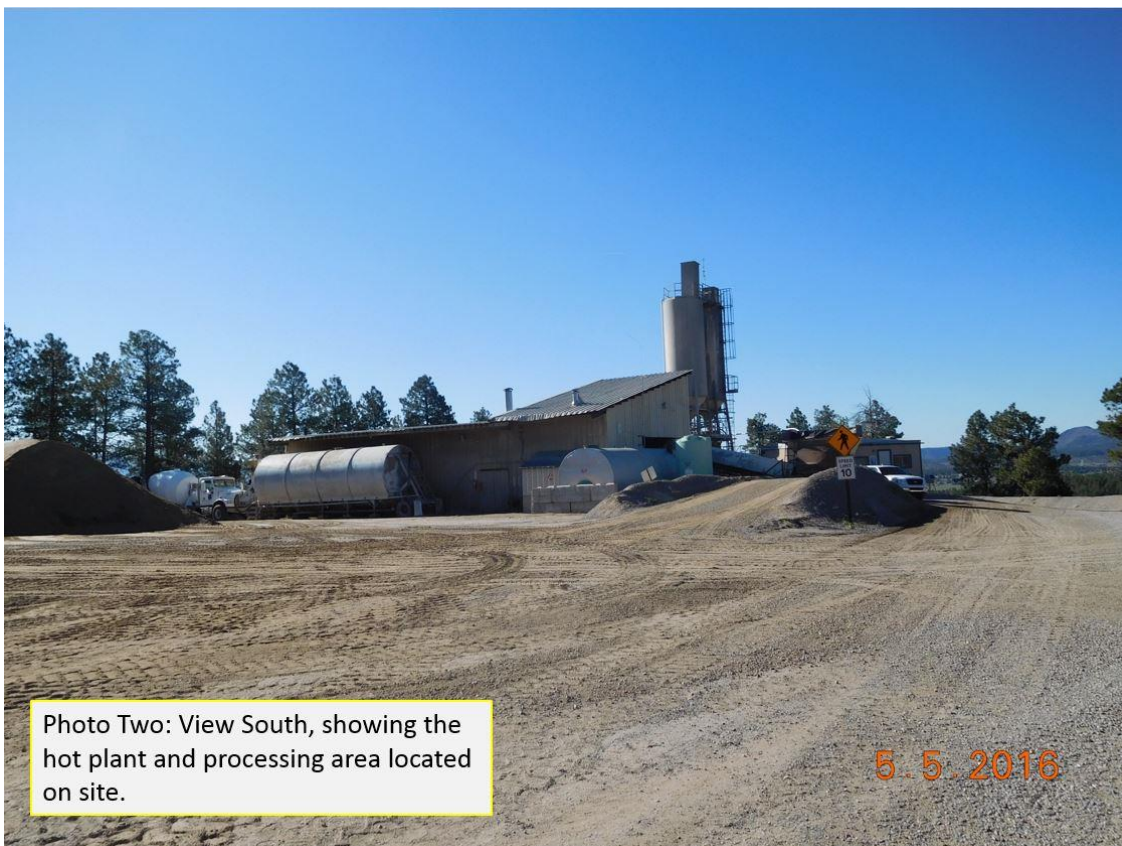
Photo Two: View South, showing the hot plant and processing area located on site.
