COLORADO DIVISION OF RECLAMATION, MINING AND SAFETY
MINERALS PROGRAM INSPECTION REPORT
PHONE: (303) 866-3567

MINE NAME: Monogram Mines	MINE/PROSPECTING ID#: M-1978-222-UG	MINERAL: Uranium and vanadium	COUNTY: Montrose
INSPECTION TYPE: Monitoring	INSPECTOR(S): Dustin M. Czapla	INSP. DATE: May 18, 2016	INSP. TIME: 10:30
OPERATOR: Nuvemco, LLC	OPERATOR REPRESENTATIVE: Craig Howell	TYPE OF OPERATION: 112d-1 - Designated Mining Operation

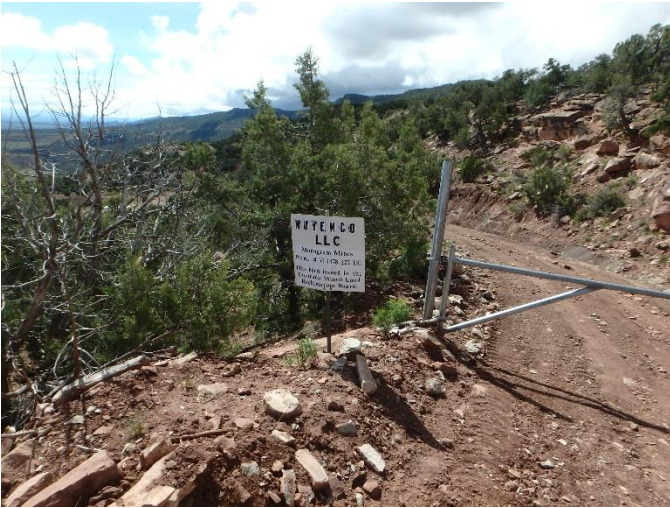
Adequate mine identification signage was noted at the entrance to the site.

Figure 1: Site entrance

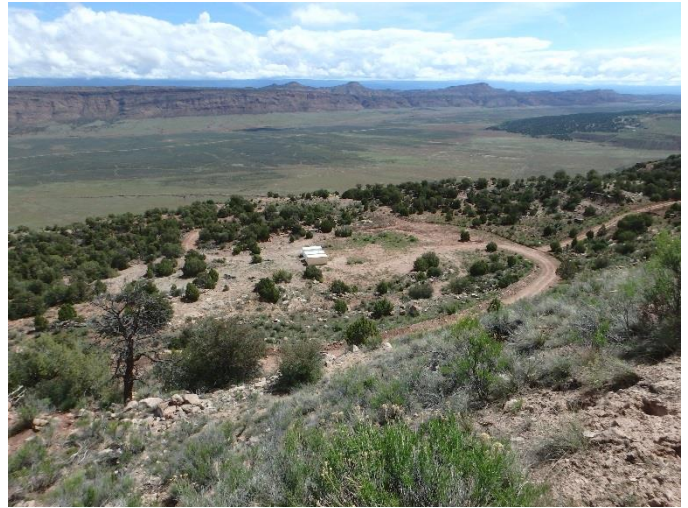
Figure 2: Overview of staging area

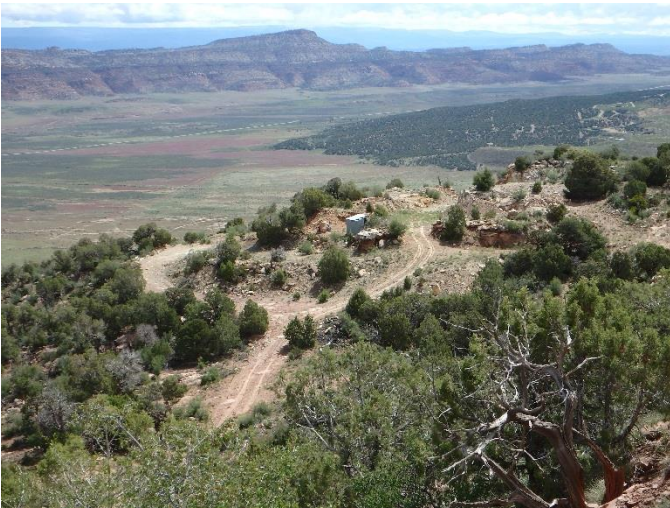
Figure 9: Overview of open pit area

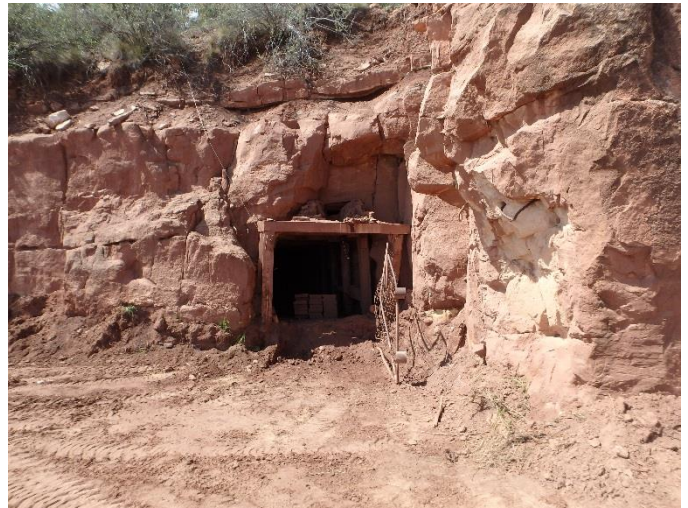
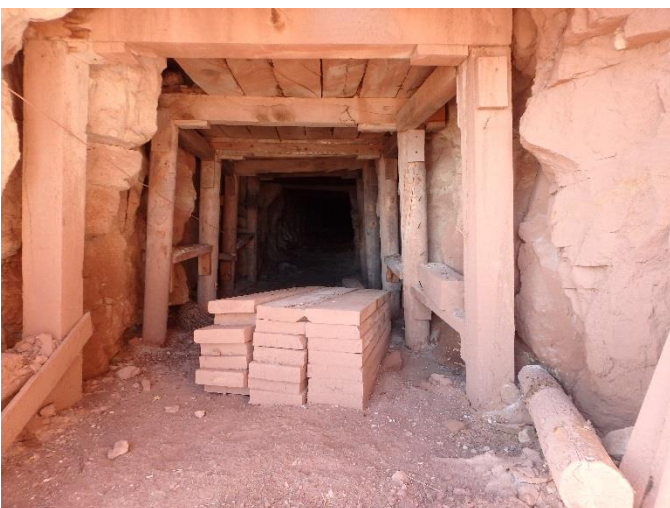
Figure 10: Historic portal re-opened

Figure 11: Historic portal re-opened

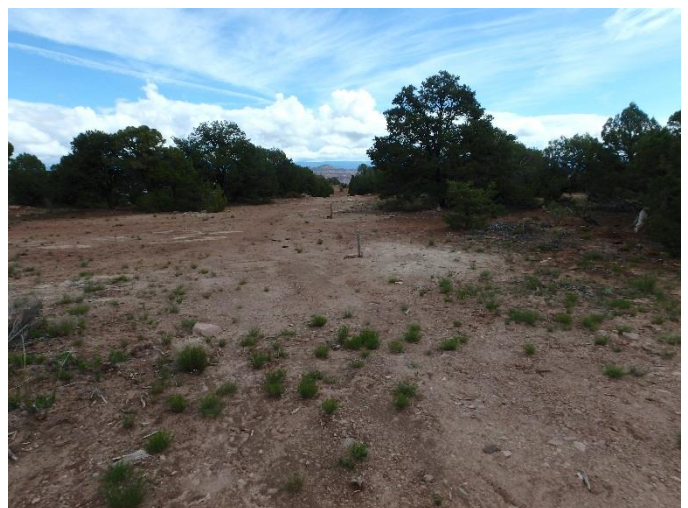
All drill holes observed during the inspection were adequately plugged with no signs of settling.

Figure 12: Typical borehole closures
