The Division of Reclamation, Mining and Safety has conducted an inspection of the mining operation noted below. This report documents observations concerning compliance with the terms of the permit and applicable rules and regulations of the Mined Land Reclamation Board.

MINE NAME:	MINE/PROSPECTING ID#:	MINERAL:	COUNTY:
Iris	P-2012-003	Gold	Saguache
INSPECTION TYPE:	INSPECTOR(S):	INSP. DATE:	INSP. TIME:
Surety Release Inspection	Dustin M. Czapla	June 1, 2016	12:00
OPERATOR:	<b>OPERATOR REPRESENTATIVE:</b>	TYPE OF OPERATION:	
Garth Cooke	Steve Crittendon	MP - Mineral Prospecting

<b>REASON FOR INSPECTION:</b>	BOND CALCULATION TYPE:	BOND AMOUNT:
Surety Release Requested	None	\$4,071.00
DATE OF COMPLAINT:	POST INSP. CONTACTS:	JOINT INSP. AGENCY:
NA	None	None
WEATHER:	<b>INSPECTOR'S SIGNATURE:</b>	SIGNATURE DATE:
Clear	De	June 6, 2016

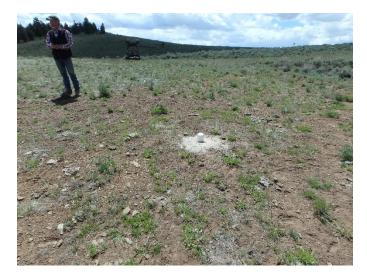
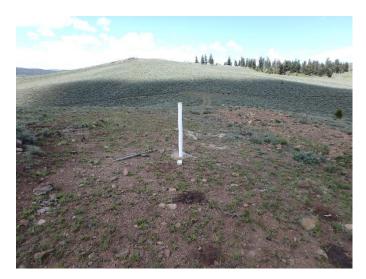
The Iris project included two boreholes on private land located near the historic Iris townsite. The drilling occurred on preexisting roads. This inspection verified that reclamation has been adequately completed and that the holes have been backfilled and capped in accordance with the approved reclamation requirements
