**COLORADO DIVISION OF RECLAMATION, MINING AND SAFETY
MINERALS PROGRAM INSPECTION REPORT**

MINE NAME: Hitch Rack Ranch	MINE/PROSPECTING ID#: P-2014-016	MINERAL: Granite, granite gneiss	COUNTY: El Paso
INSPECTION TYPE: Monitoring	INSPECTOR(S): Timothy A. Cazier	INSP. DATE: June 7, 2016	INSP. TIME: 10:30
OPERATOR: Transit Mix Concrete Co.	OPERATOR REPRESENTATIVE: Brandon Heser, Paul Kos & Bob Stabo	TYPE OF OPERATION: ME - Mineral Exploration

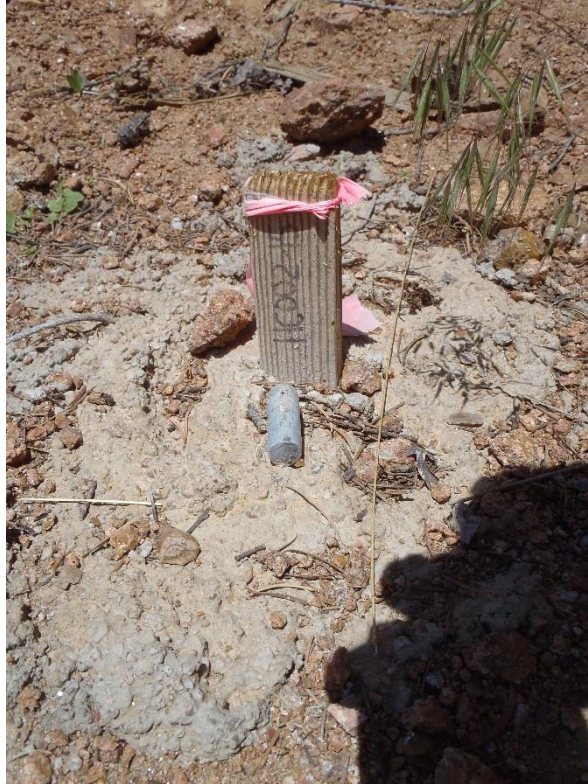
The Division does not require a posted sign for NOIs. No prospecting equipment (drill rig, dozer, skid steer) were observed on site. Drill pads and roads for boreholes B-3, B-4, B-5, B-6, HC002-15 (see **Photos 1 and 2**), HC005-15, HC006-15, and HC007-15 were visited during the inspection. Each borehole appeared to be sealed at the surface. Transit Mix indicated during the April 12, 2016 inspection that all the boreholes were dry (which is supported by the logs submitted for the initial/pre-MD-01 drilling program). As such, only the surface is required to be sealed.

Photo 1. Borehole HC002-15 appeared to be sealed

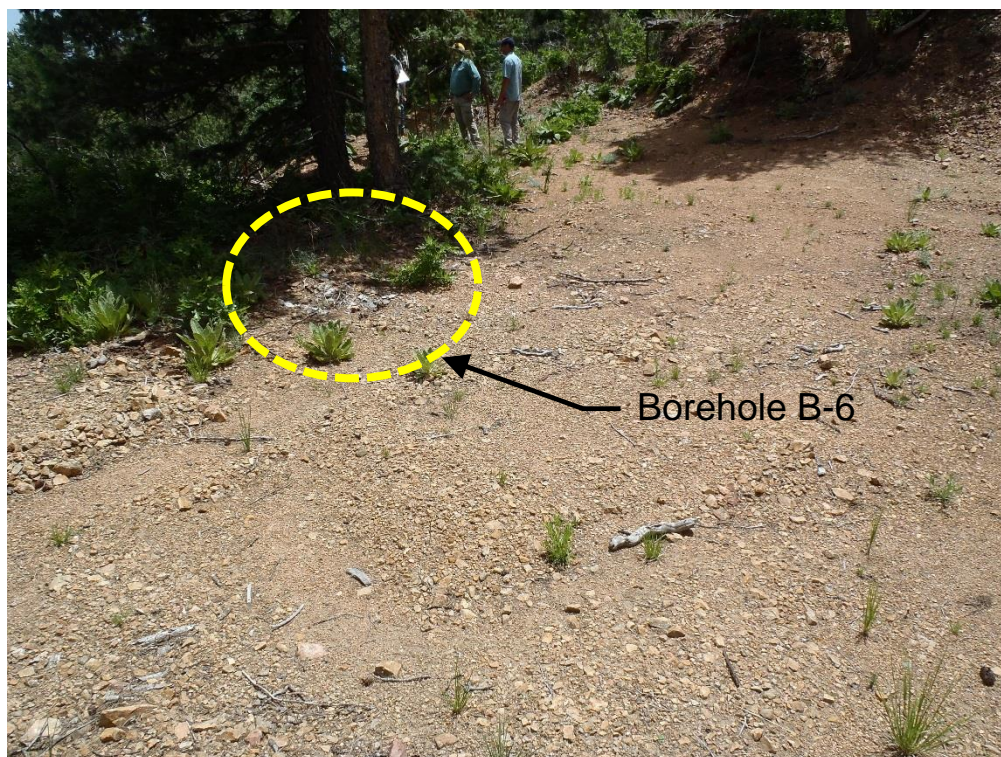
Photo 2. Borehole B-6 pad (looking SE).

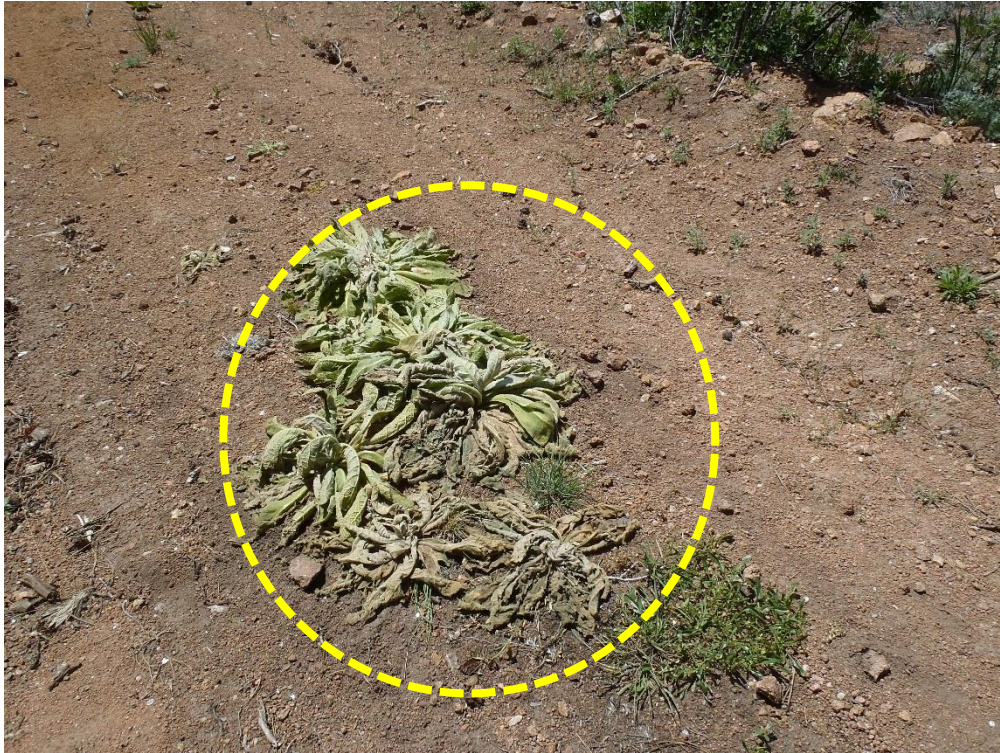
Revegetation is proposed for the drill pads and new roads, but had not been initiated at the time of the inspection. A significant number of common mullein on the drill roads were observed to have been treated (see **Photo 3**). The Transit Mix representatives indicated a weed control plan had been developed for El Paso County and that it would get incorporated in the mine reclamation permit application (M-2016-010) currently under review by the Division.

Photo 3. Treated Common Mullein on Drill Road between Boreholes B-2 and B-3.

The prospector is required to submit a modification to the NOI to incorporate a weed control plan as indicated on page 1 of the previous inspection report. Transit Mix requested and the Division approved an extension on the weed control plan submittal to July 12, 2016.
