COLORADO DIVISION OF RECLAMATION, MINING AND SAFETY
MINERALS PROGRAM INSPECTION REPORT
PHONE: (303) 866-3567

MINE NAME: Orlando Pit	MINE/PROSPECTING ID#: M-2001-106	MINERAL: Sand and gravel	COUNTY: Huerfano
INSPECTION TYPE: Monitoring	INSPECTOR(S): Tyler V. O'Donnell	INSP. DATE: January 15, 2016	INSP. TIME: 08:45
OPERATOR: Huerfano County	OPERATOR REPRESENTATIVE: Melanie Bounds	TYPE OF OPERATION: 112c - Construction Regular Operation

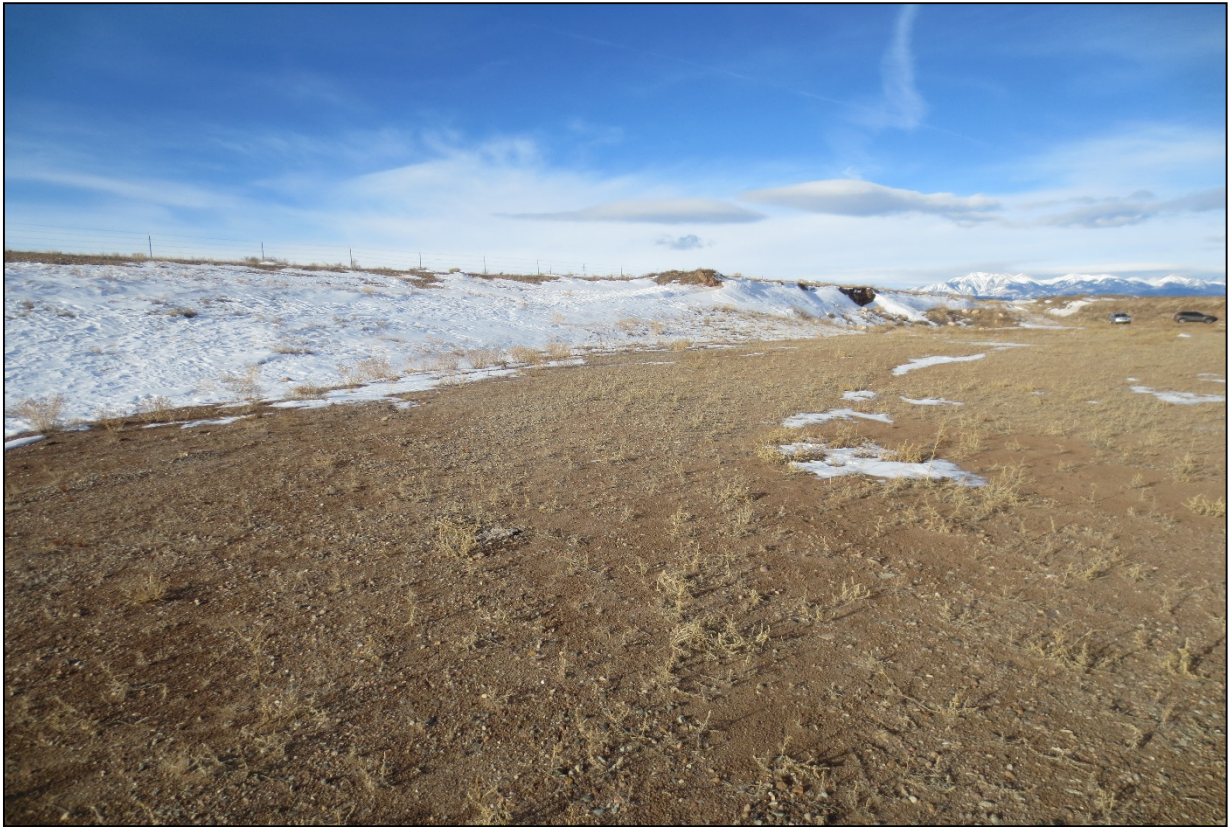
There was a highwall just east of the access road, the highwall nearly paralleled the access road. The highwall had an average height of approximately 15 feet and was approximately 250ft long, running roughly north-south. The highwall had an approximant slope of .5H:1V to just flatter than 1H:1V. All mined areas daylight off the terrace to the northeast. The site has been graded between the crest of the terrace to the active highwall along the southern affected land boundary. The Operator has graded portions of the affected land to 3H:1V or flatter. No exposed groundwater was observed. When completing final reclamation, the Operator will need to grade all slopes to 3H:1V or flatter to comply with the approved reclamation plan. All slopes appeared to be structurally stable.

Photo 1: Southern reclaimed slope at or near the affected land boundary. The majority of the slope has been graded to 3H:1V or flatter.

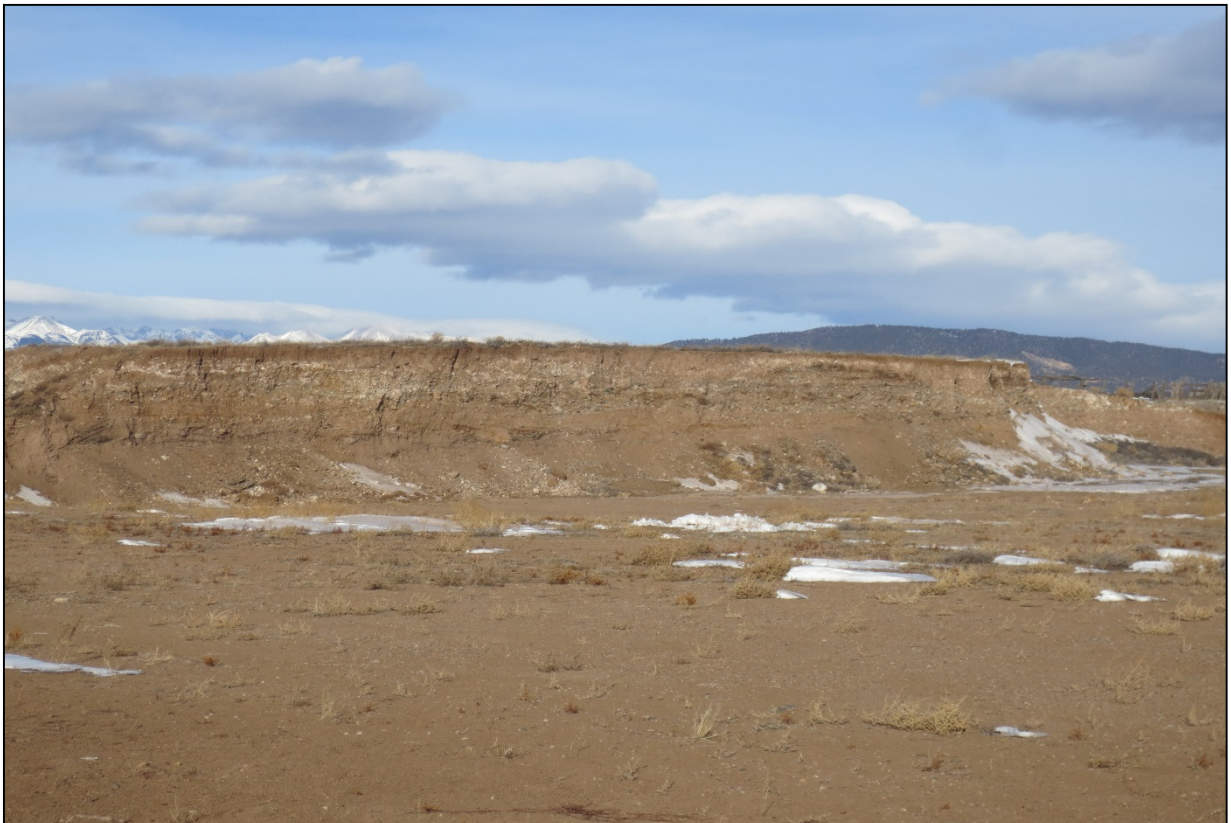
Photo 2: Active highwall progressing to the west, highwall runs roughly north-south.

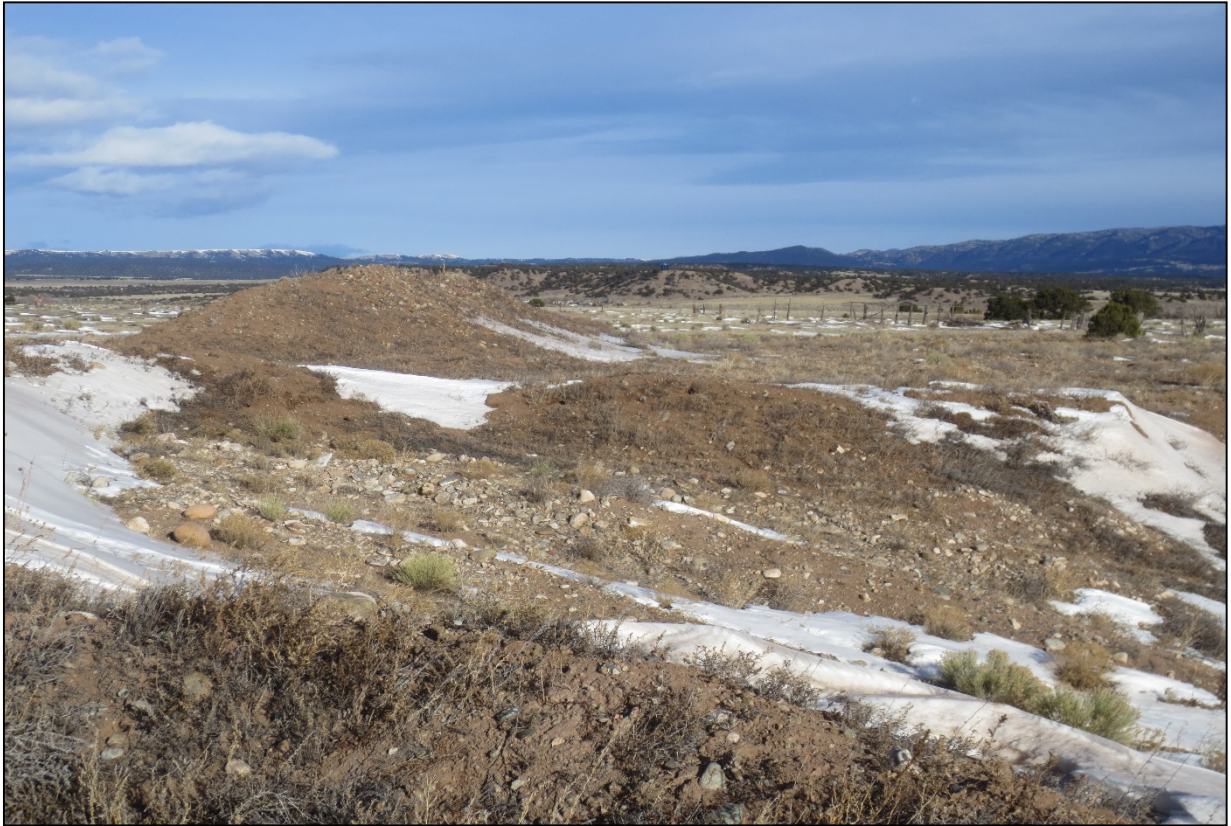
There was a topsoil stockpile located on top of the highwall just east of the access road. The topsoil stockpile had decent vegetative cover to protect from erosion. There appeared to be just enough topsoil to reclaim the current mining disturbance.

Photo 3: Topsoil stockpile on top the highwall.

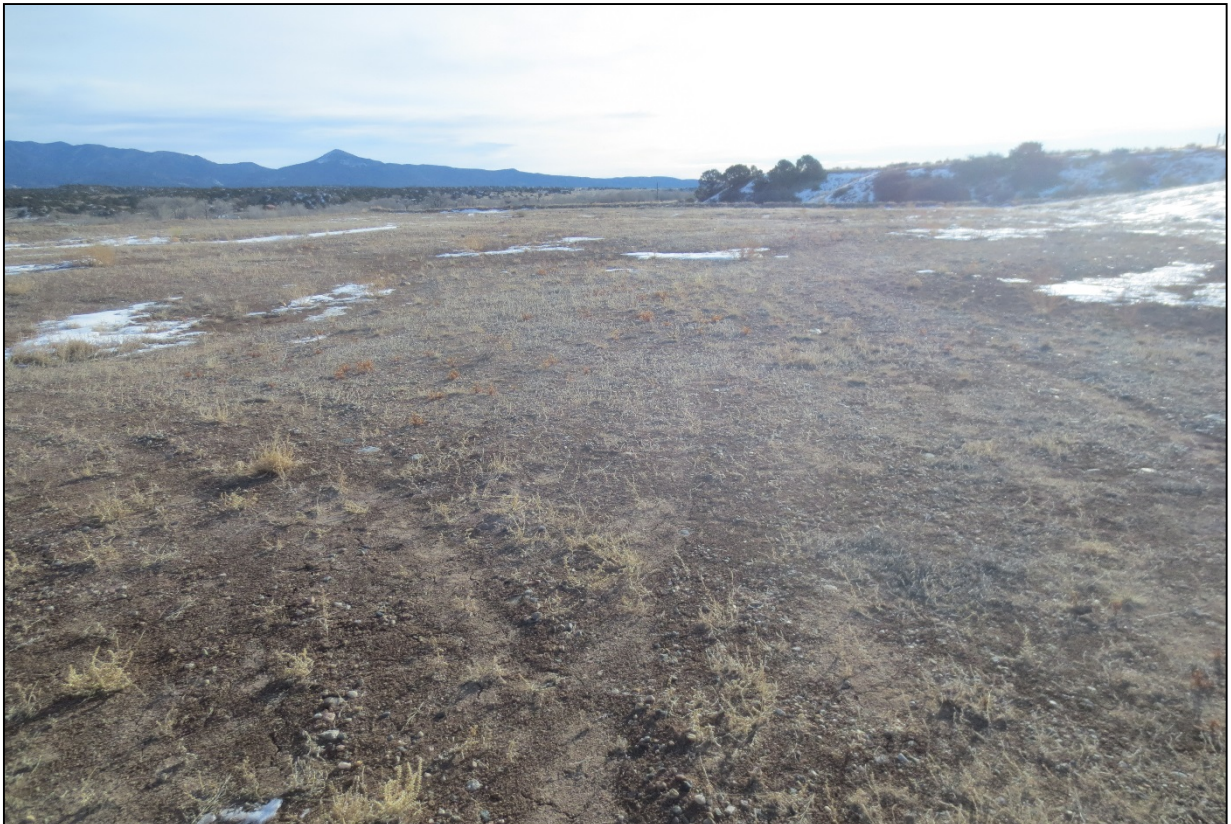
The mined out eastern portion of the site has been successfully backfilled and graded to 3H:1V or flatter in areas, creating a stable land surface. It appears that the Operator may have replaced the topsoil, in the eastern portion of the site, just west of the crest of the terrace. It appears that the eastern portion of the site has not been revegetated yet. Volunteer vegetation and annual weeds have begun to establish in the eastern portion of the site.

Photo 4: Eastern portion of the pit. Pit floor appears to be well graded. It appears that topsoil has been spread over this area.

The Operator appears to be conducting mining operations as approved in the permit. It appears that an area in the eastern portion of the site has nearly been mined out. Once the Operator completes mining in the furthest southeastern portion of the site, the Operator should consider reclaiming the eastern extent of the affected land because this area will have been mined out. Also the amount of topsoil salvaged appears to be barely adequate to complete final reclamation, additional topsoil should be salvaged when new areas are opened up for mining.
