**COLORADO DIVISION OF RECLAMATION, MINING AND SAFETY**  
**MINERALS PROGRAM INSPECTION REPORT**  
**PHONE: (303) 866-3567**

<b>MINE NAME:</b> Keeling Pit	<b>MINE/PROSPECTING ID#:</b> M-1991-081	<b>MINERAL:</b> Sand and gravel	<b>COUNTY:</b> Huerfano
<b>INSPECTION TYPE:</b> Monitoring	<b>INSPECTOR(S):</b> Tyler V. O'Donnell	<b>INSP. DATE:</b> January 15, 2016	<b>INSP. TIME:</b> 11:15
<b>OPERATOR:</b> Sam Keeling	<b>OPERATOR REPRESENTATIVE:</b> Sam Keeling	<b>TYPE OF OPERATION:</b> 110c - Construction Limited Impact

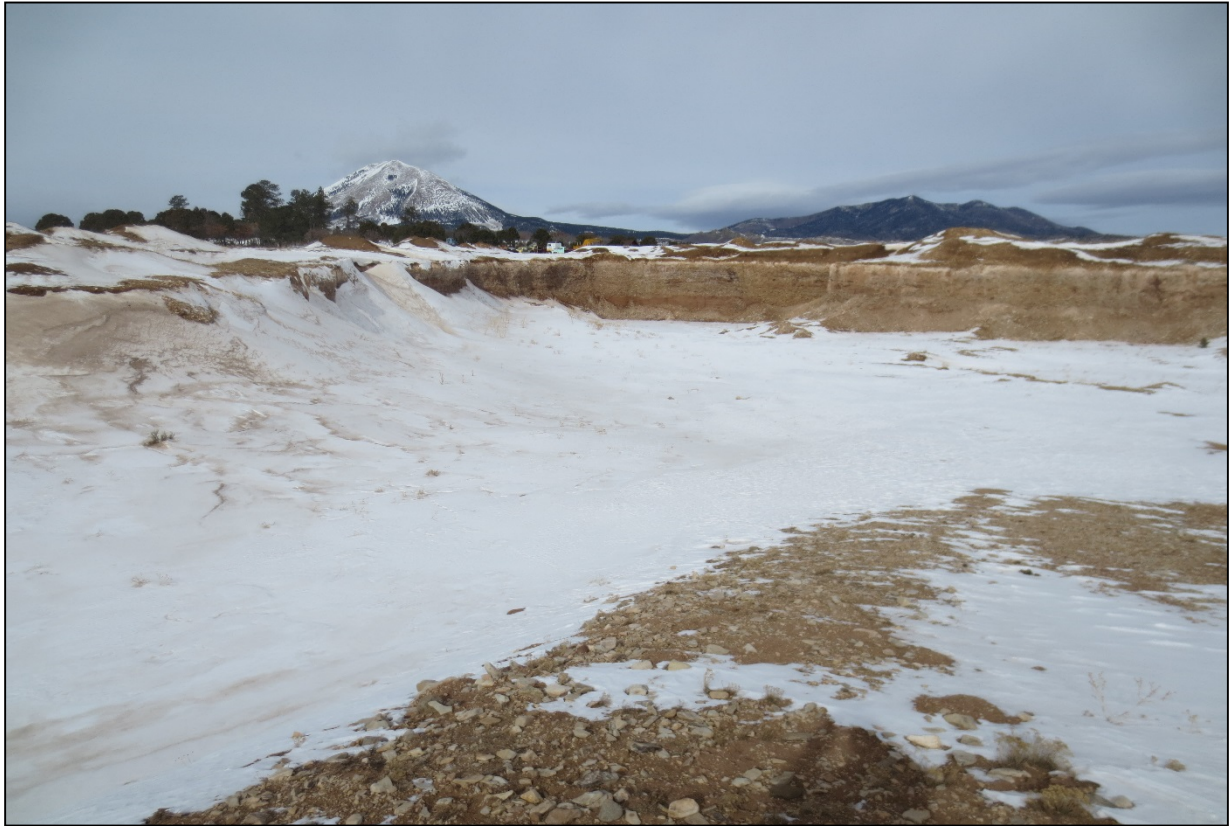
There was a highwall around the entire perimeter of the affected land boundary. The Highwall was a circular excavation. The highwall was approximately 20 feet high and 1,200 feet long. No exposed groundwater was observed. When completing final reclamation, the Operator will need to grade all slopes to 3H:1V or flatter to comply with the approved reclamation plan. All slopes appeared to be structurally stable.

**Photo 1:** Western side of the pit. Highwall was near vertical.

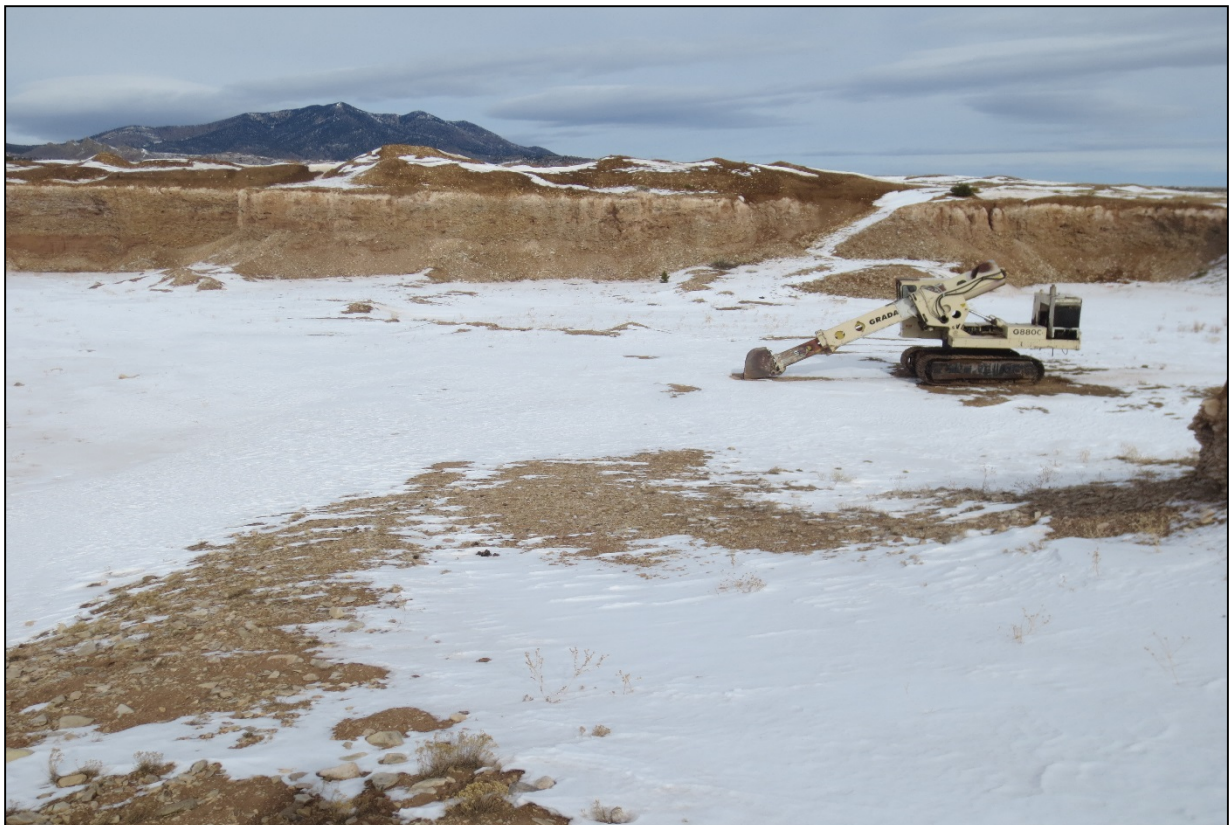
**Photo 2:** central portion of the pit. Highwall was near vertical.

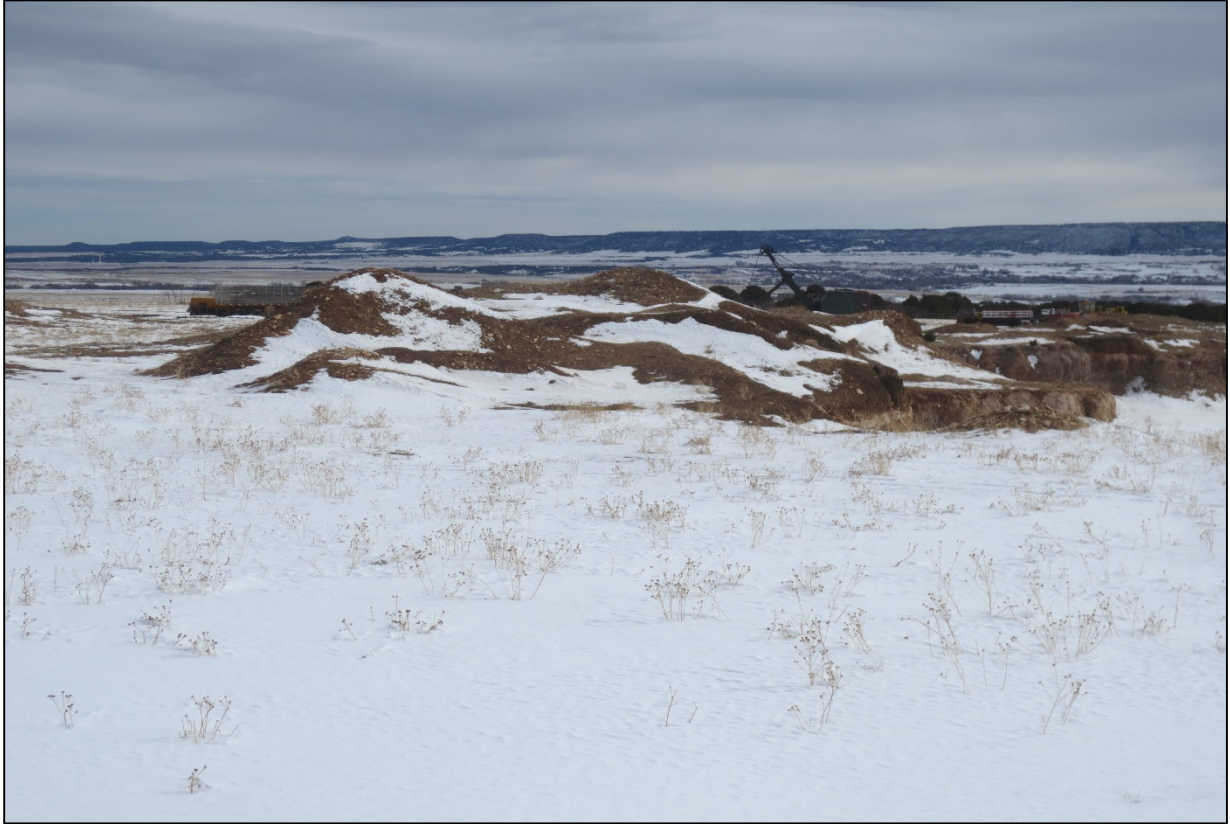
There were a topsoil stockpiles located on top of the highwall around portions of the site. Topsoil had been salvaged in advance of mining. The topsoil stockpiles were well vegetated, thus providing good protection from erosion. There appeared to be an adequate amount of topsoil around the site to reclaim the current mining disturbance.

**Photo 3:** Topsoil along the eastern side of the pit.

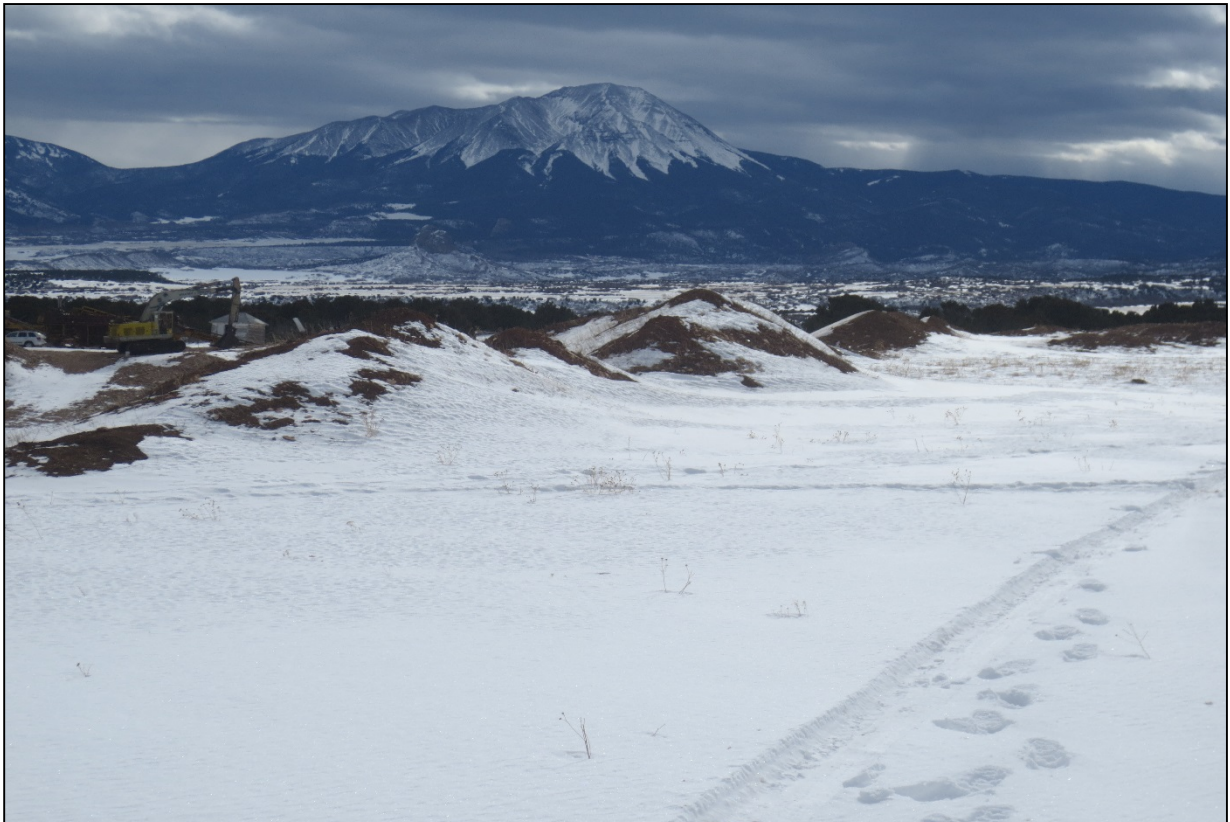
**Photo 4:** Topsoil along the western side of the pit.
