COLORADO DIVISION OF RECLAMATION, MINING AND SAFETY
MINERALS PROGRAM INSPECTION REPORT
PHONE: (303) 866-3567

MINE NAME: Double Eagle	MINE/PROSPECTING ID#: M-2016-002	MINERAL: Feldspar and quartz	COUNTY: Teller
INSPECTION TYPE: Preoperation Inspection	INSPECTOR(S): Timothy A. Cazier	INSP. DATE: June 9, 2016	INSP. TIME: 10:20
OPERATOR: Donald J. Self	OPERATOR REPRESENTATIVE: Jeff Self	TYPE OF OPERATION: 110(1) - Hard Rock Limited Impact

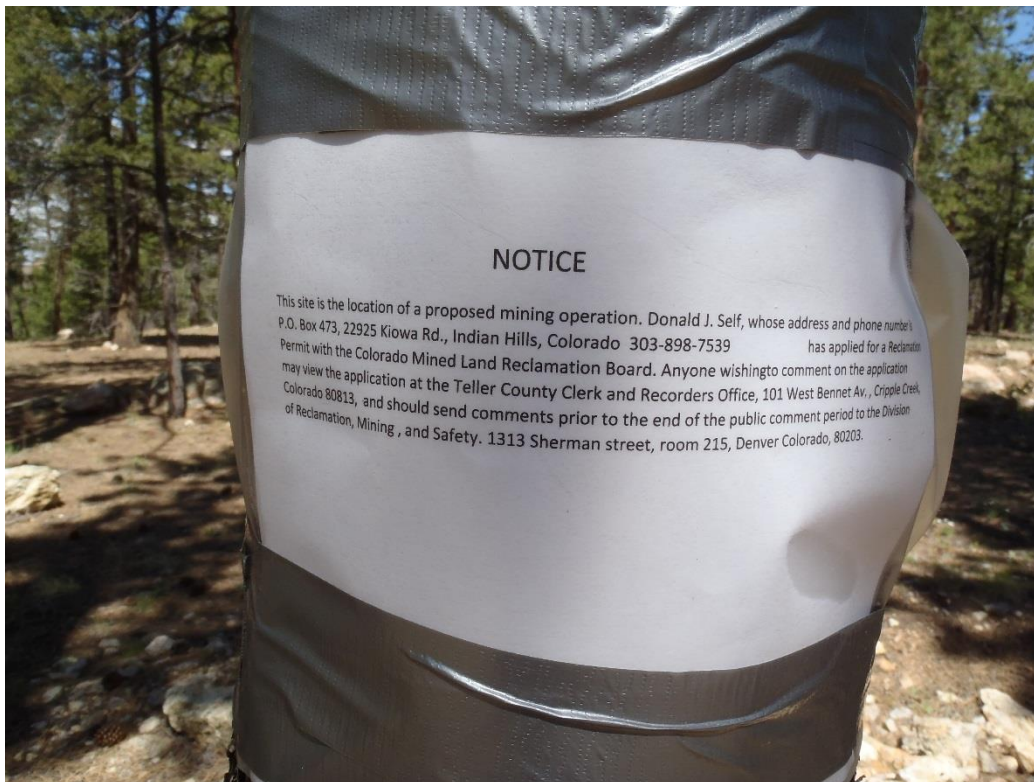
Markers & Boundary – The required notice was posted (see **Photo 1**) on a tree at the claim entrance. The Division explained to the Applicant representatives that boundary markers would be required to identify edges of the permit for future inspections. The boundary markers will need to delineate extents of the area to be affected by mining activities (including: trenches, spoil piles and access roads requiring reclamation by the USFS. It was agreed on site by the USFS, Applicant and the Division that the Applicant would be responsible for road reclamation beginning at the “Y” (see **Photo 2**) at the top of the hill (approximately 39° 0'59.11"N, 105°17'10.69"W). The Division believes the length of road to be roughly 350 feet (based on the September 27, 2013 Google Earth satellite image) by 8 feet wide, but is seeking clarification as to whether additional road segments west of the proposed dig sites are to be included.

Photo 1. Posted notice at time of inspection.

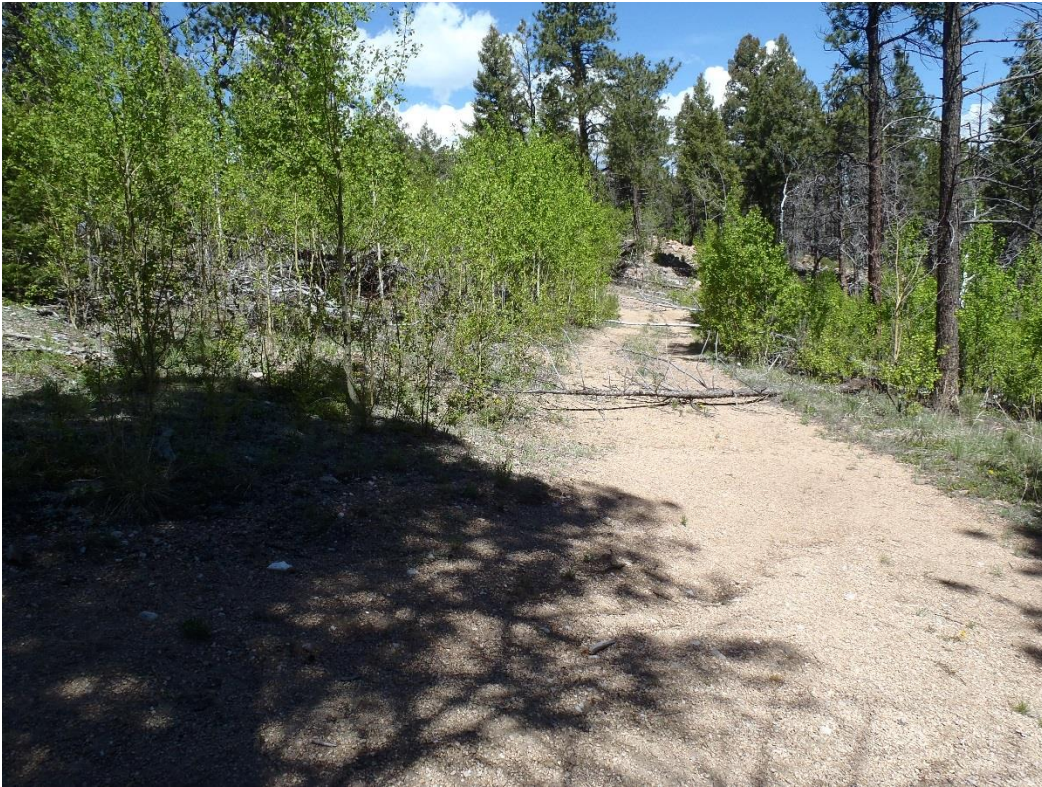
Photo 2. Access road from "Y" at top of hill (looking NW).

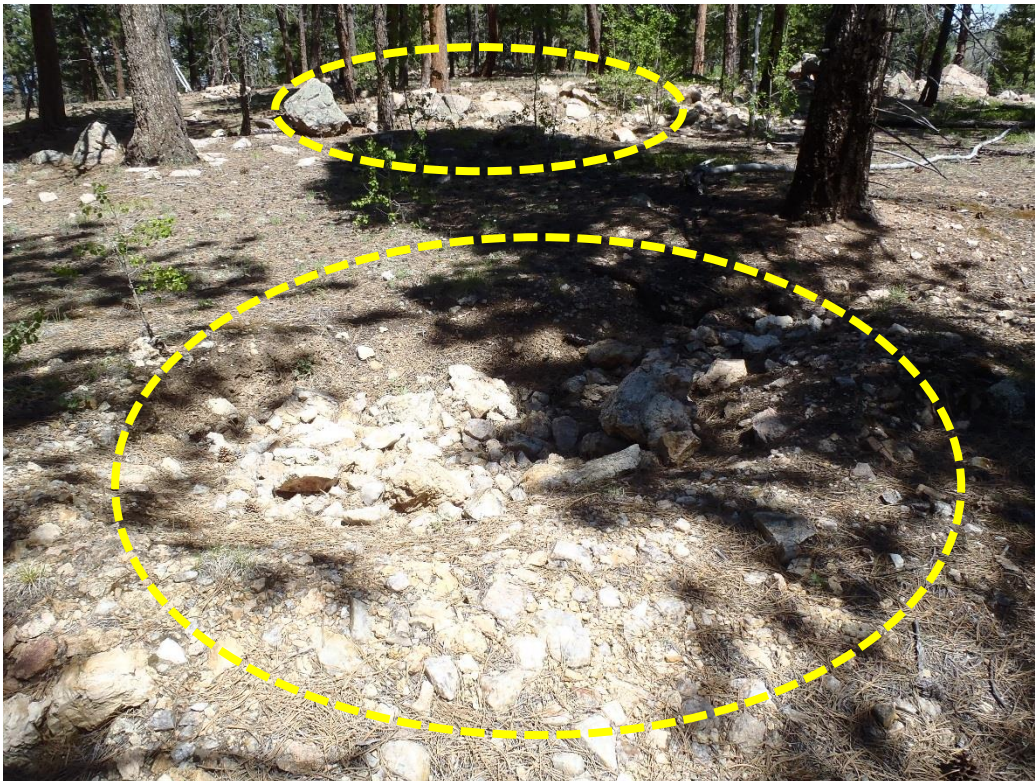
Mining Plan – Several shallow trenches and holes (and associated small spoil piles) were observed in the area (see **Photos 3** through **5**). None appeared to have been worked for quite some time. Mr. Self explained that the claim had previously belonged to a gem club. No recent disturbances were observed. The proposed mine plan anticipates three 100-foot long trenches. The Division is seeking further clarification through concurrent adequacy review comments. No structures were observed in the area.

Photo 3. Shallow trenches and holes (1 of 3, ridge top, looking west).

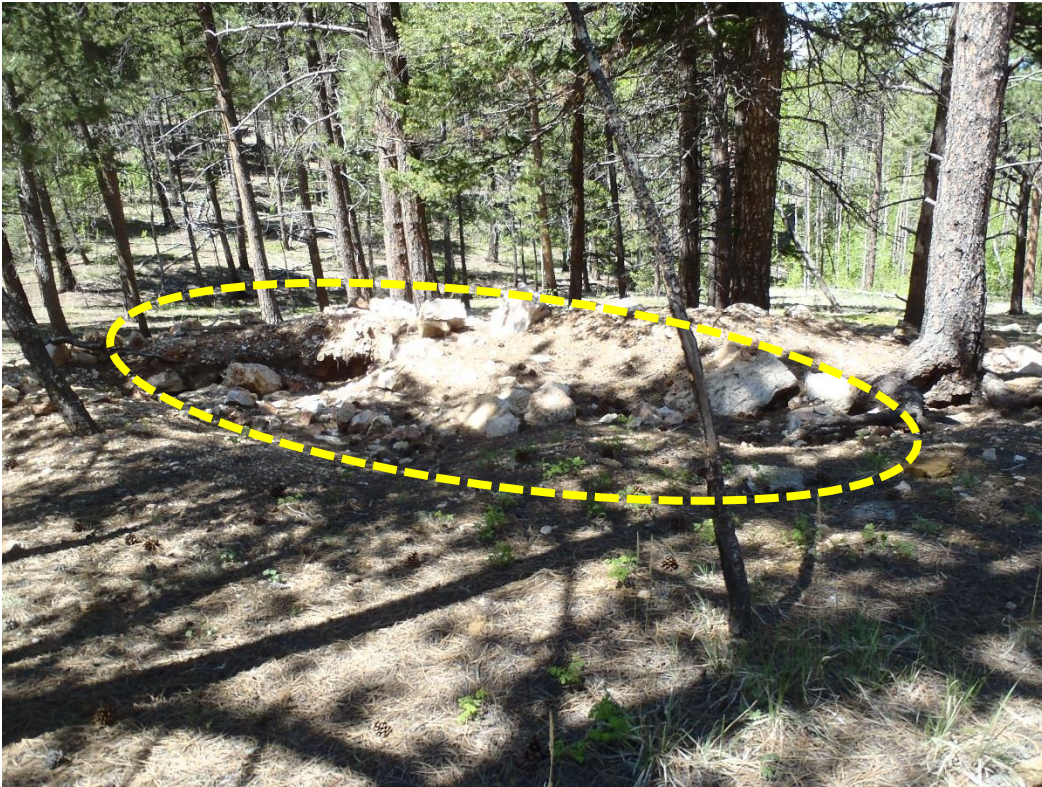
Photo 4. Shallow trenches and holes (2 of 3, ridge top, looking SW).

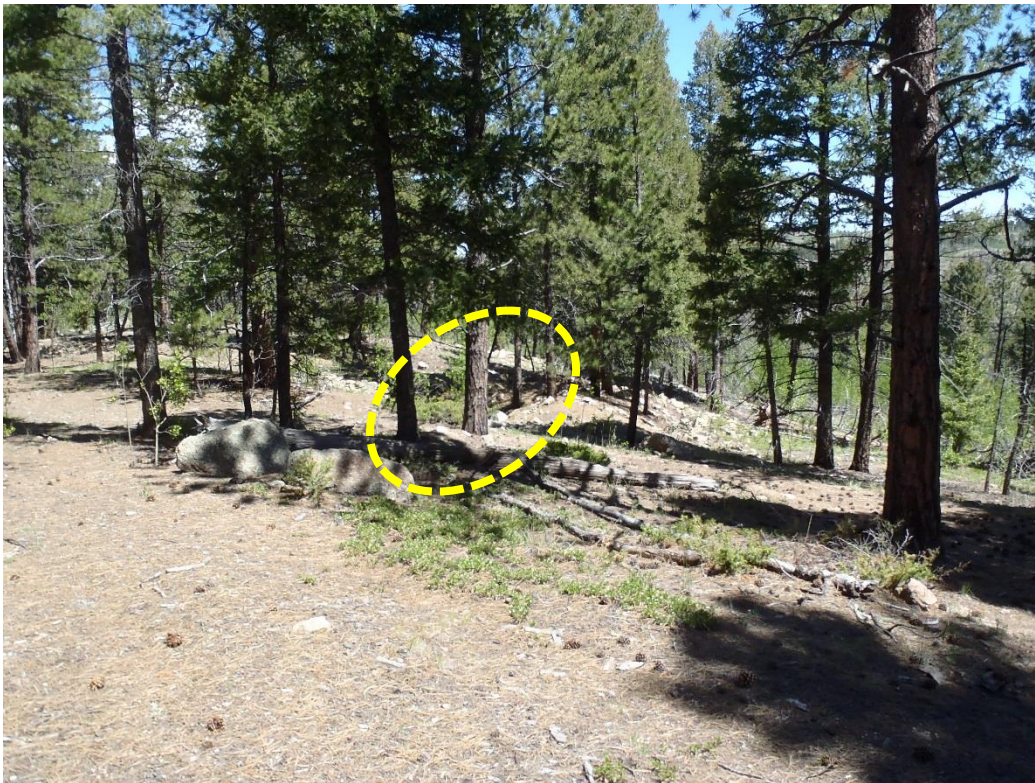
Photo 5. Shallow trenches and holes (3 of 3, ridge top, looking NW).

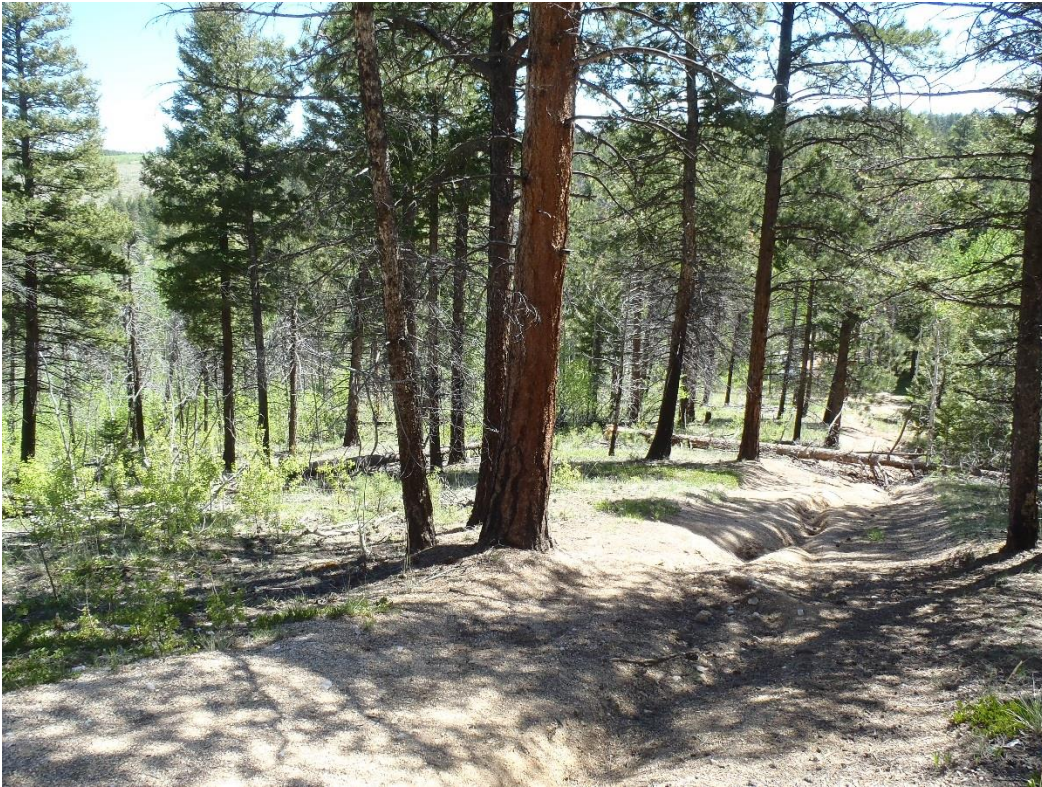
Photo 6. Hill access road, not considered for reclamation (looking east from "Y" at top).

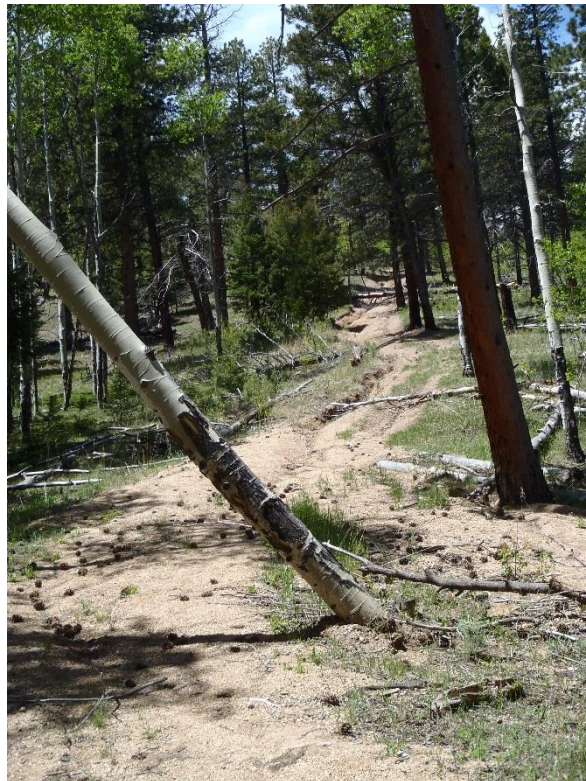
Photo 7. Hill access road, not considered for reclamation (looking west from bottom).
