**COLORADO DIVISION OF RECLAMATION, MINING AND SAFETY**  
**MINERALS PROGRAM INSPECTION REPORT**  
**PHONE: (303) 866-3567**

| <b>MINE NAME:</b><br>Morgan Pit | <b>MINE/PROSPECTING ID#:</b><br>M-2006-077 | <b>MINERAL:</b><br>Sand and gravel | <b>COUNTY:</b><br>Huerfano |
| <b>INSPECTION TYPE:</b><br>Monitoring | <b>INSPECTOR(S):</b><br>Tyler V. O'Donnell | <b>INSP. DATE:</b><br>January 15, 2016 | <b>INSP. TIME:</b><br>12:30 |

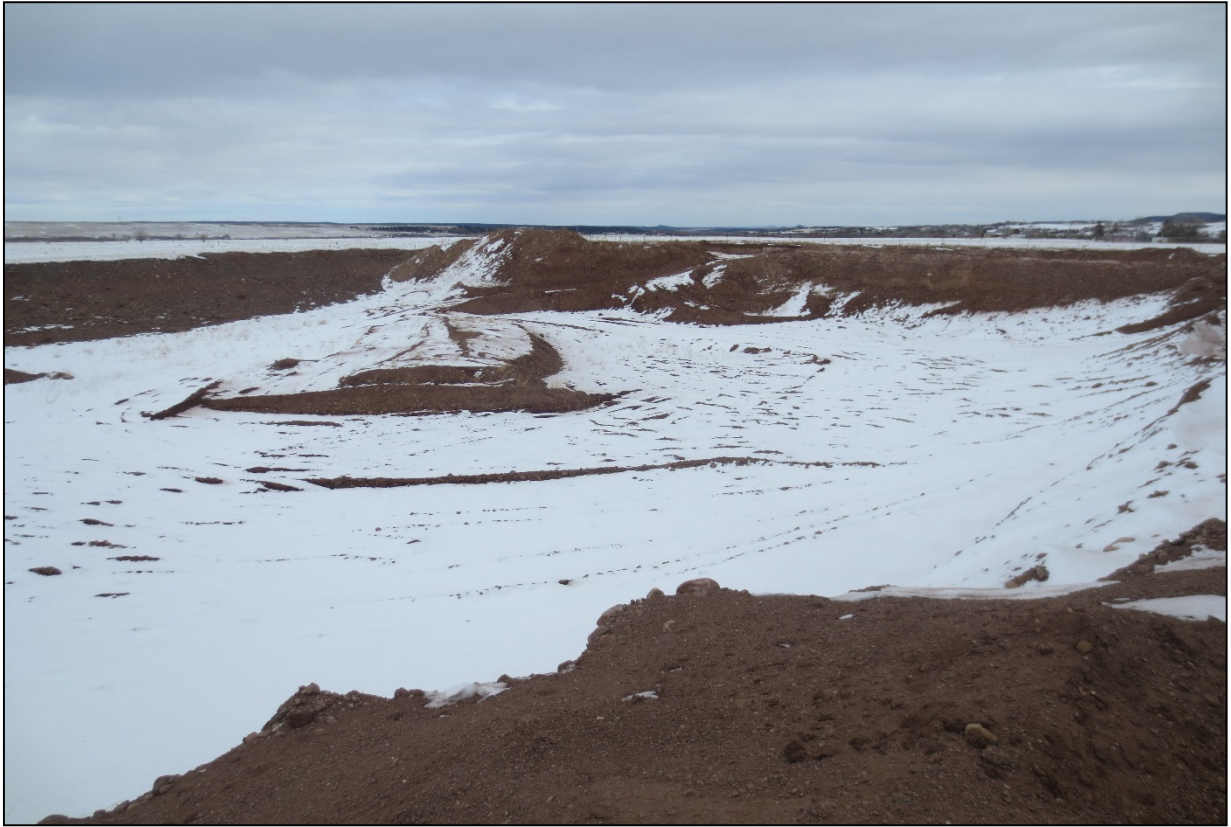
There were highwalls around all 4 sides of the current pit excavation, located in the northern portion of the site. The highwalls were approximately 20 feet high and contained a total cumulative length of approximately 1,200 feet. Portions of the highwalls were vertical, graded to 3H:1V, or partially graded at 2H:1V. The approved permit states that the side slopes (east and west) will be mined at 3H:1V or flatter (Enclosed portions of the reclamation and mining plans). The Operator must immediately grade all side slopes to a 3H:1V, or flatter, thereby bringing the slopes in to compliance with the approved permit. The Operator must resume mining the side slopes at 3H:1V or flatter. If the Operator wishes to continue to mine slopes steeper than a 3H:1V the approved permit will need to be revised. No exposed groundwater was observed. At the time of the inspection all slopes appeared to be structurally stable. There were also small stockpiles of broken up concrete and asphalt on site, it appears that the Operator maybe recycling the material. The imported concrete, asphalt and other material cannot be used for backfill without the Division's approval.

**Photo 1:** Eastern side of the current exaction. Small highwall along the east side of the pit. The northern side of the pit (left hand side of the photo) has been graded to approximately 2H:1V to 3H:1V.

All mining activity appeared to be within the approved affected land boundary. There were several pieces of mining equipment scattered throughout the site. There was also a crushing plant and a screening plant located just south of the current excavation. The approved permit states that the side slopes (east and west) will be mined at 3H:1V or flatter (Enclosed portions of the reclamation and mining plans). The Operator must immediately grade all side slopes to a 3H:1V or flatter, thereby bringing the slopes in to compliance with the approved permit. The Operator must resume mining the side slopes at 3H:1V or flatter. If the Operator wishes to continue to mine slopes steeper than a 3H:1V the approved permit must be revised.

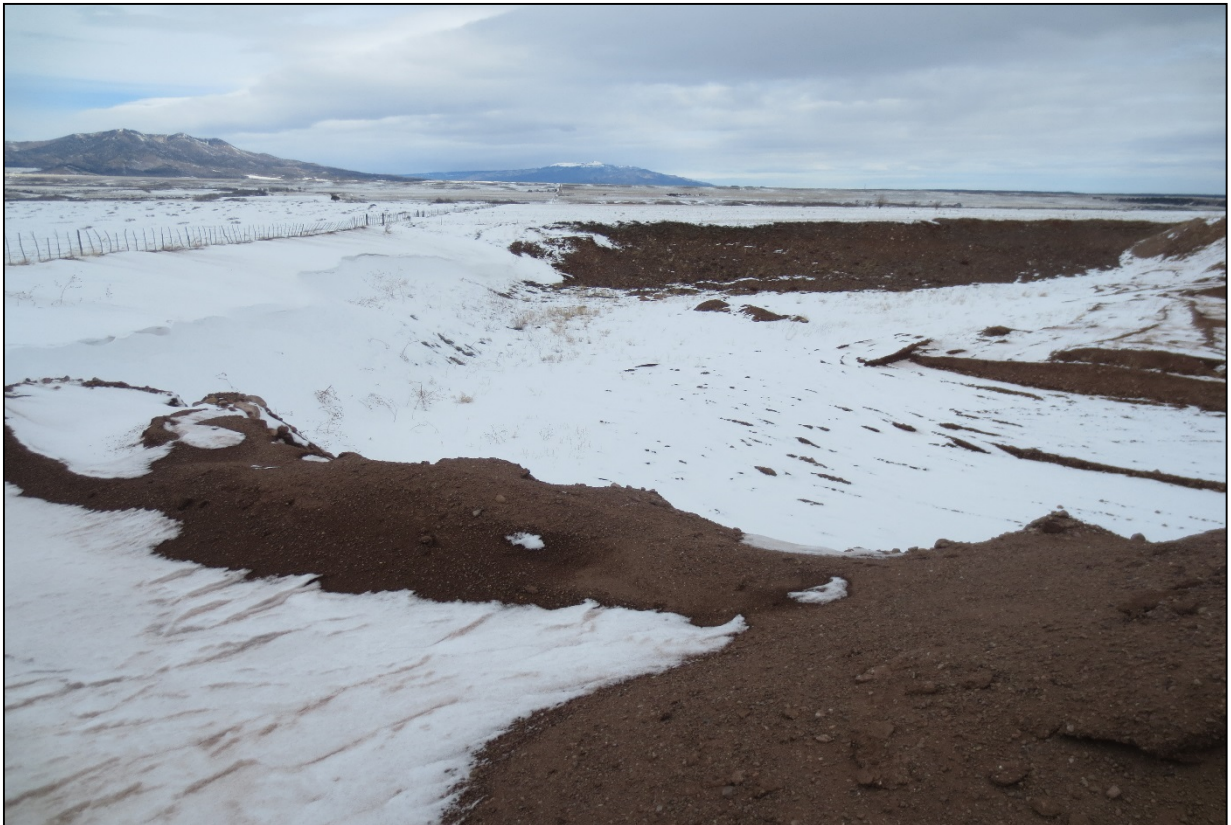
**Photo 2:** Western side of the current exaction. The northern side of the pit (background) has been graded to approximately 2H:1V to 3H:1V. The western portion of the pit (left hand side of the photo) has been graded to 3H:1V.

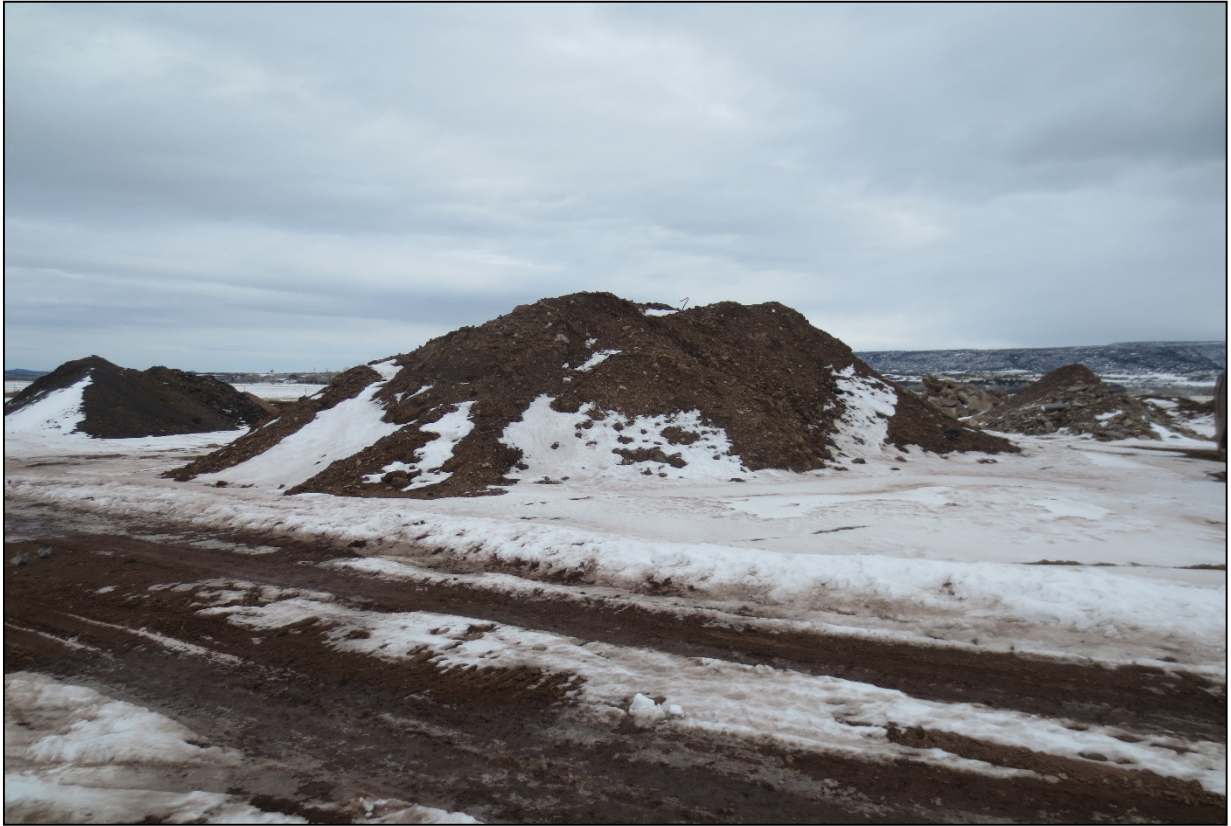
**Photo 3:** Stockpile of product. Stockpiles of concrete and asphalt in the background.

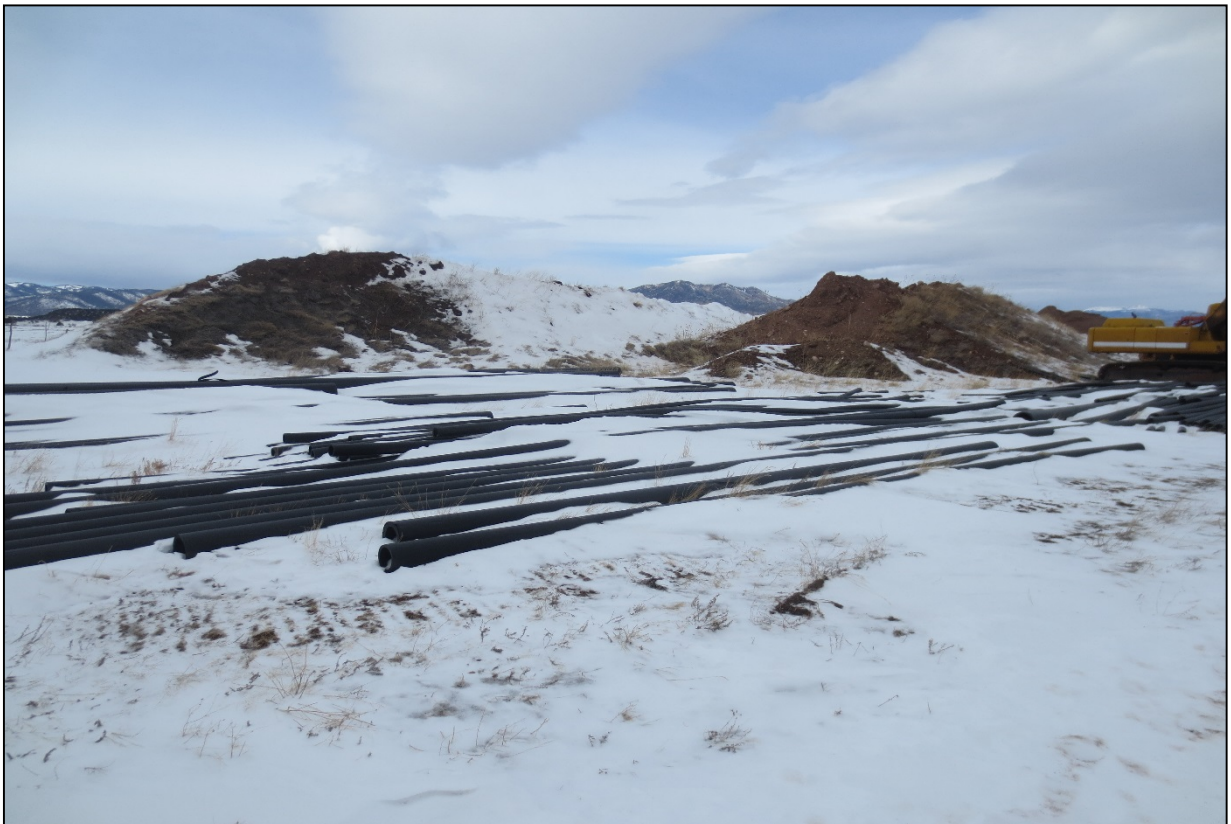
It appears that topsoil had been salvaged in advance of mining. There was one large topsoil stockpile located southwest of the current excavation. The topsoil stockpile was adequately vegetated, thus providing good protection from water and wind erosion. There appeared to be an adequate amount of topsoil in the main topsoil stockpile to reclaim the current mining disturbance.

**Photo 4:** Topsoil stockpile.
