COLORADO DIVISION OF RECLAMATION, MINING AND SAFETY
MINERALS PROGRAM INSPECTION REPORT
PHONE: (303) 866-3567

MINE NAME: Oaklands Ranch	MINE/PROSPECTING ID#: M-1989-092	MINERAL: Gravel	COUNTY: Douglas
INSPECTION TYPE: Monitoring	INSPECTOR(S): Tyler V. O'Donnell	INSP. DATE: March 14, 2016	INSP. TIME: 13:00
OPERATOR: Oaklands Ranch	OPERATOR REPRESENTATIVE: David Curtis	TYPE OF OPERATION: 112c - Construction Regular Operation

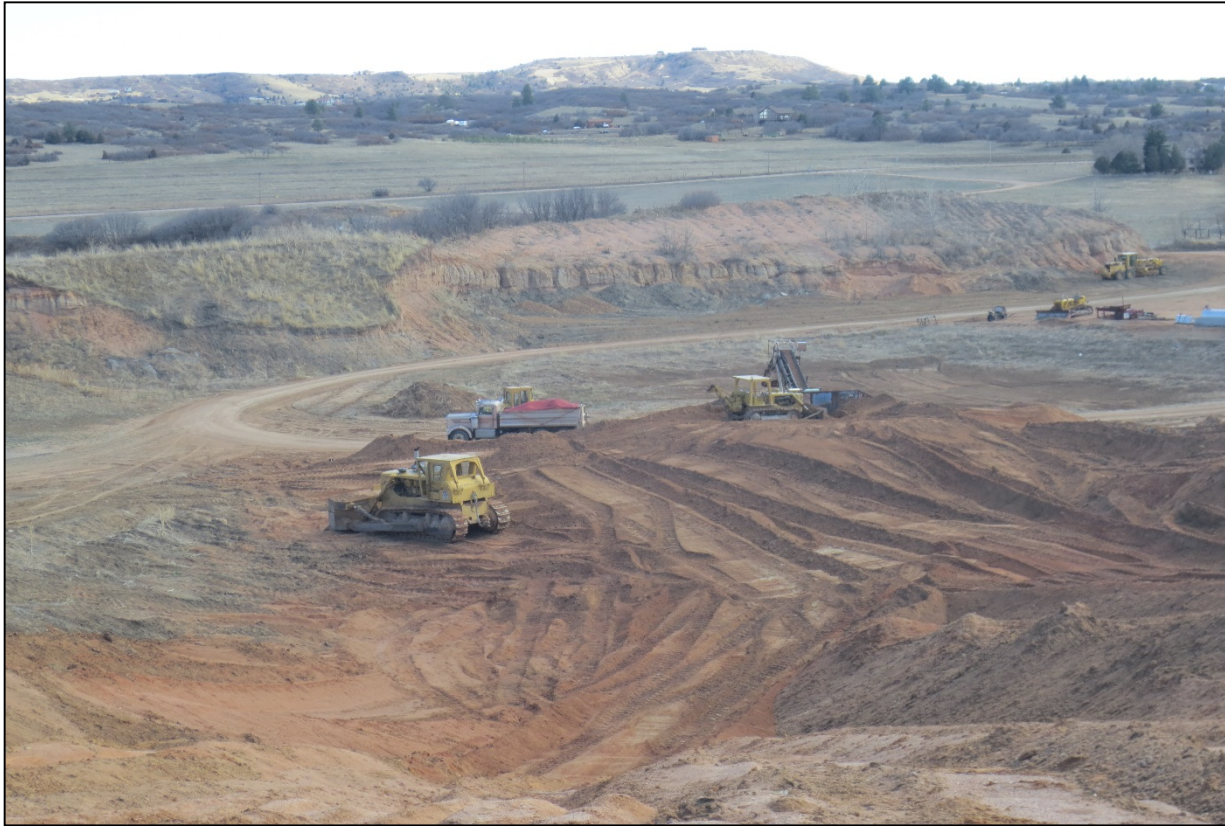
The Operator has mined just shy of 10 acres. The Operator is nearing the maximum allowed disturbance and the Operator has nearly depleted the reserves on the northern and eastern sides of the current disturbance. The Operator is encouraged to begin reclaiming portions of the pit that are mined out. The Approved post Mining land use is pastureland, the Operator must reclaim the site to support the use of the site as a hay meadow.

Photo 1: Active mining area nearing the northern permit boundary.

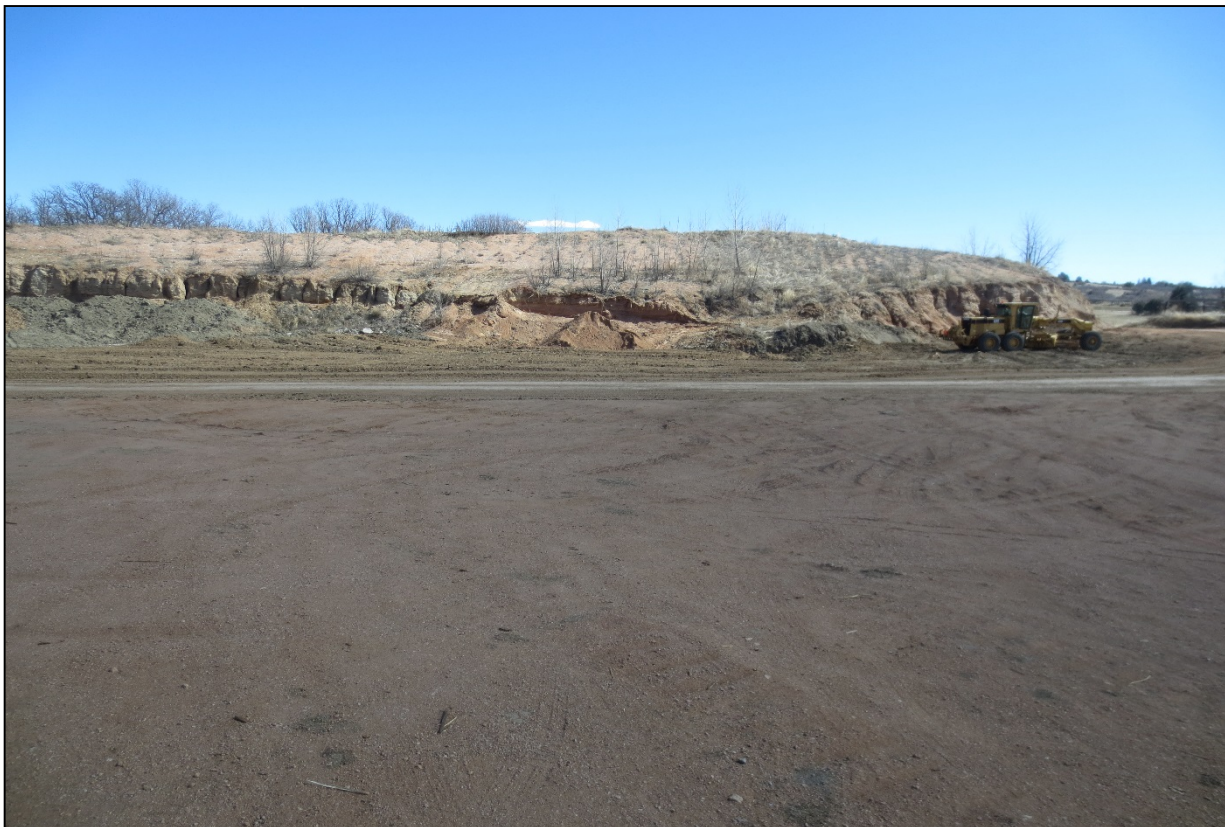
The Operator started mining on a terrace/creek bench located on the west side of Plum Creek, thereby leaving the side slope facing the creek undisturbed. The current pit had been mined down approximately 20 feet, thus leaving the pit floor 10-15 feet higher than the bottom of Plum Creek. Because the Operator started mining the pit to the west of the crest of the Plum Creek terrace/bence and mined to the west, the Operator has left undisturbed land between the pit floor and Plum Creek. The undisturbed land between Plum Creek and the Pit floor essentially looks like and functions as a large sight berm, between the pit floor and Plum Creek. The Division misunderstood the pre-mining topography during the review of TR-02, as a correction the Operator intends to leave the existing, pre-mining topography on the east side of the creek bench/terrace and not mine through the creek bench or terrace. The Operator plans on leaving undisturbed land between the creek and the pit, the Operator is not filling an area to create a berm. There were highwalls around all 3 sides of the current pit excavation, the excavation daylighted to the southeast. The highwalls were approximately 20 feet high and contained a total cumulative length of approximately 775 feet. Portions of the highwalls were vertical, graded to 4H:1V or temporally graded at approximately 2H:1V. No exposed groundwater was observed. At the time of the inspection all slopes appeared to be structurally stable. The western highwall appeared to be graded to 4H:1V or flatter. The Operator was in the process of backfilling and grading the northern and eastern highwalls with imported material. The Operator

Photo 2: West side of the remaining terrace, Creek bench.

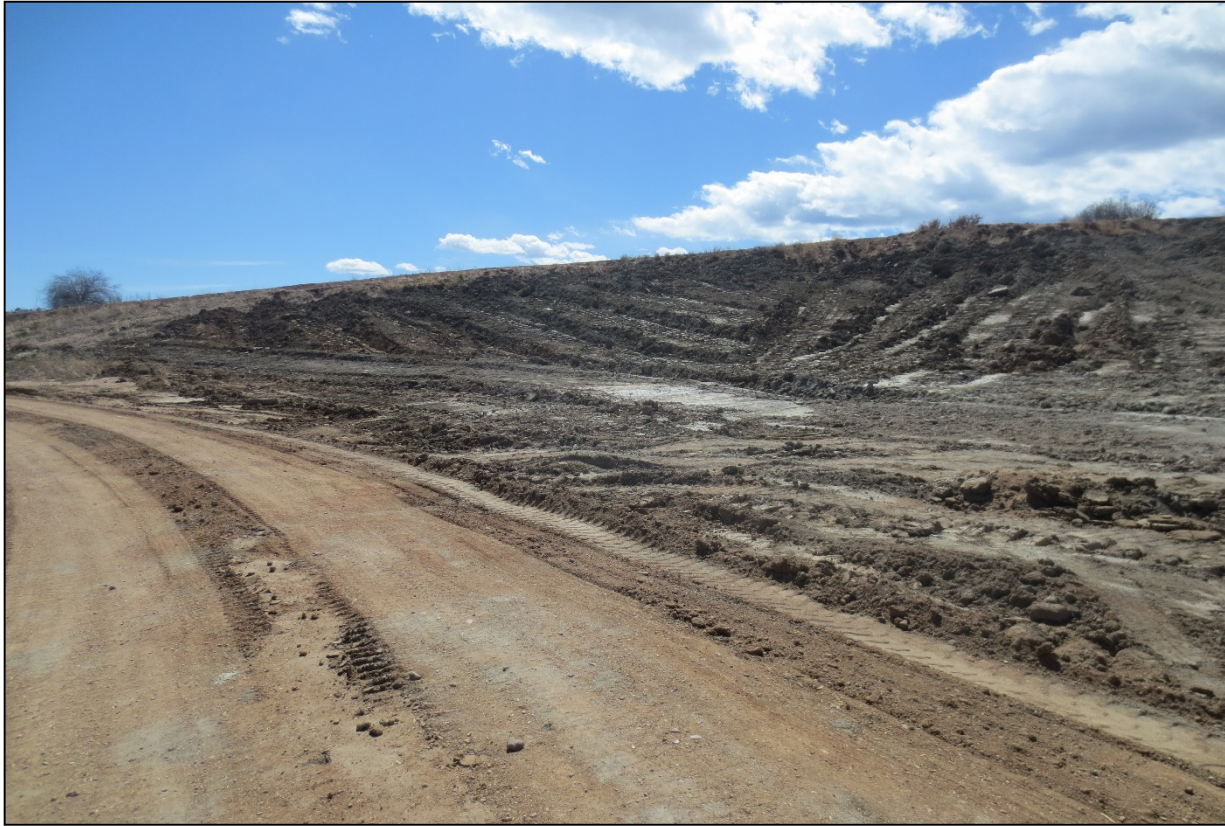
The Operator appeared to be conducting concurrent reclamation. Several portions of the site have been graded to 4H:1V or flatter. Other portions of the site still have vertical highwalls that the operator was in the process of backfilling. Several areas of the pit floor have been graded to 4H:1V. It appears that topsoil may have been spread over approximately 2 acres scattered around the site. The scattered areas around the pit floor have begun to fill in with desired native volunteer vegetation. The approved permit requires all slopes to be graded to 4H:1V or flatter. The Approved permit states that the site will be reclaimed to be hayed with a grass alfalfa mix; thereby supporting the approved post-mining land use of pastureland.

Photo 3: Western highwall, the Operator was backfilling and grading this portion of the pit. The slope was 4H:1V or flatter.

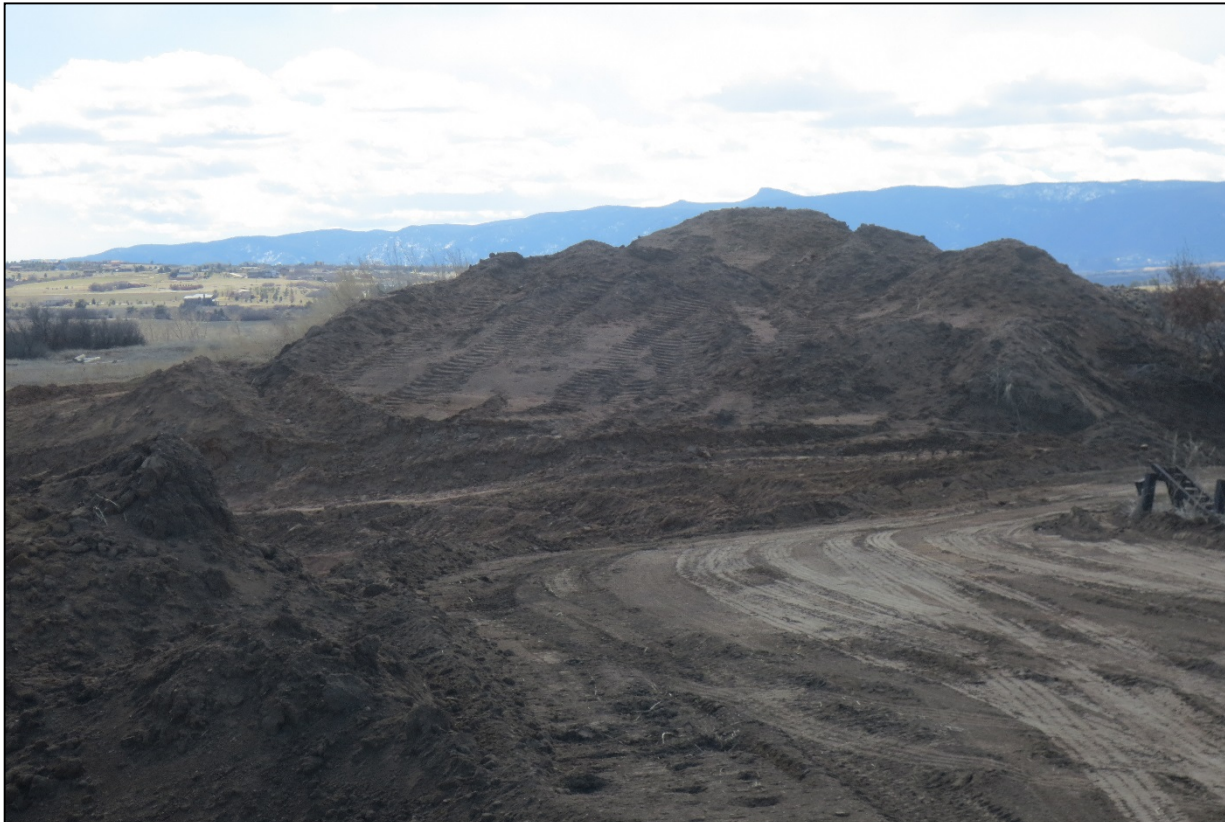
It appears that topsoil had been salvaged in advance of mining. There was a topsoil stockpile located just northwest of the current pit excavation. Also the amount of topsoil salvaged appears to be barely adequate to complete final reclamation, additional topsoil should be salvaged when new areas are opened up for mining.

Photo 4: Topsoil stockpile in the northwestern portion of the current affected lands.
