COLORADO DIVISION OF RECLAMATION, MINING AND SAFETY
MINERALS PROGRAM INSPECTION REPORT
PHONE: (303) 866-3567

MINE NAME: McNulty Cinder Pit	MINE/PROSPECTING ID#: M-1980-003	MINERAL: Sand and gravel	COUNTY: Eagle
INSPECTION TYPE: Monitoring	INSPECTOR(S): Travis H. Marshall	INSP. DATE: June 2, 2016	INSP. TIME: 11:00
OPERATOR: Quarter Circle 8 LLLP dba Cattle Creek C	OPERATOR REPRESENTATIVE: Sarah McNulty	TYPE OF OPERATION: 110c - Construction Limited Impact

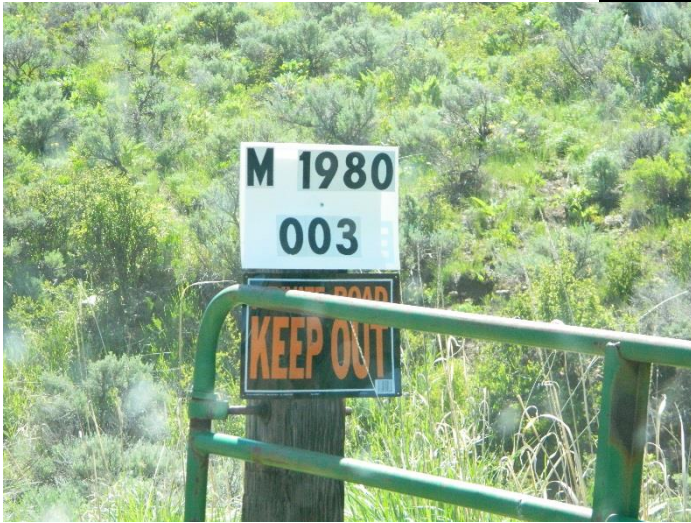
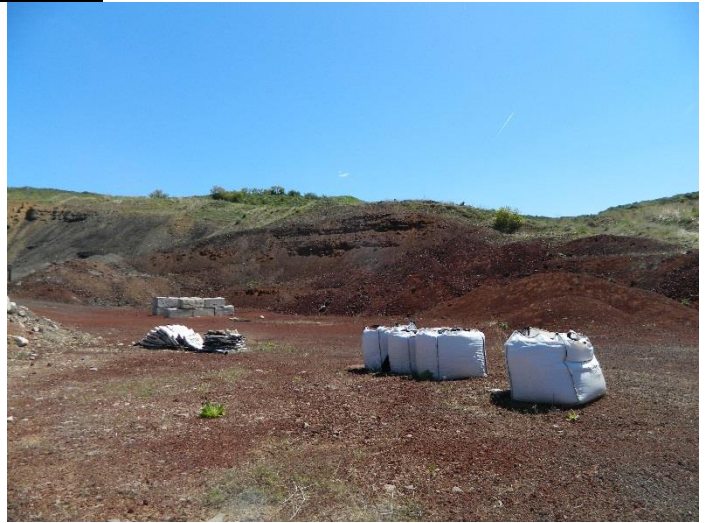
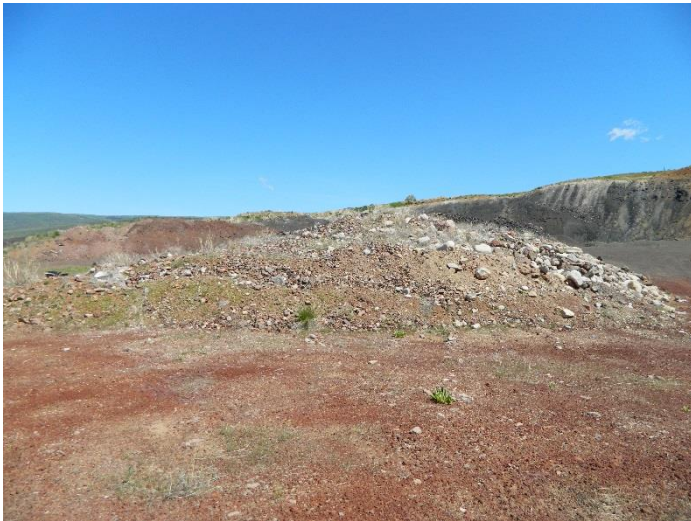
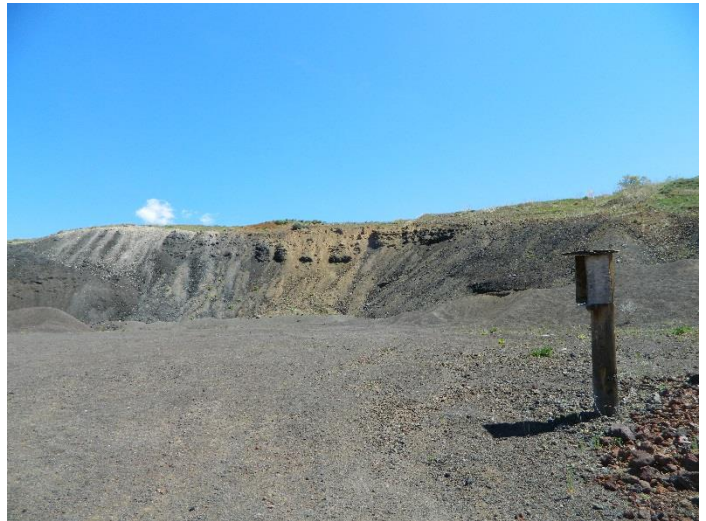
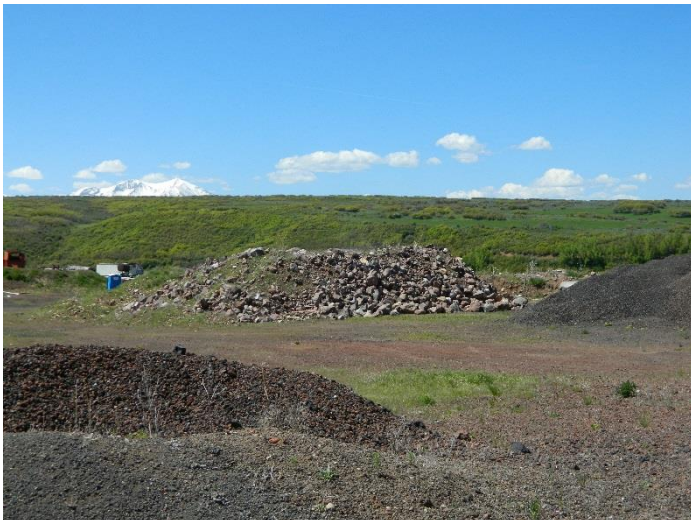
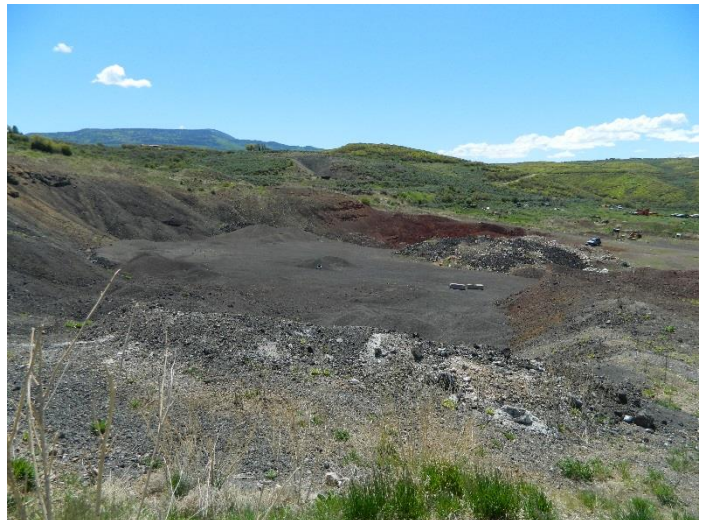
The mine identification sign and affected area boundary markers are in place and in compliance with rule 3.1.12. The permit boundary is comprised of a fencing and markers around the entire perimeter of the mine.

The site was inactive during the inspection. Various stockpiles of cinder material were observed around the pit floor.

Imported construction material was observed within the pit area. Importation of material is not consistent with the currently approved mining and reclamation plans. Per Rule 3.1.5(9) if the operator intends to import material generated outside of the approved permit area it is the operators responsibility to provide the Division notice of any proposed importation of material not identified in the approved reclamation plan. Therefore the Division must be provided a signed affidavit that notifies that the operator intends to import offsite material into the permit area (in this case material is already in the permit area). The notice to the Division must include a narrative that describes the approximate location of the proposed activity; the approximate volume of inert material to be imported; a signed affidavit certifying that the material is clean and inert, as defined in Rule 1.1(20); the approximate dates the proposed activity will commence and end; an explanation of how the backfilled site will result in a post-mining configuration that is compatible with the approved post mining land use; and a general engineering plan stating how the material will be placed and stabilized in a manner to avoid unacceptable settling and voids. **This notice must be received no later than thirty (30) days after the signature date of this inspection report.**
