COLORADO DIVISION OF RECLAMATION, MINING AND SAFETY
MINERALS PROGRAM INSPECTION REPORT
PHONE: (303) 866-3567

MINE NAME: Dotsero Cinder Pit	MINE/PROSPECTING ID#: M-1979-155	MINERAL: Volcanic materials cinders)	COUNTY: Eagle
INSPECTION TYPE: Monitoring	INSPECTOR(S): Travis H. Marshall	INSP. DATE: June 2, 2016	INSP. TIME: 13:00
OPERATOR: Colorado Department of Transportation	OPERATOR REPRESENTATIVE: NA	TYPE OF OPERATION: 110c - Construction Limited Impact

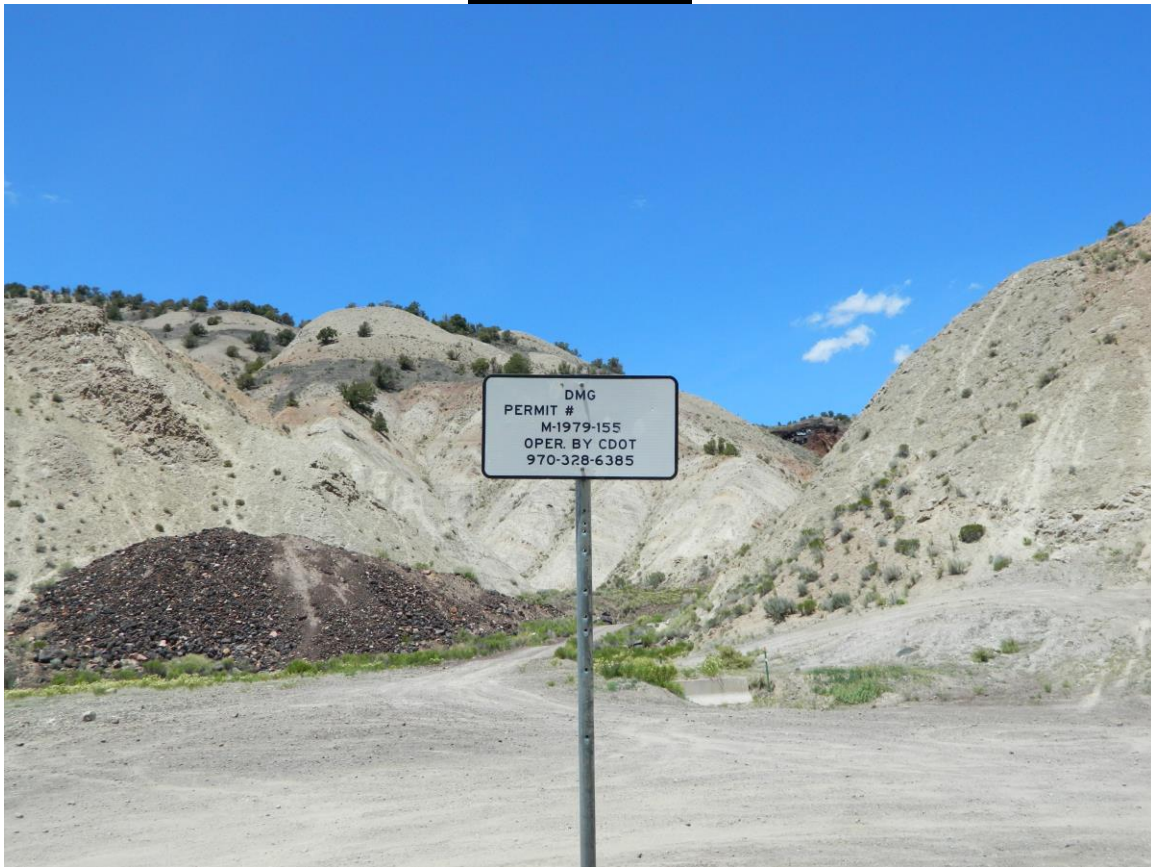
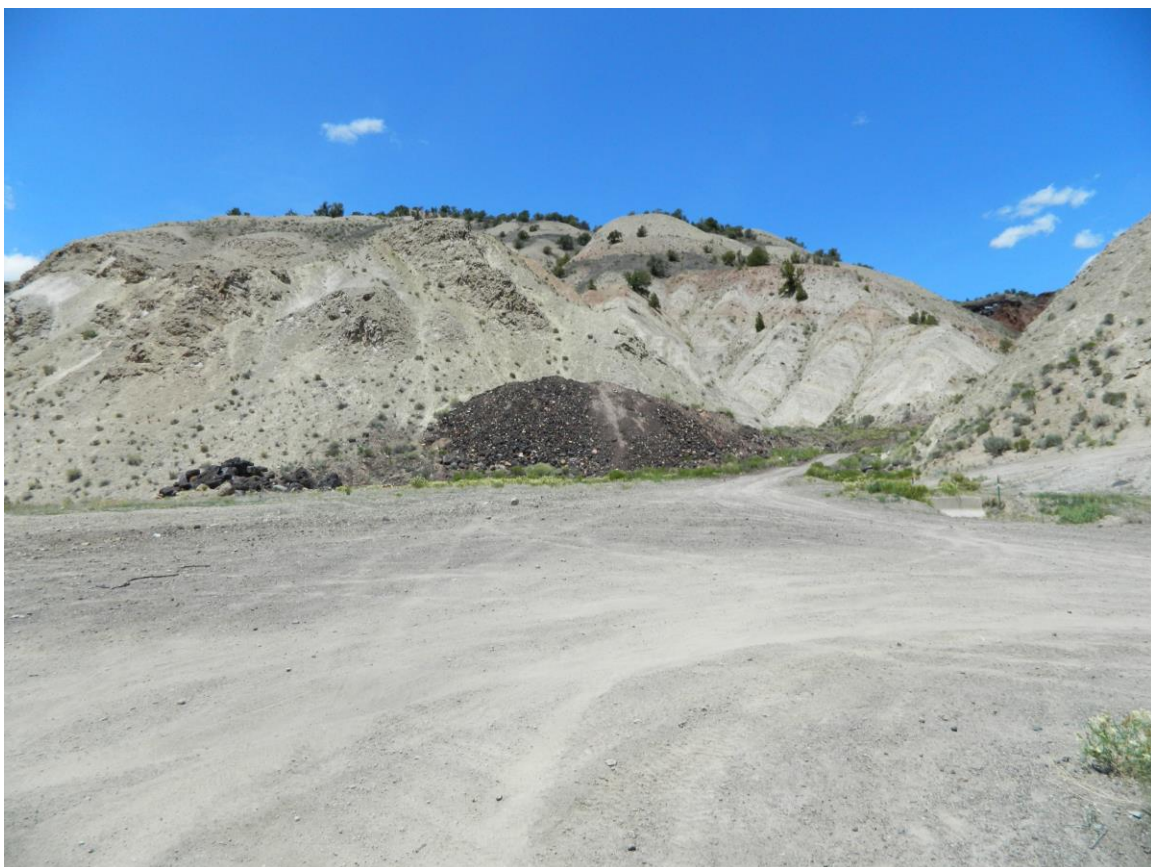
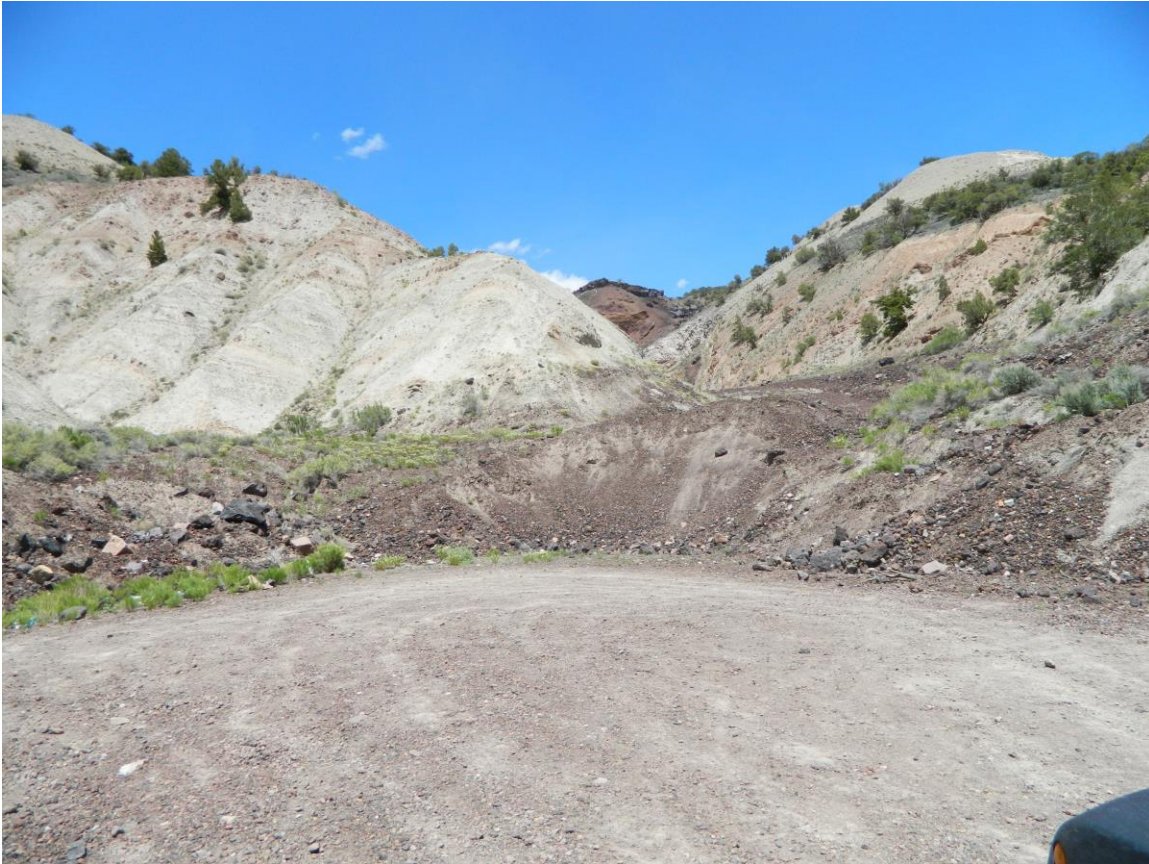
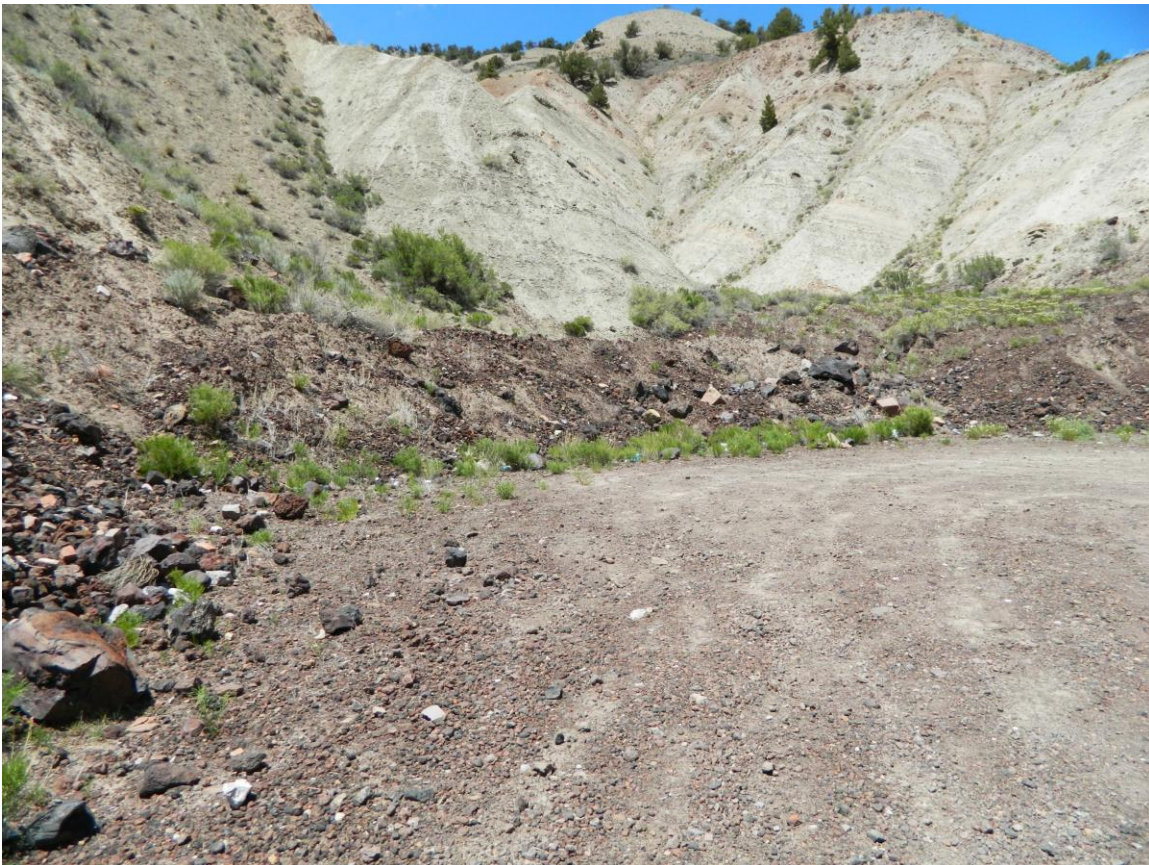
The mine identification sign is in place and in compliance with rule 3.1.12. This was only a partial inspection and the upper portion of the mine was not inspected.

The site was inactive during the inspection. No stockpiles of of cinder material were observed around the stockpile area.

The stockpile area had evidence of use from off highway vehicles and no evidence of mining activity was observed.

No noxious weeds were observed. No erosional features or off-site damage was observed during the inspection.
