COLORADO DIVISION OF RECLAMATION, MINING AND SAFETY
MINERALS PROGRAM INSPECTION REPORT
PHONE: (303) 866-3567

MINE NAME: Villard Pit #2	MINE/PROSPECTING ID#: M-2000-033	MINERAL: Sand and gravel	COUNTY: Moffat
INSPECTION TYPE: Monitoring	INSPECTOR(S): Amy C. Yeldell	INSP. DATE: June 15, 2016	INSP. TIME: 10:30
OPERATOR: Moffat County	OPERATOR REPRESENTATIVE: Billy Mack & Linda DeRose	TYPE OF OPERATION: 112c - Construction Regular Operation

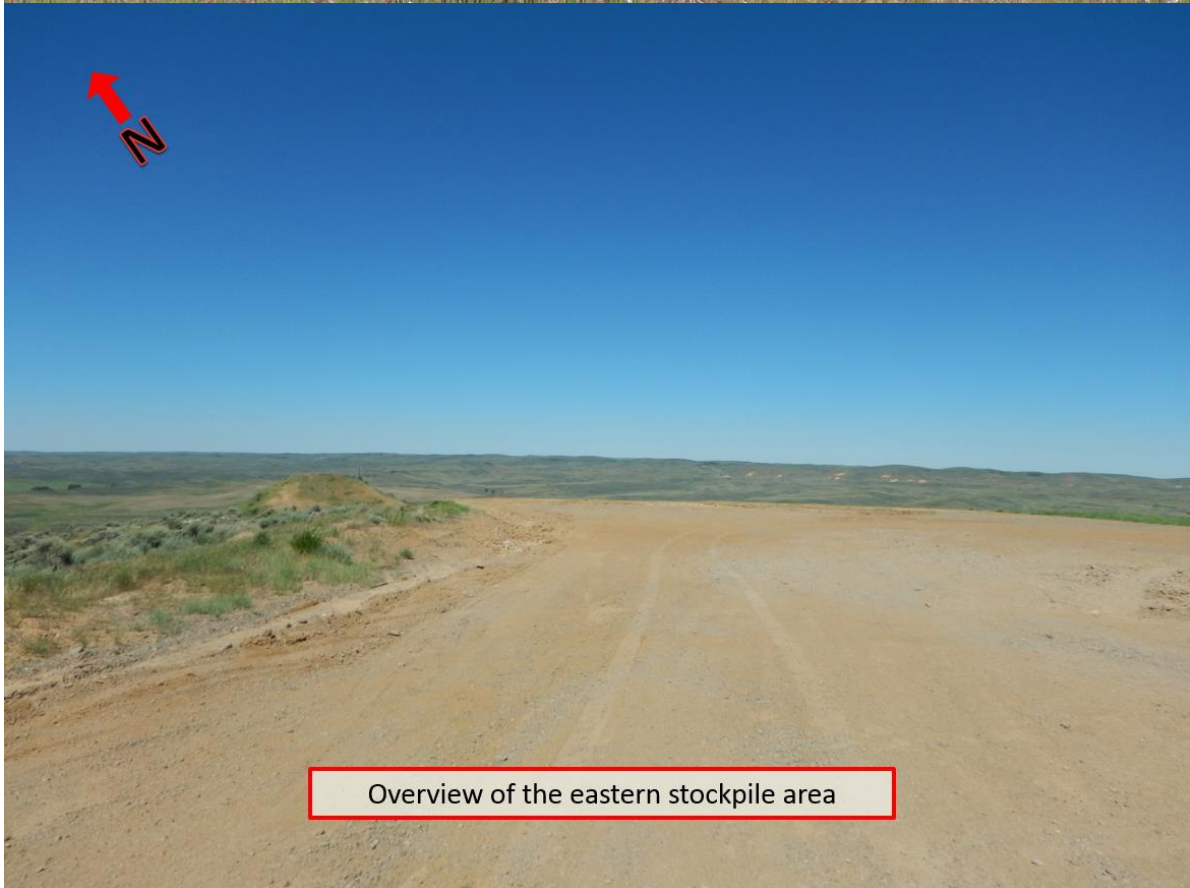
Overview of the eastern stockpile area

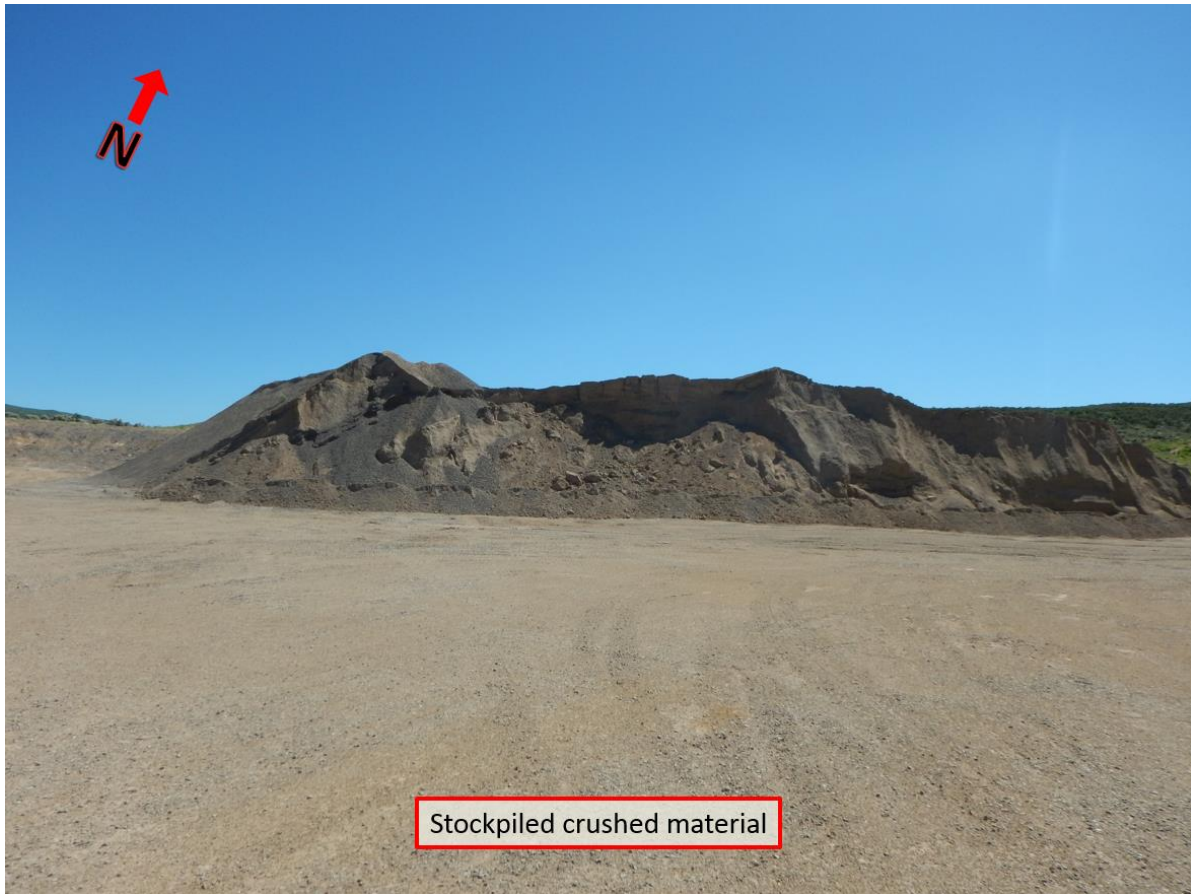
Stockpiled crushed material

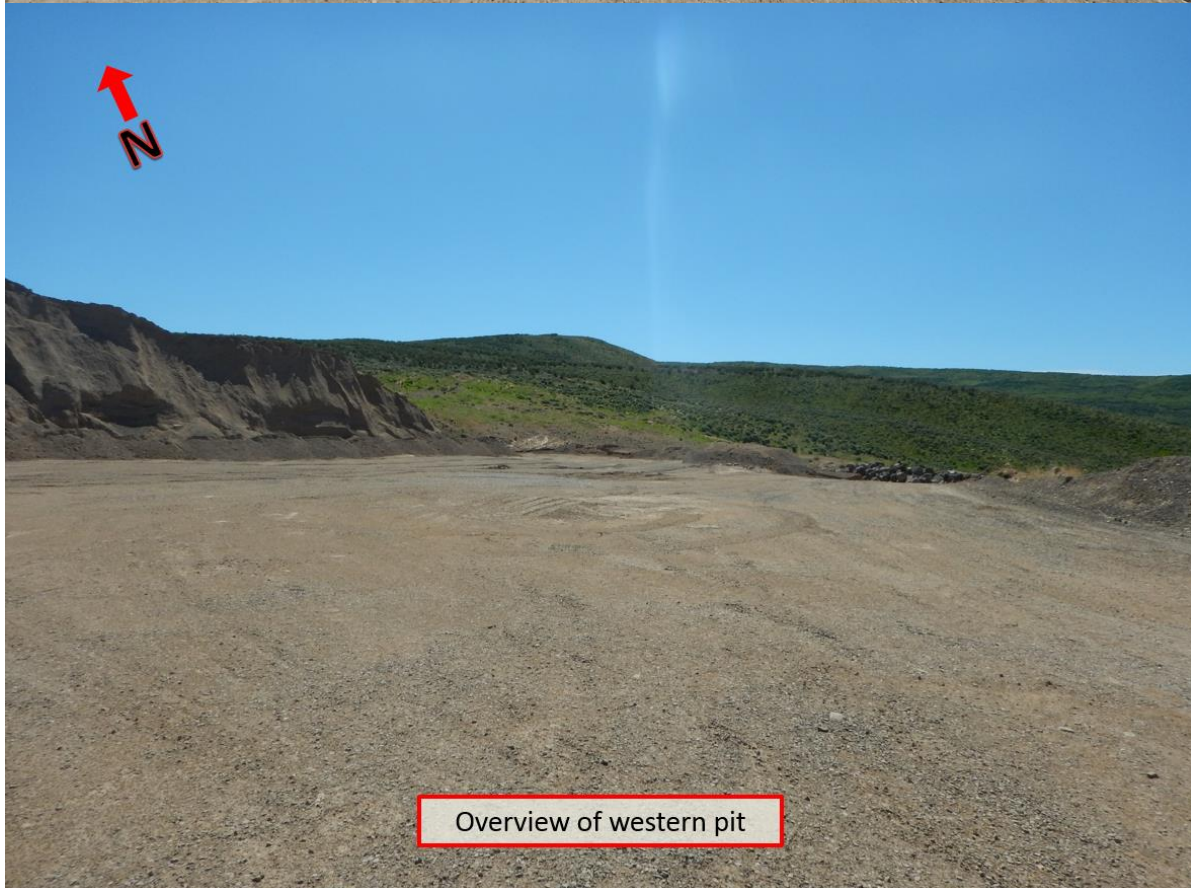
Overview of western pit
