COLORADO DIVISION OF RECLAMATION, MINING AND SAFETY
MINERALS PROGRAM INSPECTION REPORT
PHONE: (303) 866-3567

MINE NAME: Henderson Mine	MINE/PROSPECTING ID#: M-1977-342	MINERAL: Molybdenum	COUNTY: Clear Creek
INSPECTION TYPE: Monitoring	INSPECTOR(S): Peter S. Hays	INSP. DATE: May 20, 2016	INSP. TIME: 10:00
OPERATOR: Climax Molybdenum Company	OPERATOR REPRESENTATIVE: Tim Haynes, Bryce Romig	TYPE OF OPERATION: 112d-3 - Designated Mining Operation

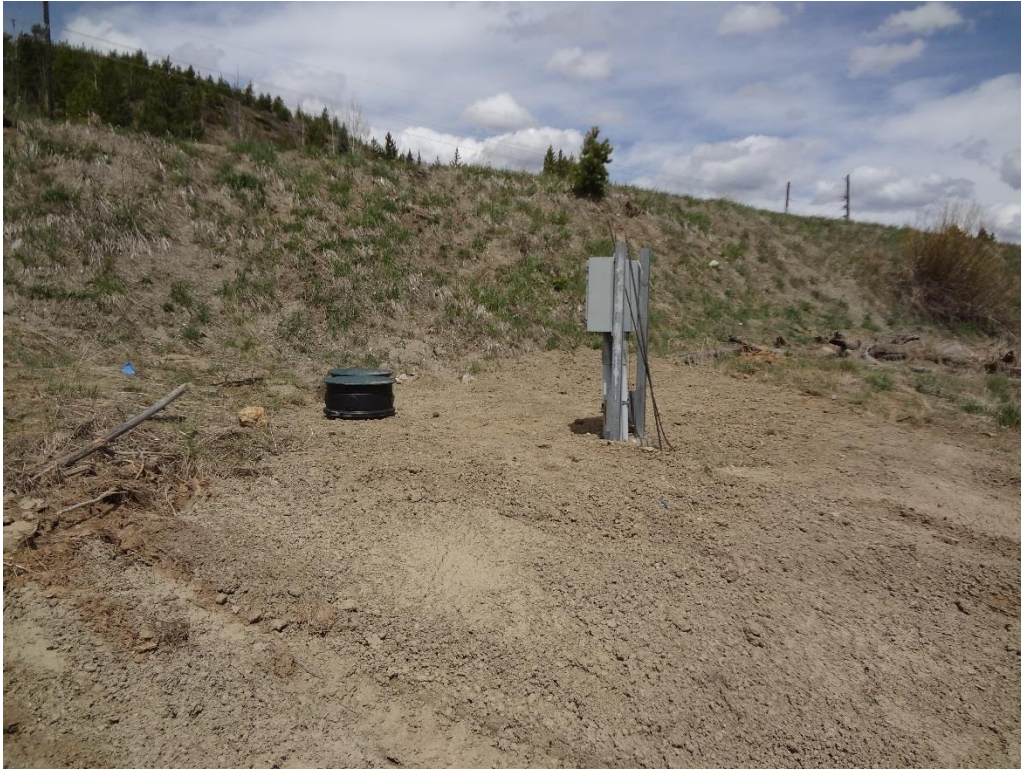
3-Dam Seepage Collection Lower Vault

Henderson notified the Division by phone of a release of process water from the 3-Dam seepwater collection system on May 3, 2016. The written follow-up notice pursuant to Rule 8.1 and 8.2 was received by the Division on May 13, 2016. The cause of the seepwater release was identified and corrected by Henderson staff on May 4, 2016. The lower and upper collection system vaults and the seep collection area were observed during the inspection. Iron staining was observed downhill from the upper vault overflow pipe. The iron staining dissipated to the east in the wetland area below the seepwater collection area. The Operator stated elevated iron levels have not been reported in groundwater monitoring wells (MLGW-18 and MLGW-19) located down gradient of the seepwater collection area.

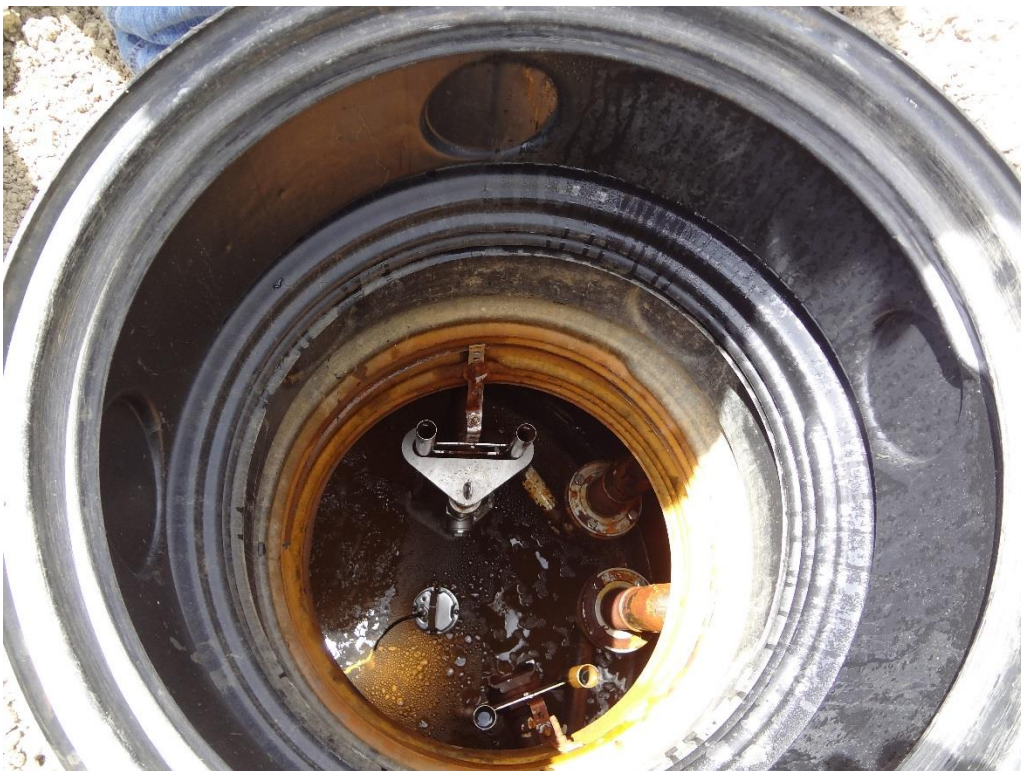
3-Dam Seepage Collection Lower Vault – Replaced Pump

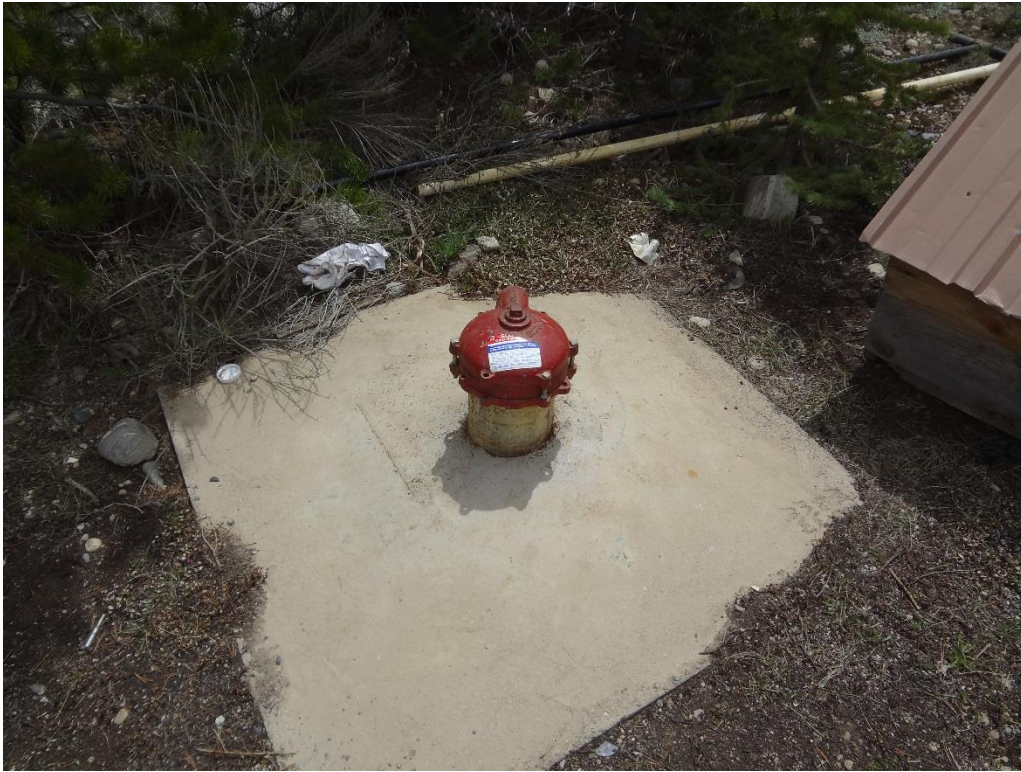
Aspen Canyon Ranch Wellhead

Henderson submitted a Groundwater Quality Memorandum for the Aspen Canyon Well (MLGW-ACR) on April 29, 2016. The well head was inspected as part of this inspection. Henderson staff is continuing to work with the well owner and the Water Quality Control Commission regarding the elevated iron and manganese levels in the Aspen Canyon Ranch well. The possibilities of rehabilitating the well with a combination of mechanical

and chemical methods and replacing the well to reduce the iron and manganese levels were discussed during the inspection.

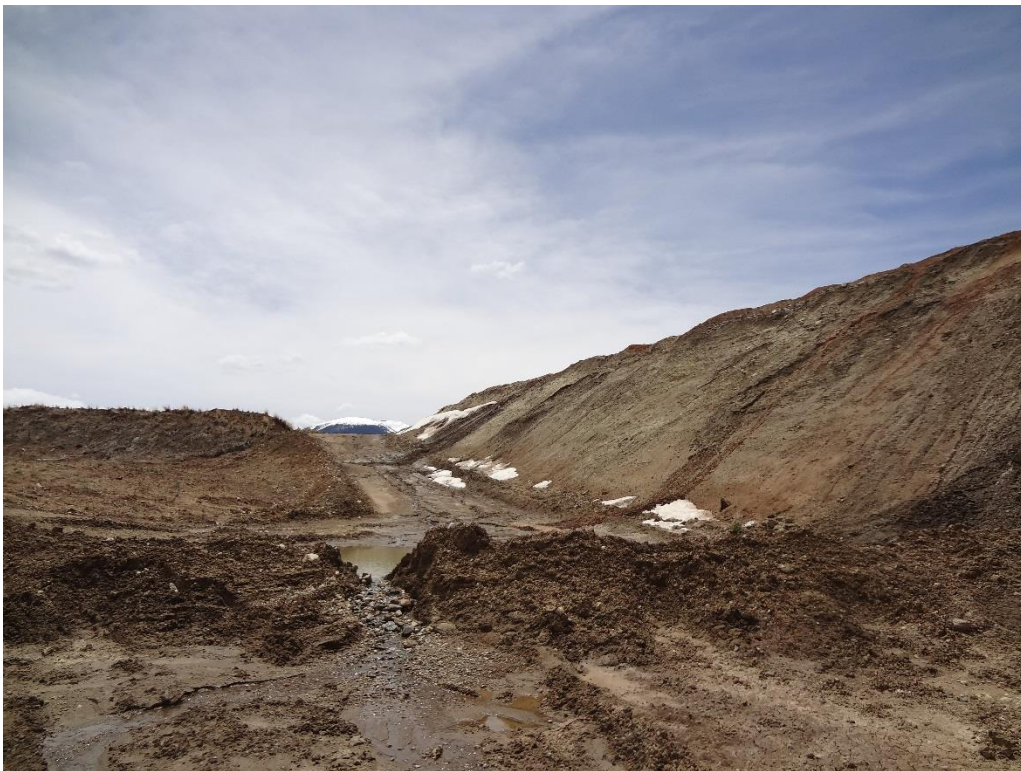
South topsoil stockpile (erosion features)
