COLORADO DIVISION OF RECLAMATION, MINING AND SAFETY
MINERALS PROGRAM INSPECTION REPORT
PHONE: (303) 866-3567

MINE NAME: Dotsero Quarry	MINE/PROSPECTING ID#: M-1987-074	MINERAL: Volcanic materials (a	COUNTY: Eagle
INSPECTION TYPE: Monitoring	INSPECTOR(S): Travis H. Marshall	INSP. DATE: June 2, 2016	INSP. TIME: 13:30
OPERATOR: Mayne Block & Stone Company	OPERATOR REPRESENTATIVE: NA	TYPE OF OPERATION: 112c - Construction Regular Operation	
REASON FOR INSPECTION: Normal I&E Program	BOND CALCULATION TYPE: Complete Bond	BOND AMOUNT: \$100.00	
DATE OF COMPLAINT: NA	POST INSP. CONTACTS: None	JOINT INSP. AGENCY: None	
WEATHER: Clear	INSPECTOR'S SIGNATURE:

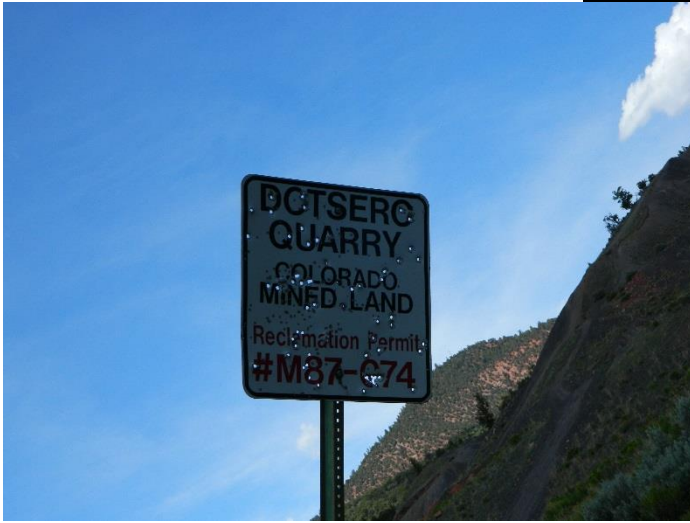
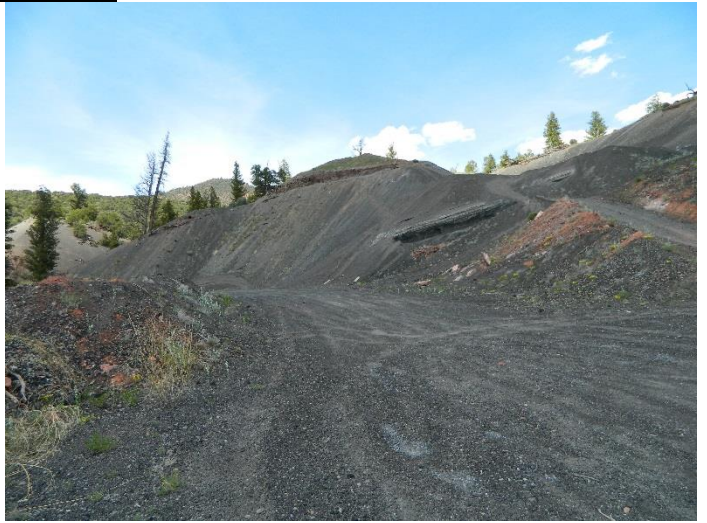
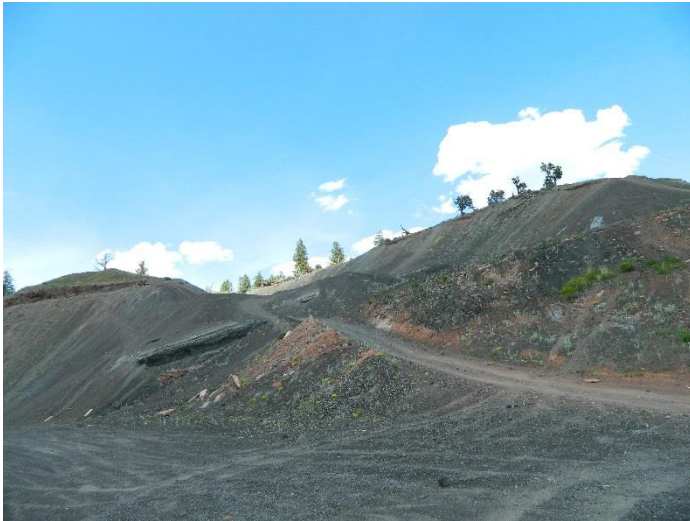
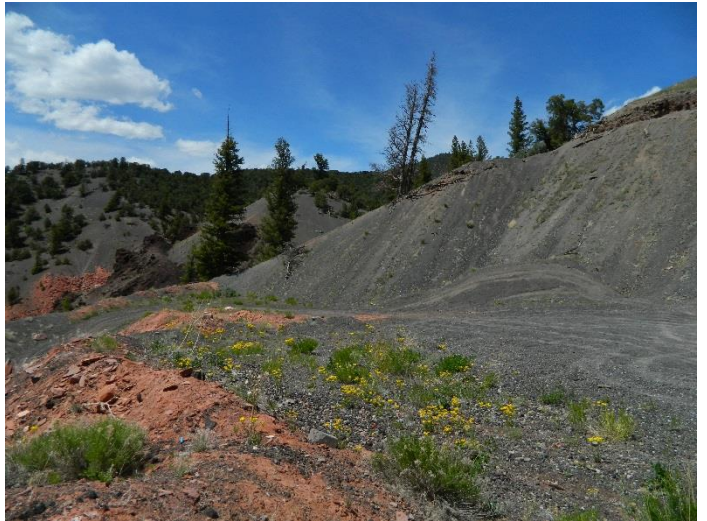
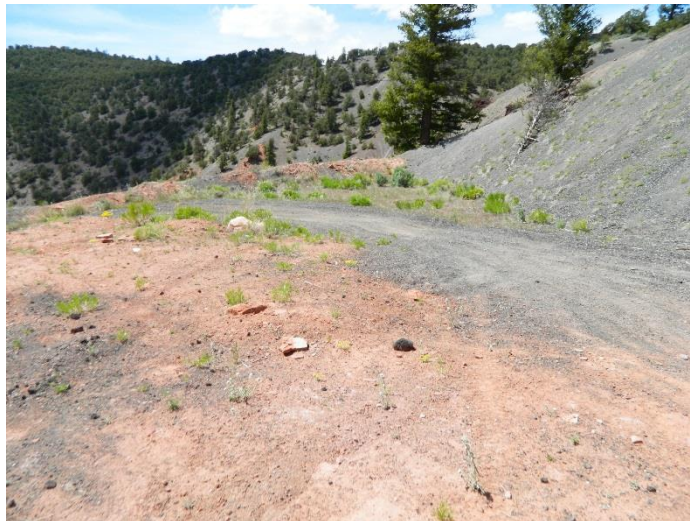
The mine identification sign and permit boundary markers were in place and in compliance with Rule 3.1.12.

The pit is currently inactive and no mining equipment was observed within the permit area.

The reclaimed slopes appear to be at or near the approved 2H:1V. Vegetation on the reclaimed slopes consisted of a variety of grasses and shrubs. Topsoil and overburden stockpiles were observed at the east end of the permit area. The topsoil appeared to have adequate vegetation to provide stability and protection against erosion. A copy of the approved reclamation plan is enclosed with this inspection report.

A variety of weeds were observed within the permit area but none appeared to be noxious.
