June inspection at West Elk Mine (C1980007), SL-09, SL-10

INSP-REPORTC_C1980007_LDS_07012016103140.pdf

This was a partial inspection by Leigh Simmons of the Division of Reclamation, Mining and Safety (Division). The focus of the inspection was on the Mine Ventilation Borehole (mvb) pads and access roads that had been reclaimed and were the subject of two surety release applications: SL-09 (phase 3) and SL-10 (phase 1).

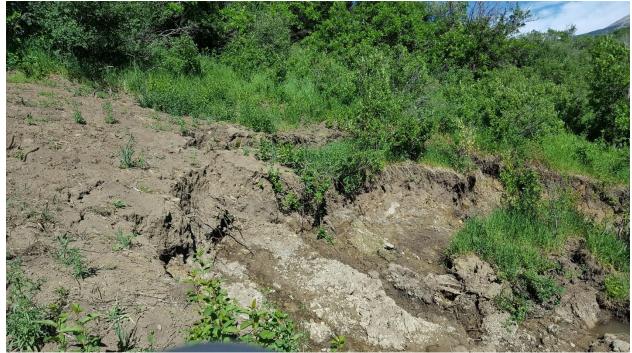
Figure 2: Slump on E3-17.5

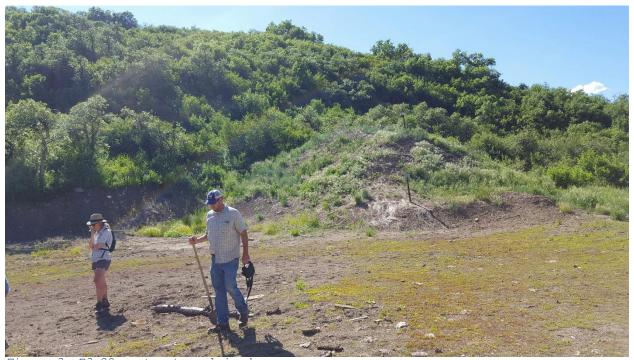
Figure 3: E3-29, not yet reclaimed

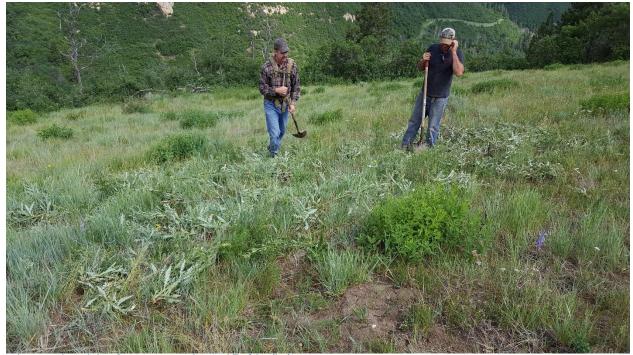
Figure 4: Thistles removed on 17-01a/b/c

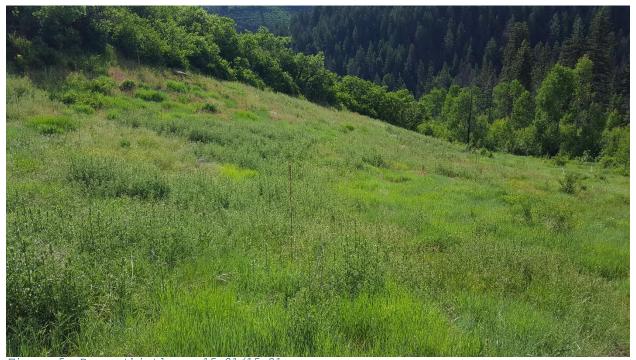
Name	Туре	SL-09 Inspection	Comments
16-01	mvb+road	6/21/2016	0.13 acre patch of Canada Thistle on pad
17-02a / b	mvb	6/21/2016	
15-02	mvb+road	6/21/2016	
15-01 / 15-01a	mvb+road	6/21/2016	Whole pad needs sprayed for thistle
15-03	mvb+road	6/21/2016	
15-03.5	mvb	6/21/2016	
16-04	mvb	6/21/2016	
16-03	mvb	6/21/2016	
16-02	mvb	6/21/2016	
17-03	mvb	6/21/2016	
15-08	mvb+road	6/21/2016	
15-09	mvb	6/21/2016	
14-09	mvb	6/21/2016	
16-05 / 16-05b	mvb	6/21/2016	
17-06	mvb	6/21/2016	
17-05	mvb+road	6/21/2016	
17-04	mvb+road	6/21/2016	
			Two small patches of thistle mechanically removed
17-01a / b / c	mvb	6/22/2016	during inspection
16-04 to 17-03	road	6/21/2016	
16-04 to 17-02	road	6/21/2016	
16-04 to junction	road	6/21/2016	
96-2-2 to 17-01	road	6/22/2016	First section of segment has not yet been reclaimed, (approximately 1000 feet)

Figure 5: Dense thistle on 15-01/15-01a

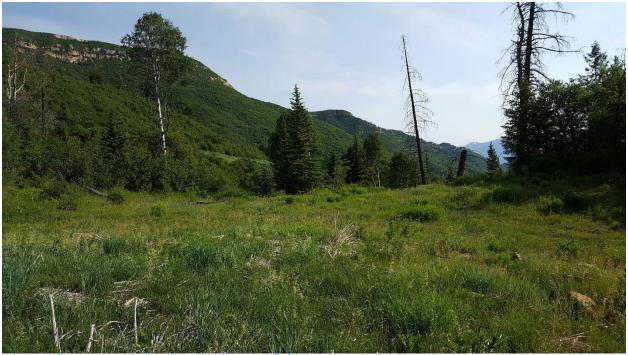
Figure 6: Dense patch of thistle on 16-01

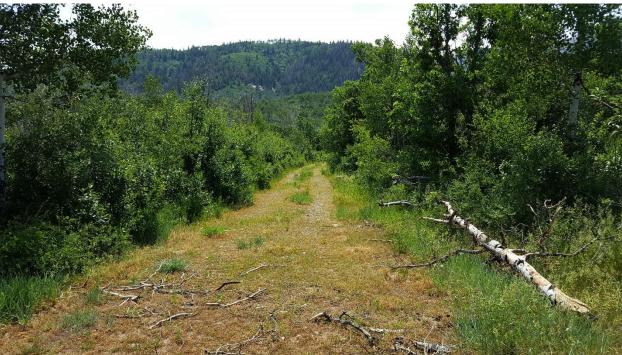
Figure 7: Deep Creek Road from 96-2-2, not yet reclaimed

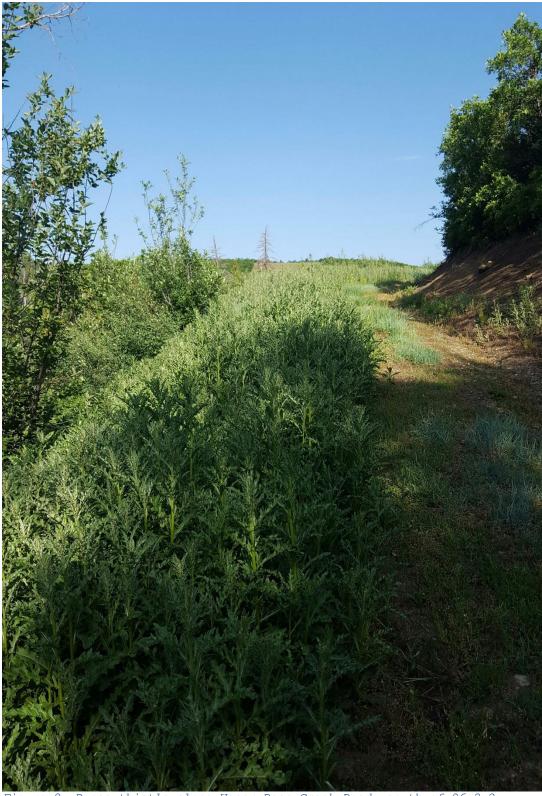
A section of Upper Deep Creek Road, approximately 1500 feet in length, leading to the 96-2-2 pad had a very dense growth of Canada Thistle along the side. Although this section of road has not yet been reclaimed, the density of the thistle means that this area should be treated as soon as possible.

Figure 8: Dense thistle along Upper Deep Creek Road, south of 96-2-2

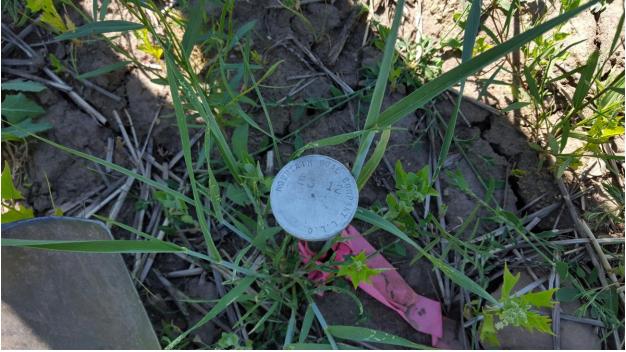
Figure 10: E3-12

Pad	Туре	SL-10 Inspection	Comments
E3-17.5	mvb	6/20/2016	No survey stake yet, thistles on spur
E3-21	mvb	6/20/2016	No survey stake yet
E3-25	mvb	6/20/2016	No survey stake yet
E3-12	mvb+road	6/20/2016	Some cheat grass
E4-14	mvb	6/20/2016	
E4-13	mvb+road	6/20/2016	
E4-12	mvb+road	6/20/2016	
E3-29	mvb	6/20/2016	Plugged and abandoned, but pad untouched
E4-11	mvb+road	6/20/2016	
09LWE4X37	well	6/20/2016	Small slump to repair
E4-01 / E4-02 / E4-			
03	mvb	6/22/2016	
E4-04	mvb+road	6/22/2016	
E4-05 / E4-06	mvb+road	6/22/2016	
E4-07 / E4-08	mvb+road	6/22/2016	Leafy spurge
09LWE4X52	well	6/22/2016	
E4-09	mvb	6/22/2016	
E4-10	mvb	6/22/2016
