COLORADO DIVISION OF RECLAMATION, MINING AND SAFETY
MINERALS PROGRAM INSPECTION REPORT
PHONE: (303) 866-3567

| MINE NAME: Hitch Rack Ranch Quarry | MINE/PROSPECTING ID#: M-2016-010 | MINERAL: Granite, granite gneiss | COUNTY: El Paso |
| INSPECTION TYPE: Preoperation Inspection | INSPECTOR(S): Amy Eschberger | INSP. DATE: June 7, 2016 | INSP. TIME: 10:00 |

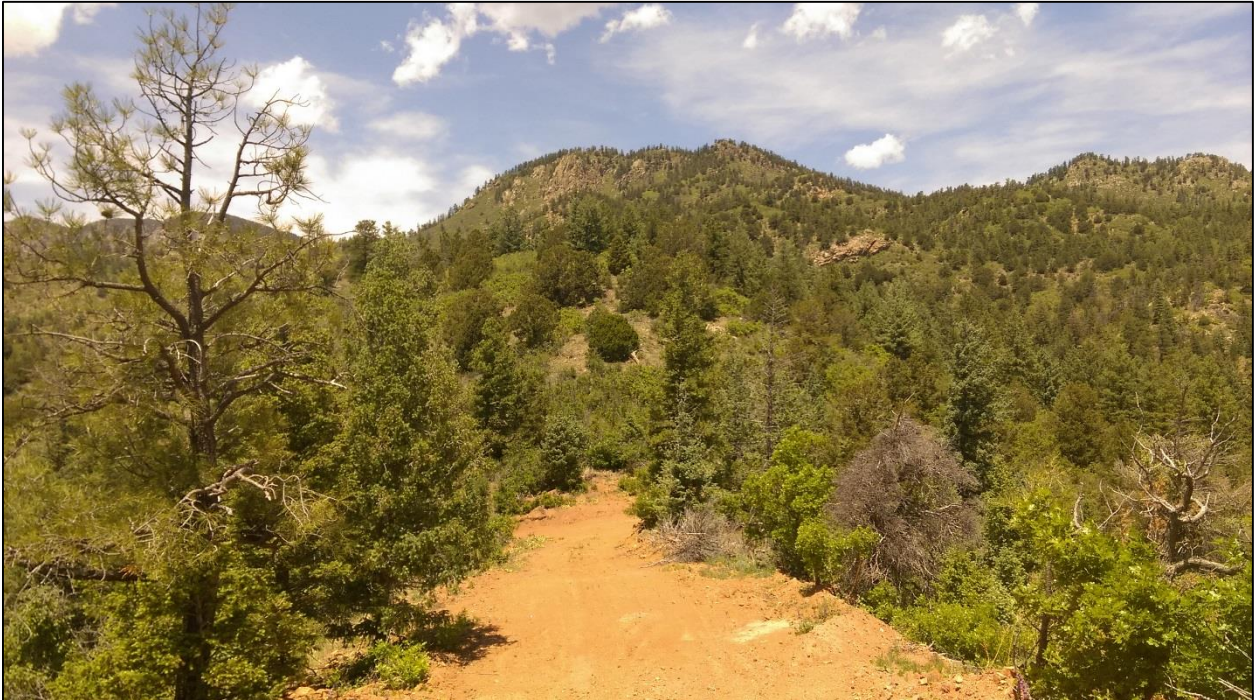
Photo 1. View looking west from drill road located at top of ridge in proposed North Pit area. All of land in foreground would be mined (not including tall ridges in background).

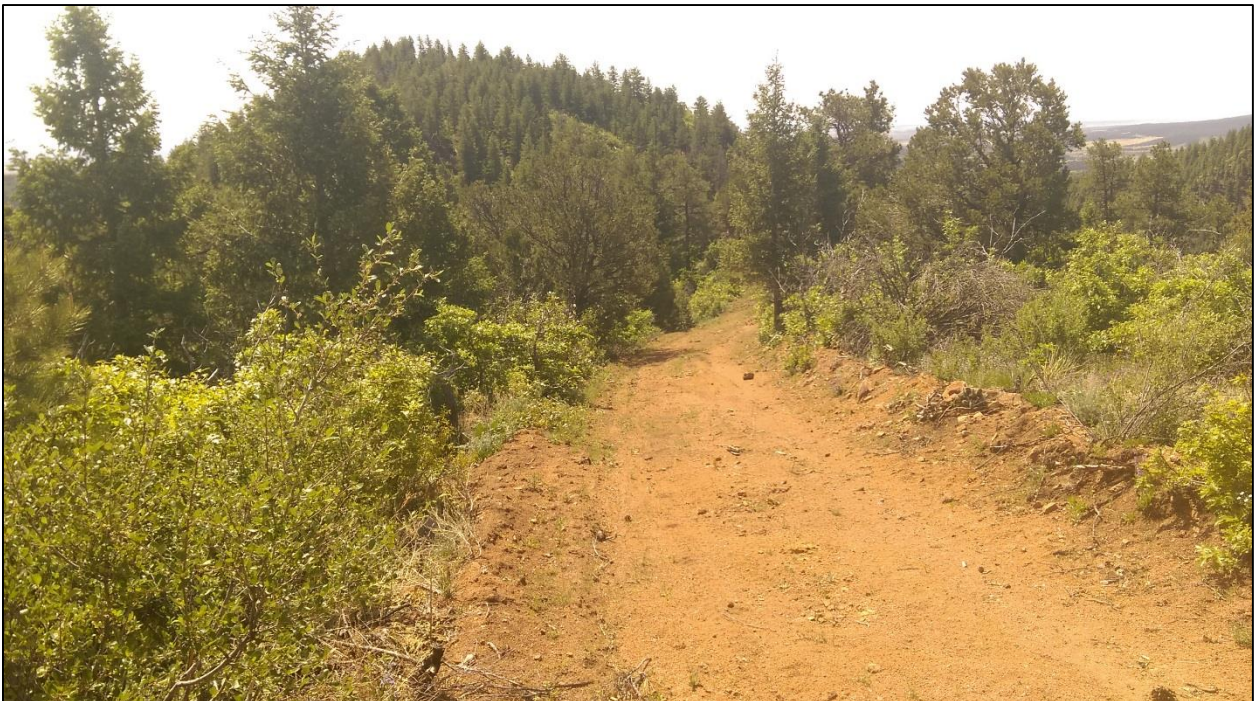
Photo 2. View looking east from drill road located at top of ridge in proposed North Pit area. All of land in foreground would be mined up to top of eastern ridge shown in background.

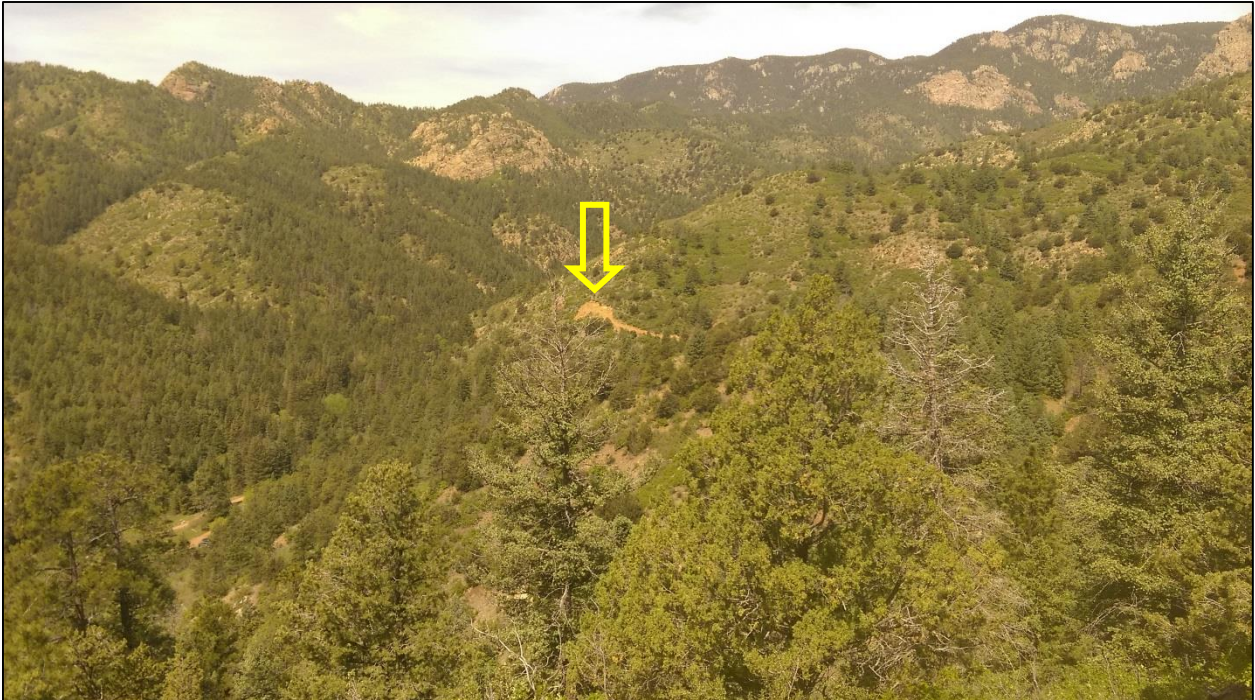
Photo 3. View looking southwest from drill road located at top of ridge in proposed North Pit area. North Pit would include all land in foreground. Drill pad for borehole B1 visible on side of ridge (at center; indicated). Tall ridges in background are outside of proposed affected land.

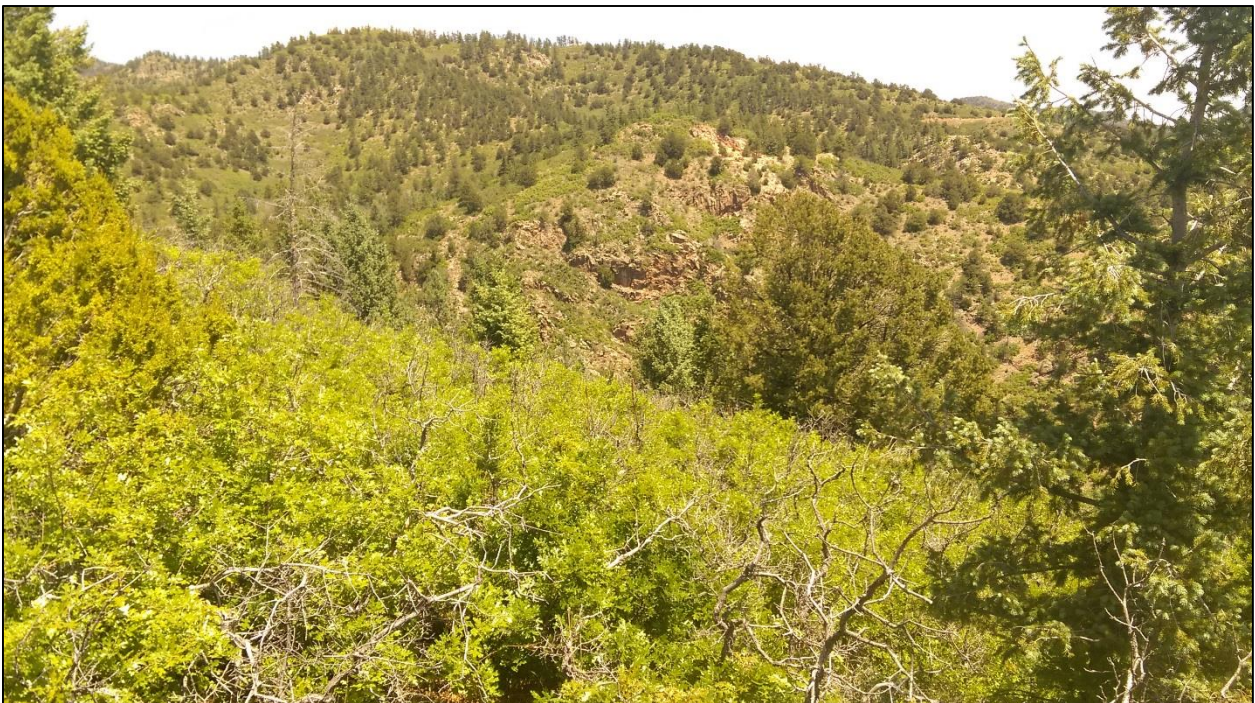
Photo 4. View looking north/northwest from eastern end of drill road located at top of ridge in North Pit area, showing proposed North Pit Expansion area north of Deadman canyon.

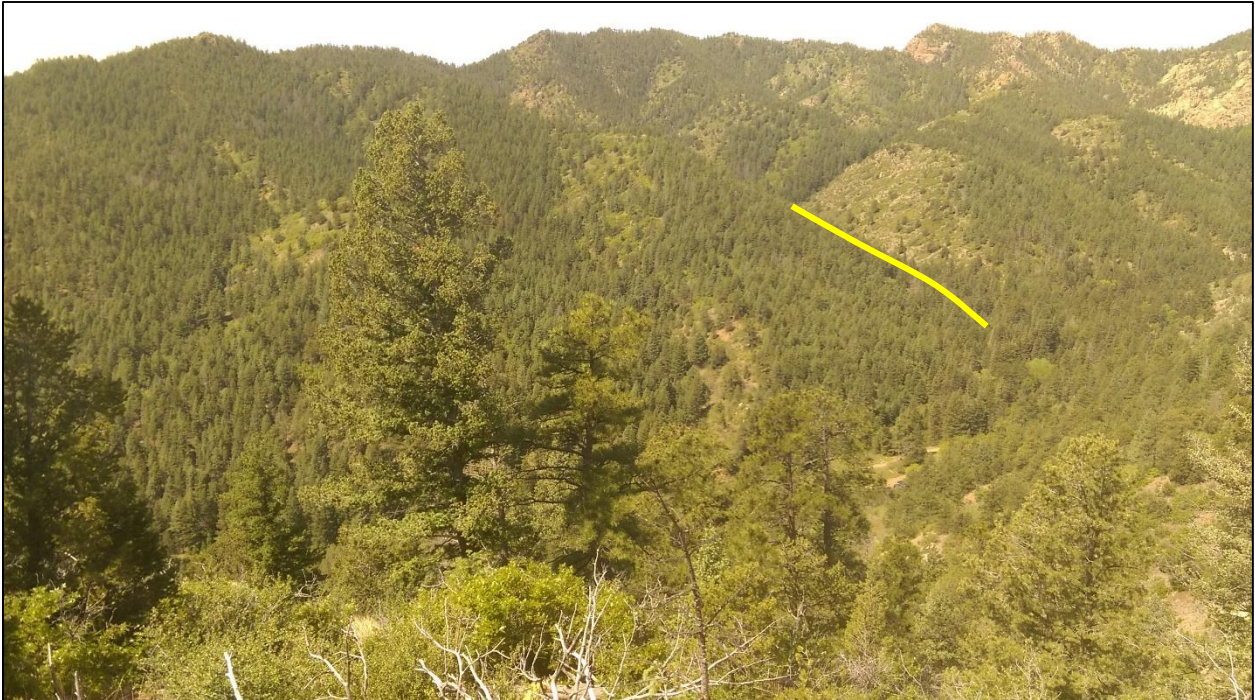
Photo 5. View looking southwest from drill road located at top of ridge in North Pit area, showing western portion of proposed South Pit area located south of Little Turkey Creek canyon. For reference, the proposed valley location for storage of fines/overburden is indicated.

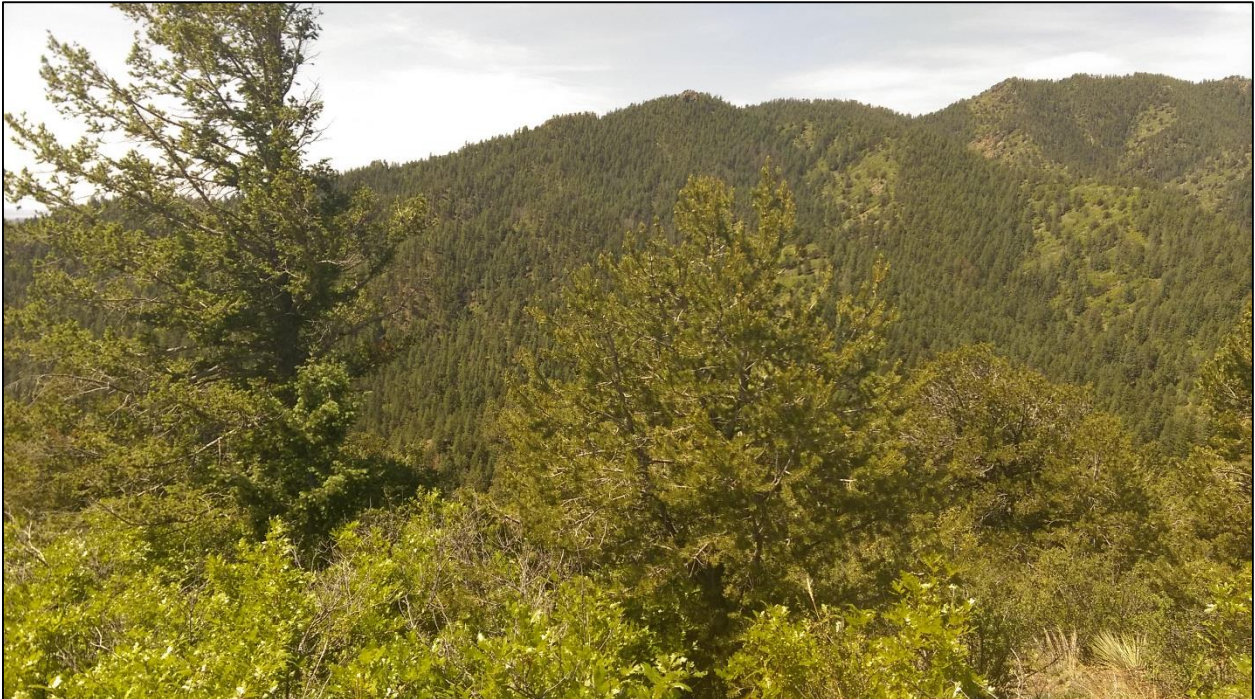
Photo 6. View looking south from drill road located at top of ridge in North Pit area, showing eastern portion of proposed South Pit area located south of Little Turkey Creek canyon.

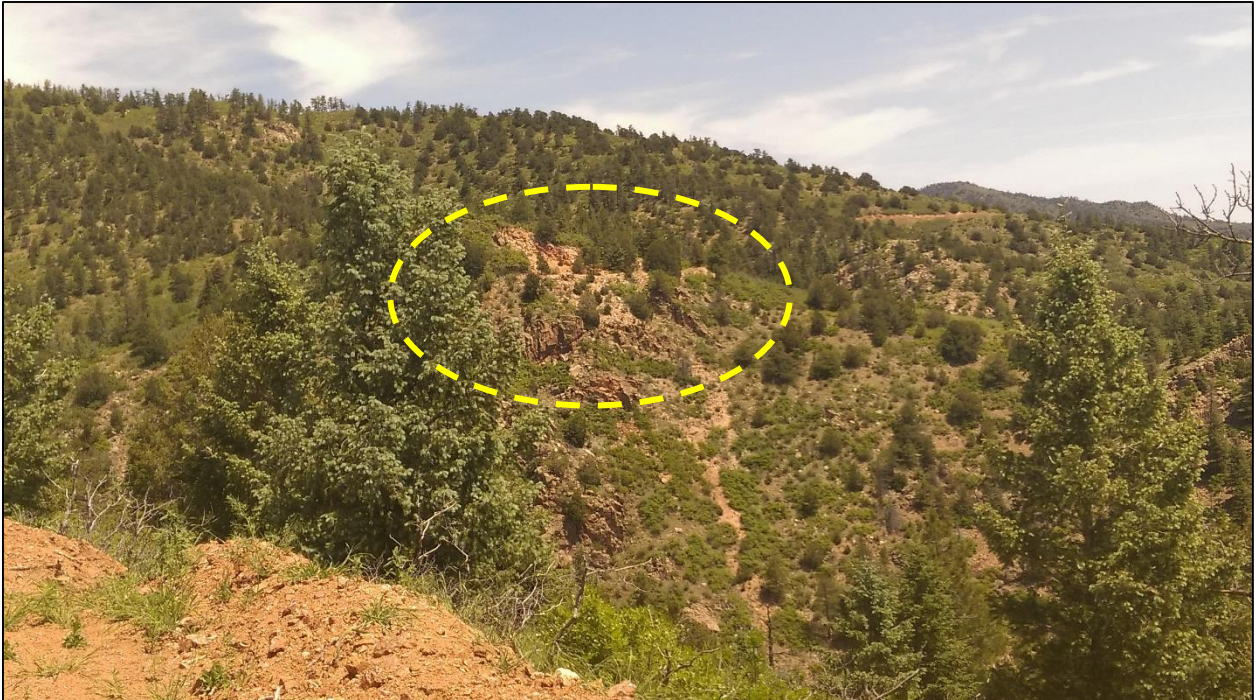
Photo 7. View looking north from eastern end of drill road located at top of ridge in North Pit area, showing small existing mica quarry (circled) present to the east of proposed North Pit Expansion.

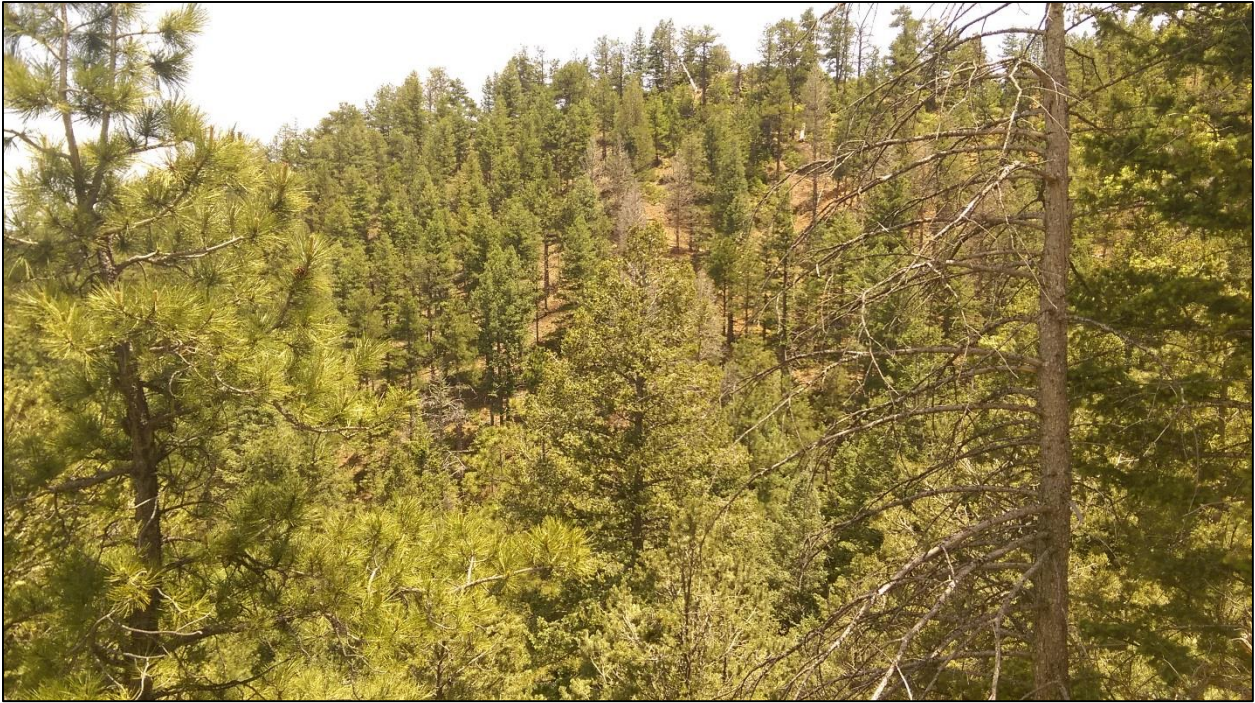
The South Pit area was approached by a drill hole exploration road. Boreholes HC006-15, B5, and B6 were observed and appeared to have been sealed at the surface. The South Pit area consists of a series of steep, rocky ridges and valleys with dense tree cover (**Photos 9 and 10**). From a high point near the center of the proposed South Pit area, the Division observed the far eastern ridge in the North Pit area (mentioned above) which the applicant proposes to leave as a visual screen (**Photo 11**). Overall, visibility of the proposed pit areas appears to be significantly shielded by ridges surrounding the site (**see enclosed Google Earth Images no. 1-5 showing different perspective views of proposed affected land**).

Photo 9. View looking east from drill road located at top of ridge in South Pit area, showing steep topography with dense tree cover. All land shown in photo would be mined.

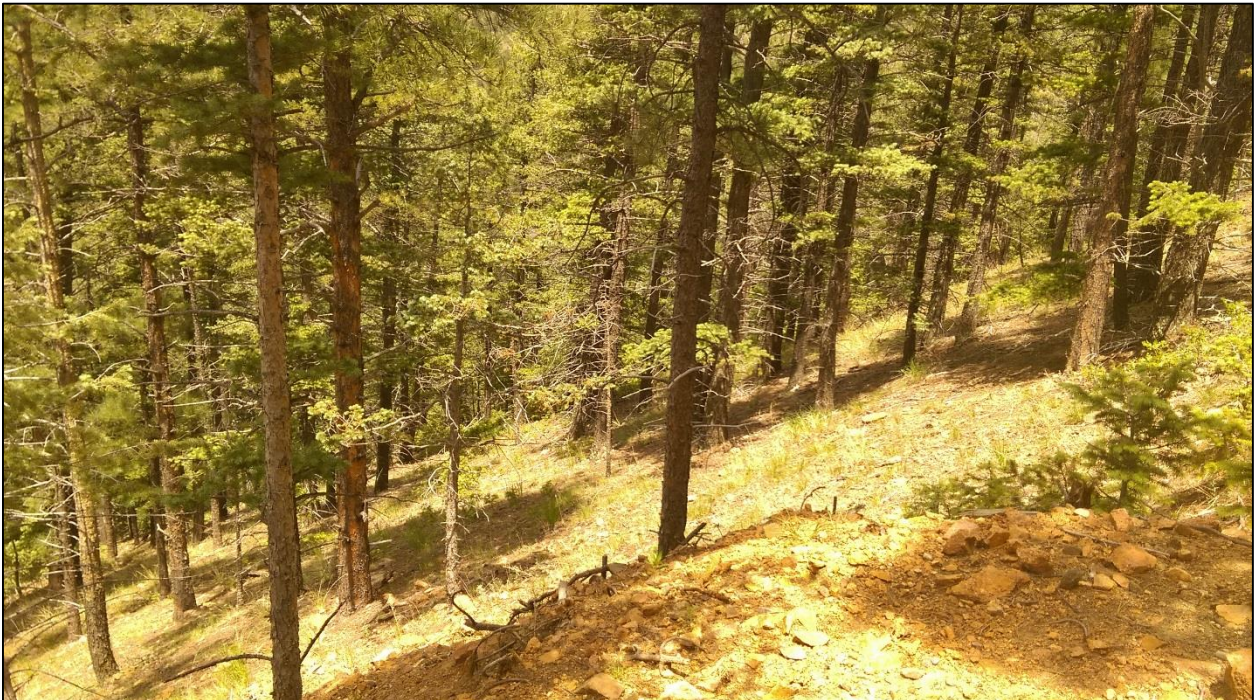
Photo 10. View looking downhill from drill road located at top of ridge in South Pit area, showing steep topography with dense tree cover. All land shown in photo would be mined.

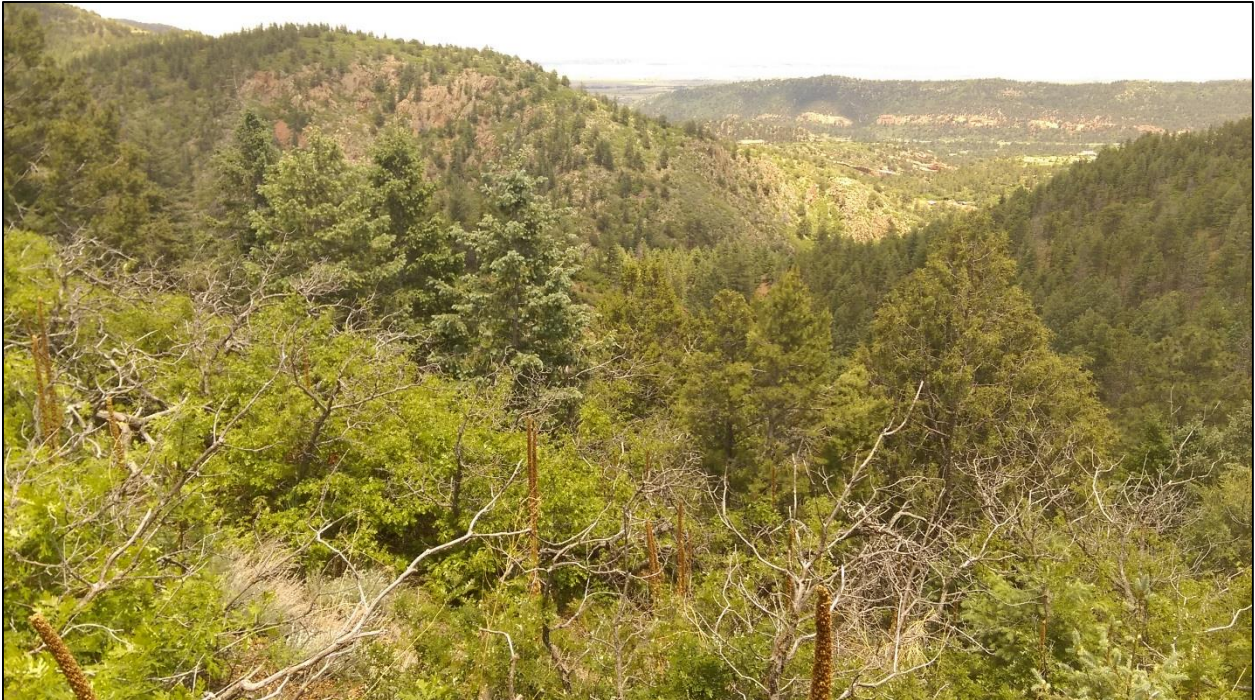
Photo 11. View looking northeast from drill road located at top of ridge in South Pit area, showing steep topography with dense tree cover. Note ridge in background that would be partially mined, leaving eastern side to help reduce visibility from east.

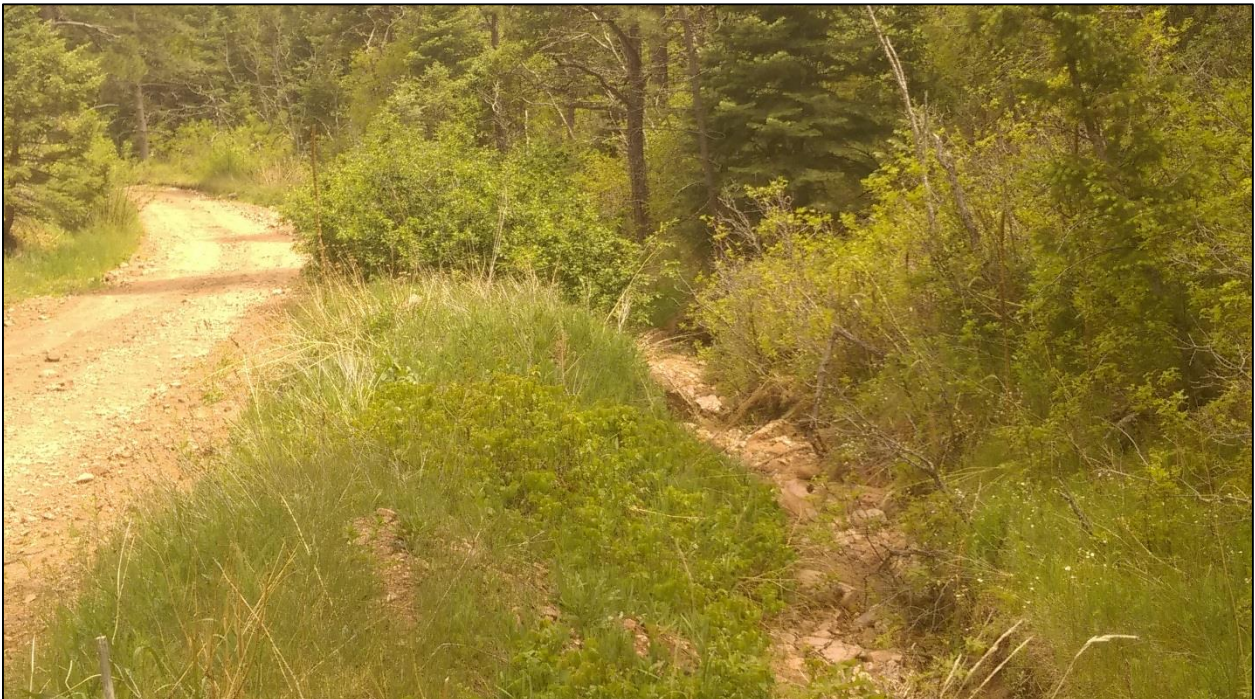
Portions of the North Pit area were accessed by Deadman Creek Road (**Photos 12 and 13**). Survey stakes were observed nearby Deadman Creek Road, marking the proposed 100 foot wide crossing that would be constructed during mining phase IV. This access road would connect the North Pit to the North Pit Expansion. An existing access road is present in the North Pit Expansion area (**Photo 14**). This road appears to have been used to access the old mica quarry located on the eastern edge of the ridge, north of Deadman Creek. According to the

Photo 12. View looking southeast from Deadman Creek Road (at left), showing Deadman Creek (at right) that was dry at the time of the inspection.

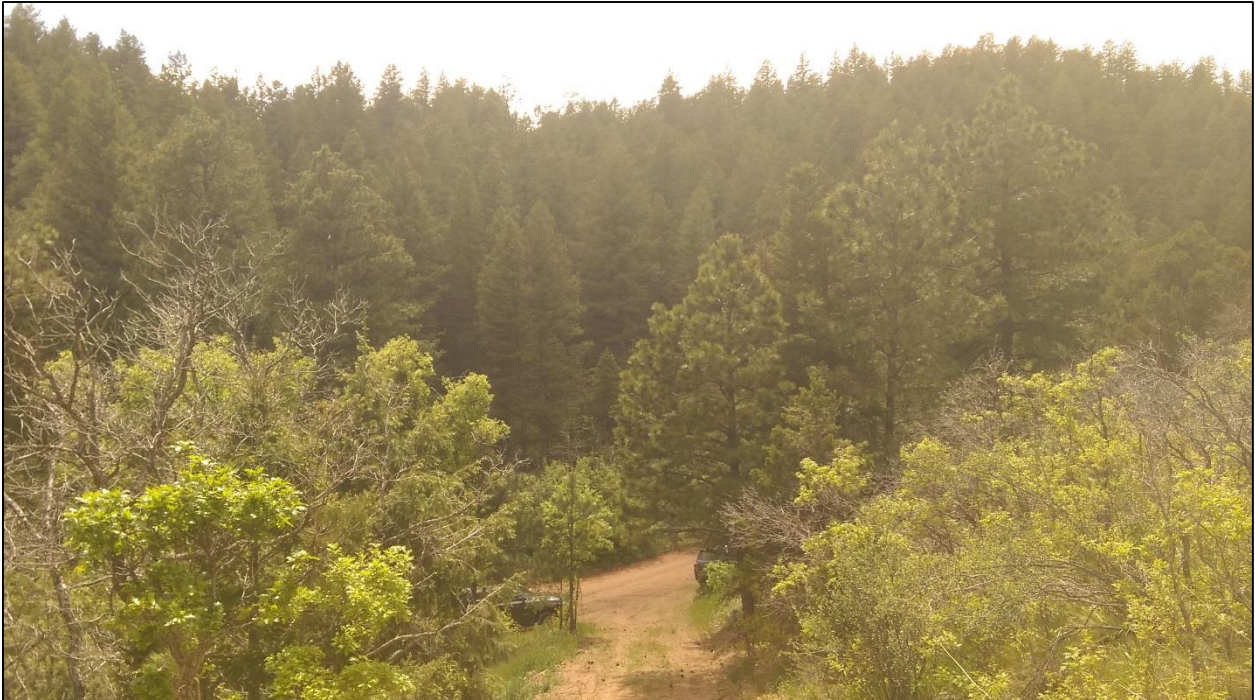
Photo 13. View looking southwest from North Pit Extension area, showing northeast side of North Pit ridge with dense tree cover.

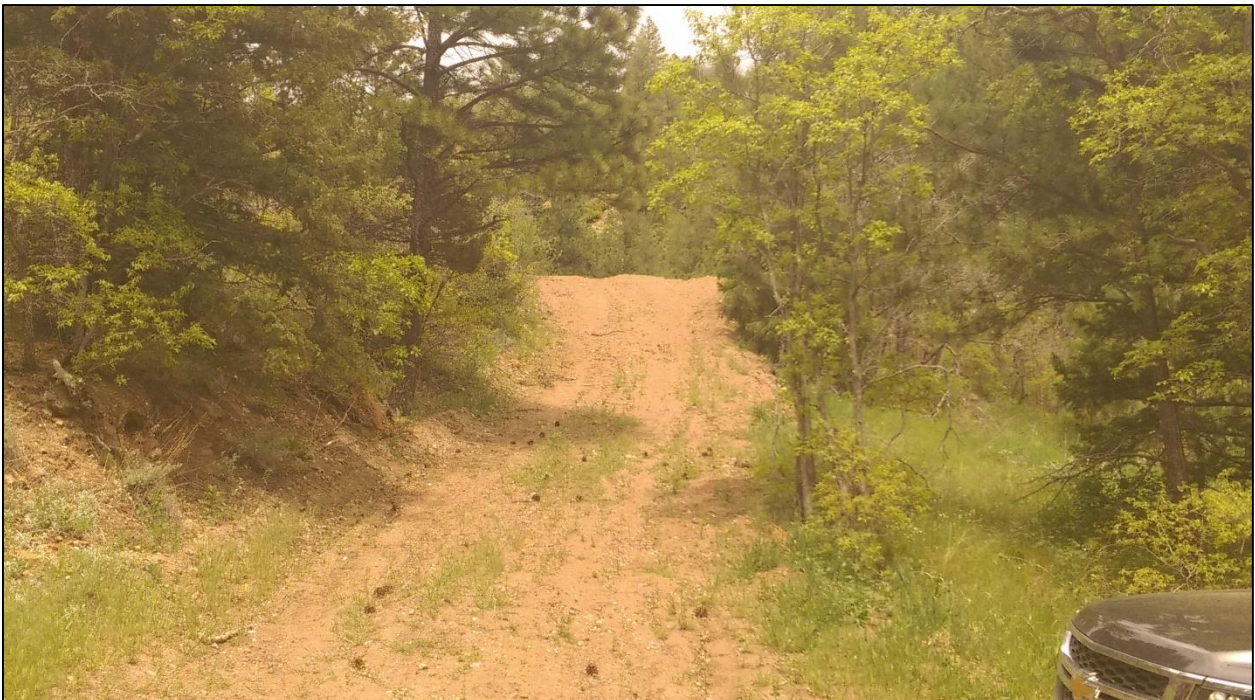
Photo 14. View looking northeast from Deadman Creek Road, showing existing road that leads to old mica quarry. The proposed crossing into North Pit Extension would utilize this existing road.

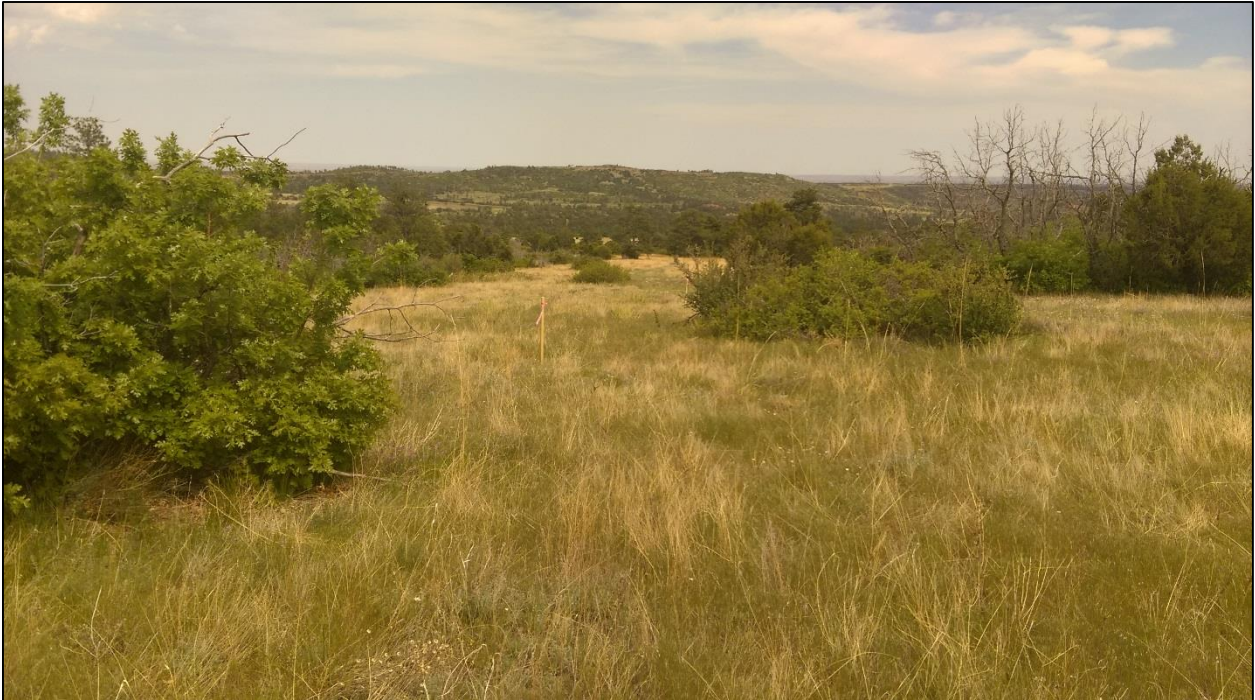
The Division observed the eastern portion of the proposed affected land where the new access road would be constructed. The alignment of the proposed new access road was marked with survey lath (**Photos 15 and 16**). The haul road would cross Hitch Rack Ranch Road in two areas. The applicant will need to obtain structure agreements for all existing roads inside of or within 200 feet of the proposed affected land. There were two small ponds located off of Hitch Rack Ranch Road, one was labeled as Glen Cairn Reservoir in the application. Because these ponds are located more than 200 feet from the proposed affected land (access road), no structure agreements are required for these structures. The eastern edge of the proposed affected area (where the access road would enter the property) abuts to Hwy 115 and is also within 200 feet of a road located on the other side of Hwy 115 that appears to enter the Fort Carson area. Therefore, the applicant will need to obtain structure agreements for both of these roads. The Division observed the area along the proposed access road where the scale house would be constructed (**Photo 17**). From this location, the access road would turn north, entering the ridges of the South Pit area. This area would require some blasting to make way for the access road.

Photo 15. View looking east across relatively flat land with native grasses and shrubs where proposed access road would cross Hitch Rack Ranch property.

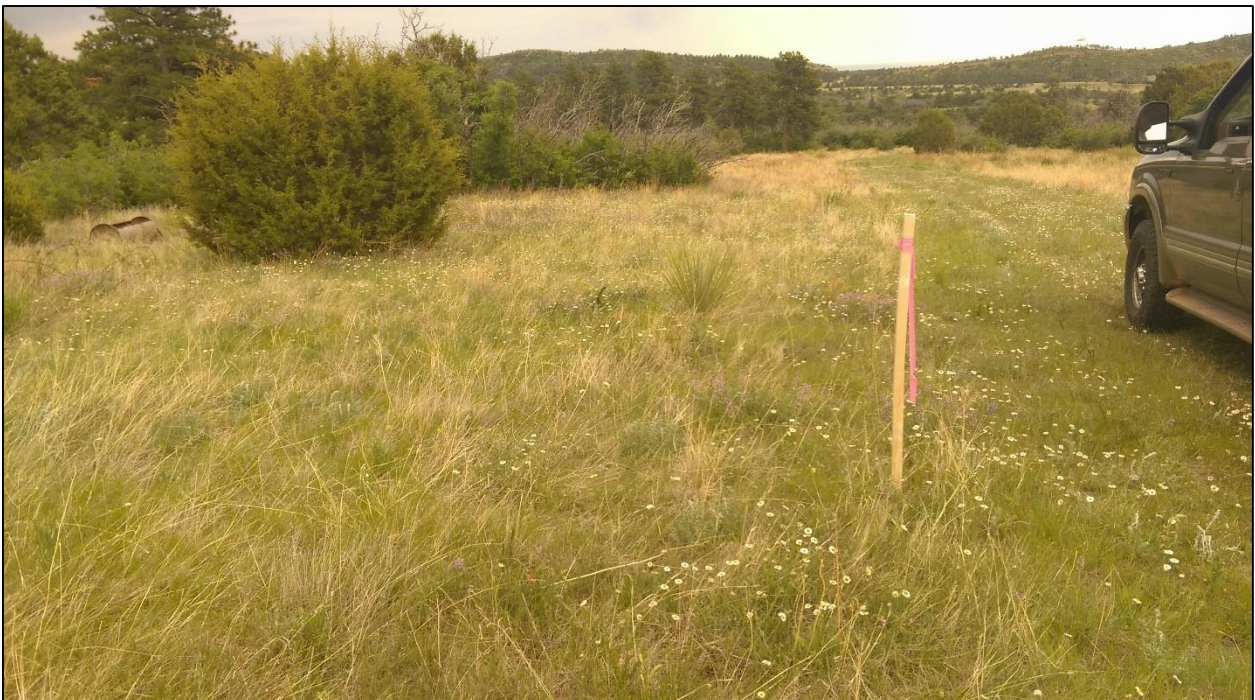
Photo 16. View looking east across relatively flat land with native grasses and shrubs where proposed access road would cross. Note wooden stake marking centerline of proposed road.

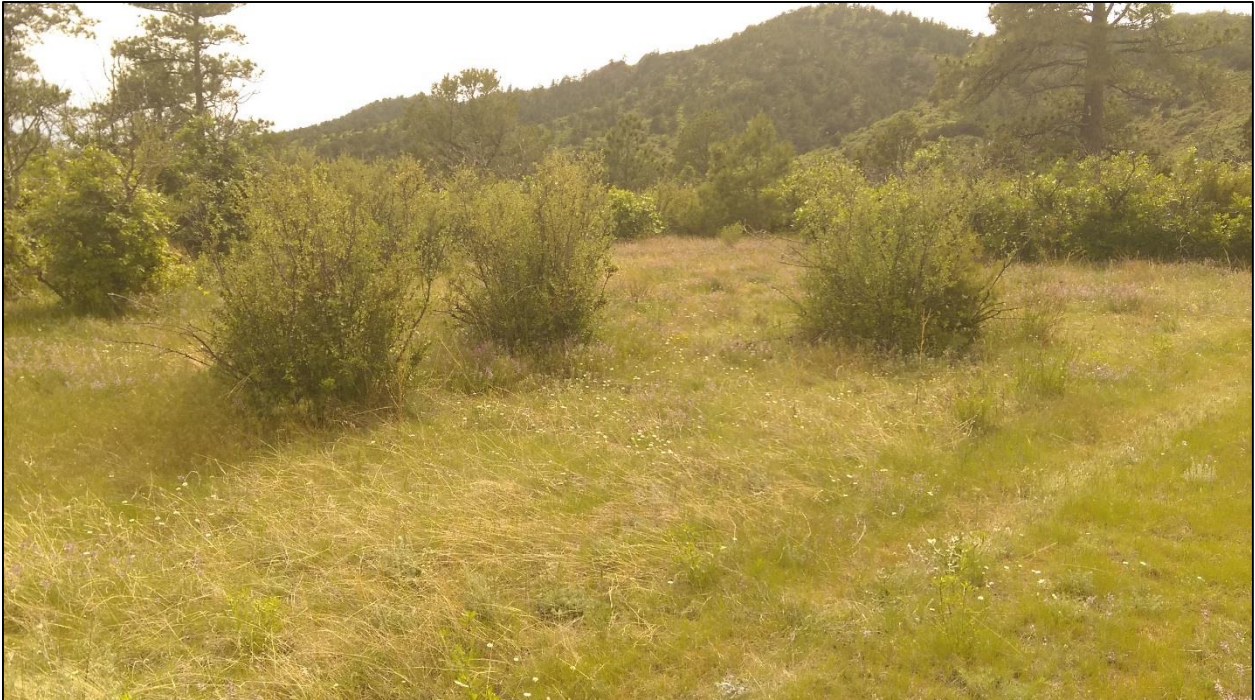
Photo 17. View looking west/southwest across location of proposed scale house south of access road.
