## MINERALS PROGRAM INSPECTION REPORT

| <b>MINE NAME:</b><br>Hitch Rack Ranch Quarry | <b>MINE/PROSPECTING ID#:</b><br>M-2016-010 | <b>MINERAL:</b><br>Granite, granite gneiss | <b>COUNTY:</b><br>El Paso |
| <b>INSPECTION TYPE:</b><br>Aerial Inspection | <b>INSPECTOR(S):</b><br>Amy Eschberger | <b>INSP. DATE:</b><br>June 17, 2016 | <b>INSP. TIME:</b><br>11:50 |

| <b>REASON FOR INSPECTION:</b><br>Preoperation Inspection | <b>BOND CALCULATION TYPE:</b><br>N/A – Application in Review | <b>BOND AMOUNT:</b><br>N/A – Application in Review |

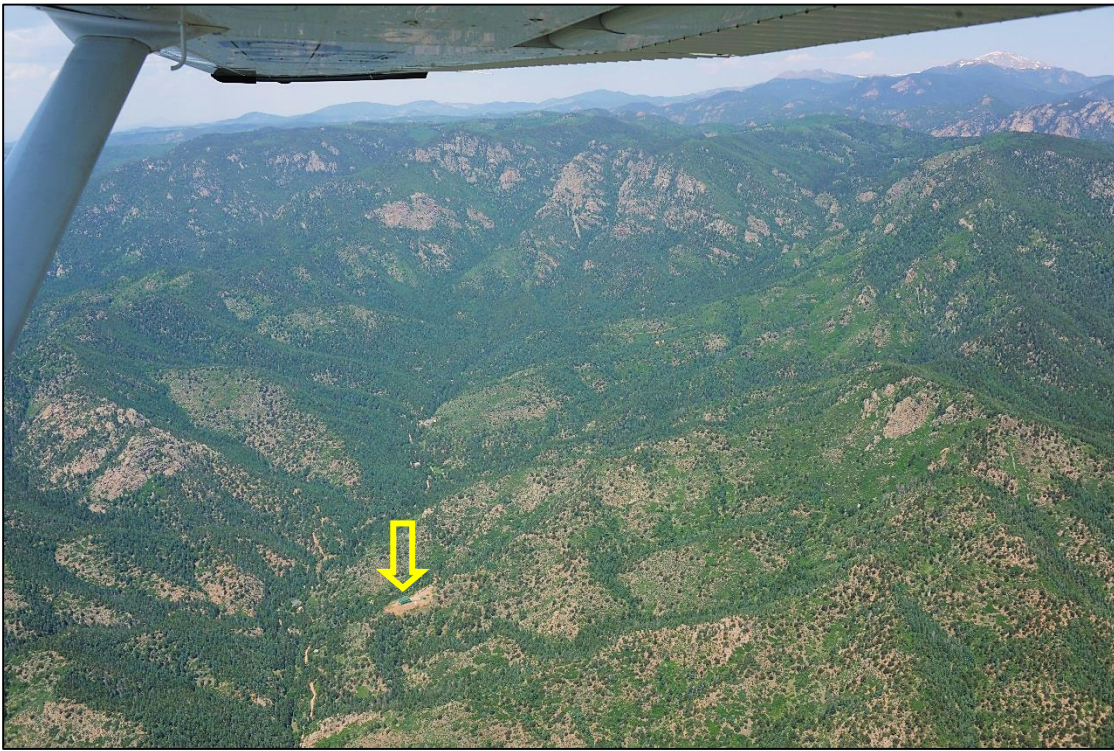
| <b>Photo No.</b> | <b>Shown in Photo</b> | <b>Direction</b> | <b>Notes</b> |
|---|---|---|--|
| <b>1</b> | Looking upstream LTC | NW | House top ridge located ~1,000 ft west from proposed affected land; Proposed affected land not shown |

**Photo 1.** View looking northwest, upstream of Little Turkey Creek. Note house (indicated) on top of ridge in foreground, which is located approximately 1,000 feet west of proposed affected land (not shown here).

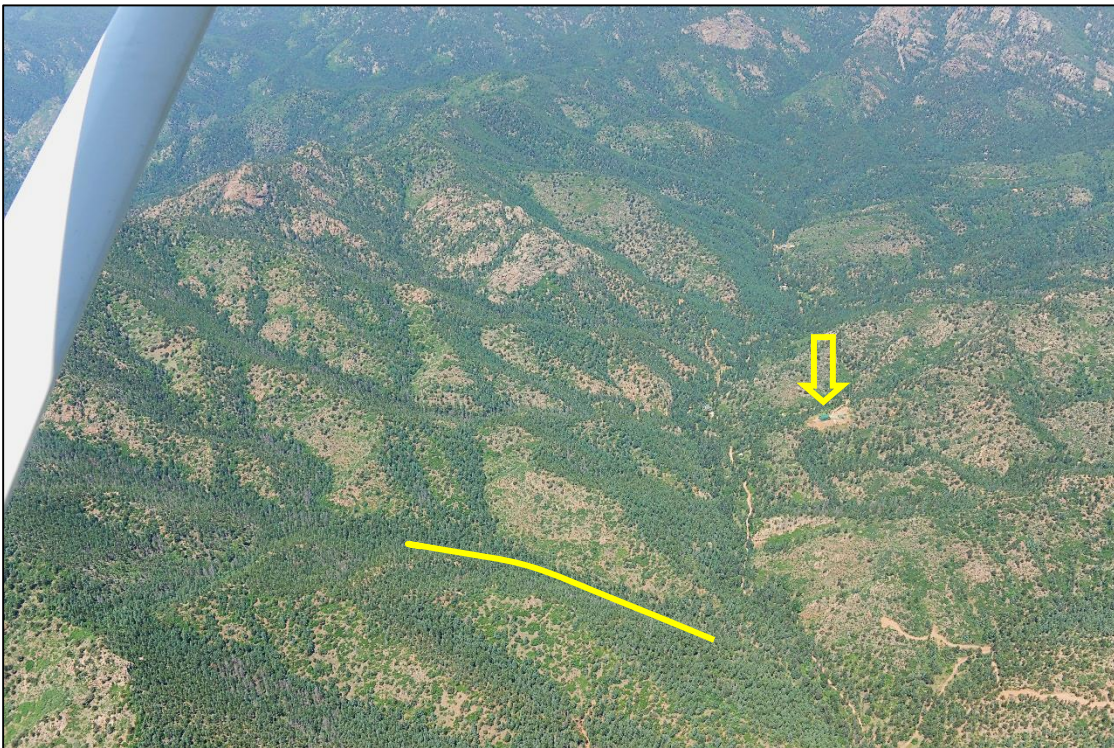
| <b>Photo No.</b> | <b>Shown in Photo</b> | <b>Direction</b> | <b>Notes</b> |
|---|---|---|--|
| <b>2</b> | Looking upstream LTC; Drill road at western edge of proposed North Pit; Proposed valley for Fines/OB storage in South Pit | NW | House top ridge located ~1,000 ft west from proposed affected land; Western edge of proposed affected land shown |

**Photo 2.** View looking northwest, upstream of Little Turkey Creek. Note house (indicated) on top of ridge, located approximately 1,000 feet west from proposed affected land. Western portion of proposed affected land shown in foreground. Drill road at western edge of North Pit at bottom right. For reference, proposed valley for fines/overburden storage in South Pit (indicated with line) at bottom center.

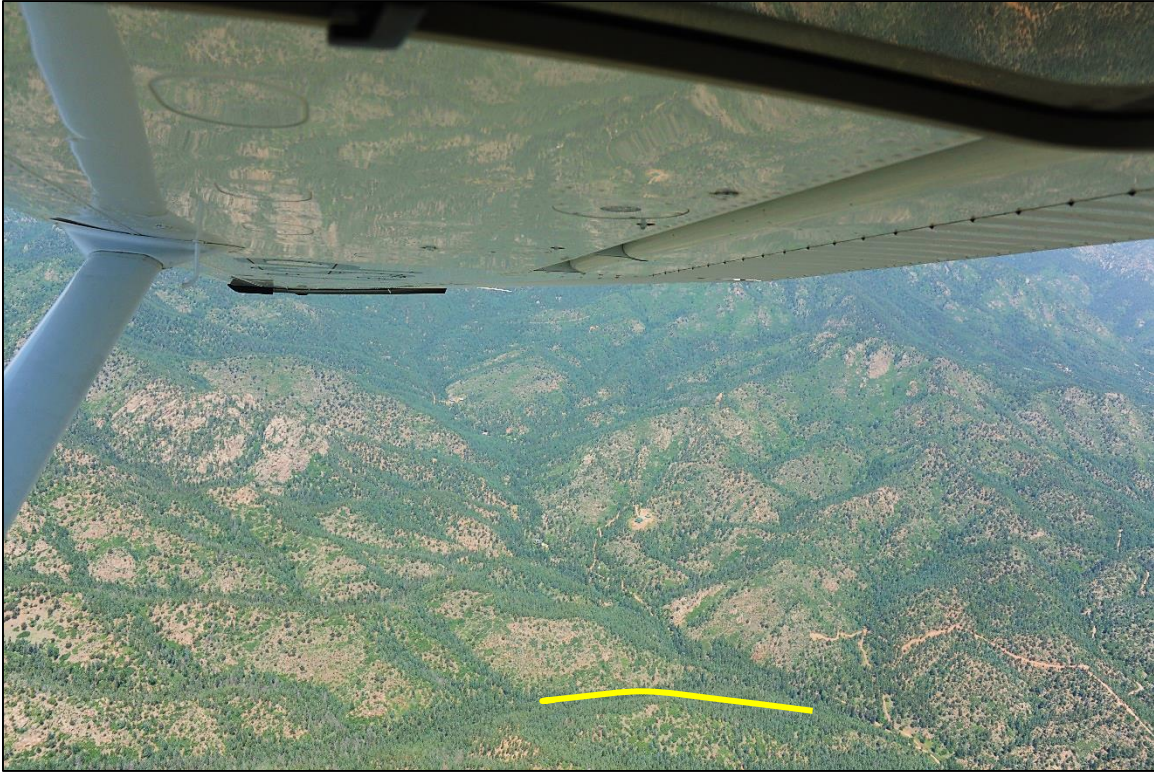
| <b>Photo No.</b> | <b>Shown in Photo</b> | <b>Direction</b> | <b>Notes</b> |
|---|---|---|--|
| <b>3</b> | Looking upstream LTC; Drill road at western edge of proposed North Pit; Proposed valley for Fines/OB storage in South Pit | NW | Only western edge of proposed affected land shown |

**Photo 3.** View looking slightly northwest, upstream of Little Turkey Creek. Only western edge of proposed affected land shown. Note drill road at western edge of proposed North Pit at bottom right. For reference, proposed valley for fines/overburden storage in South Pit (indicated with line) at bottom center.

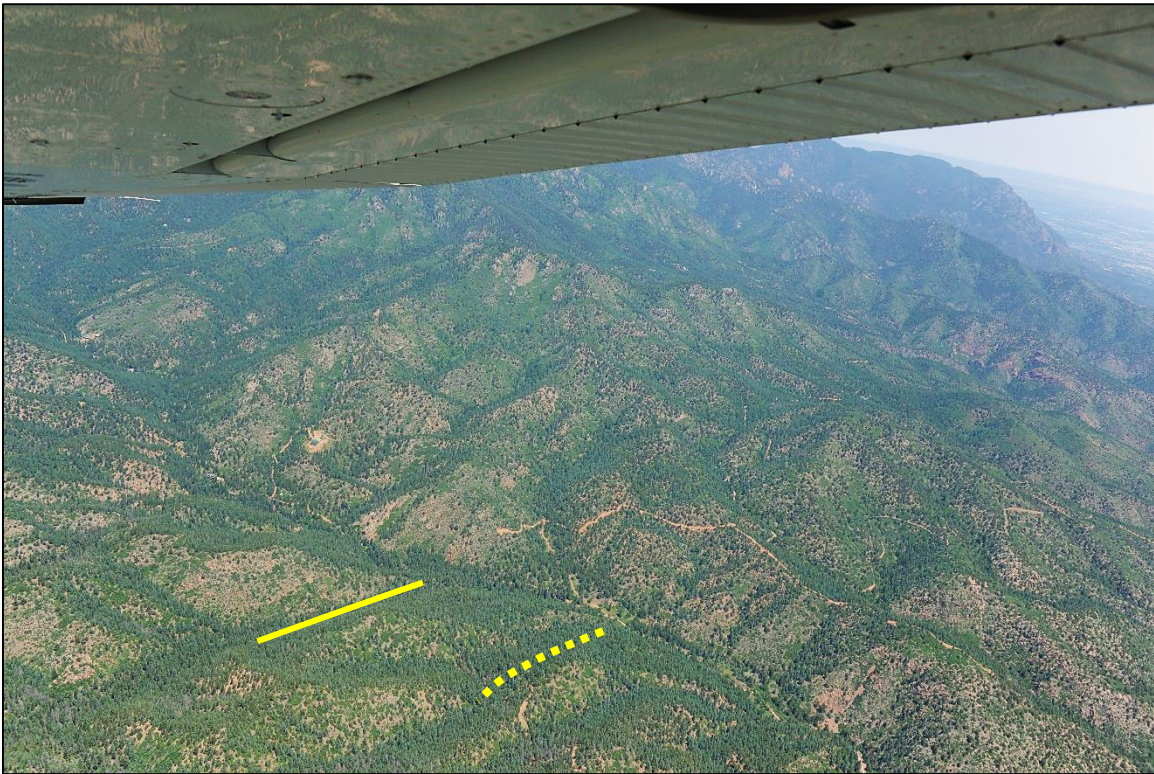
| <b>Photo No.</b> | <b>Shown in Photo</b> | <b>Direction</b> | <b>Notes</b> |
|---|---|---|--|
| <b>4</b> | Drill road at western edge of proposed North Pit; Proposed valley for Fines/OB storage in South Pit; Proposed valley for topsoil storage in South Pit | NW | Further east than in Photo 3; Only western edge of proposed affected land shown |

**Photo 4.** View looking slightly northwest, further east than in **Photo 3**. Only western portion of proposed affected land shown. Note drill road across top ridge in proposed North Pit near center. Proposed valley for fines/overburden storage in South pit (indicated with solid line) at bottom left. Proposed valley for topsoil storage in South Pit (indicated with dotted line) shown at bottom center.

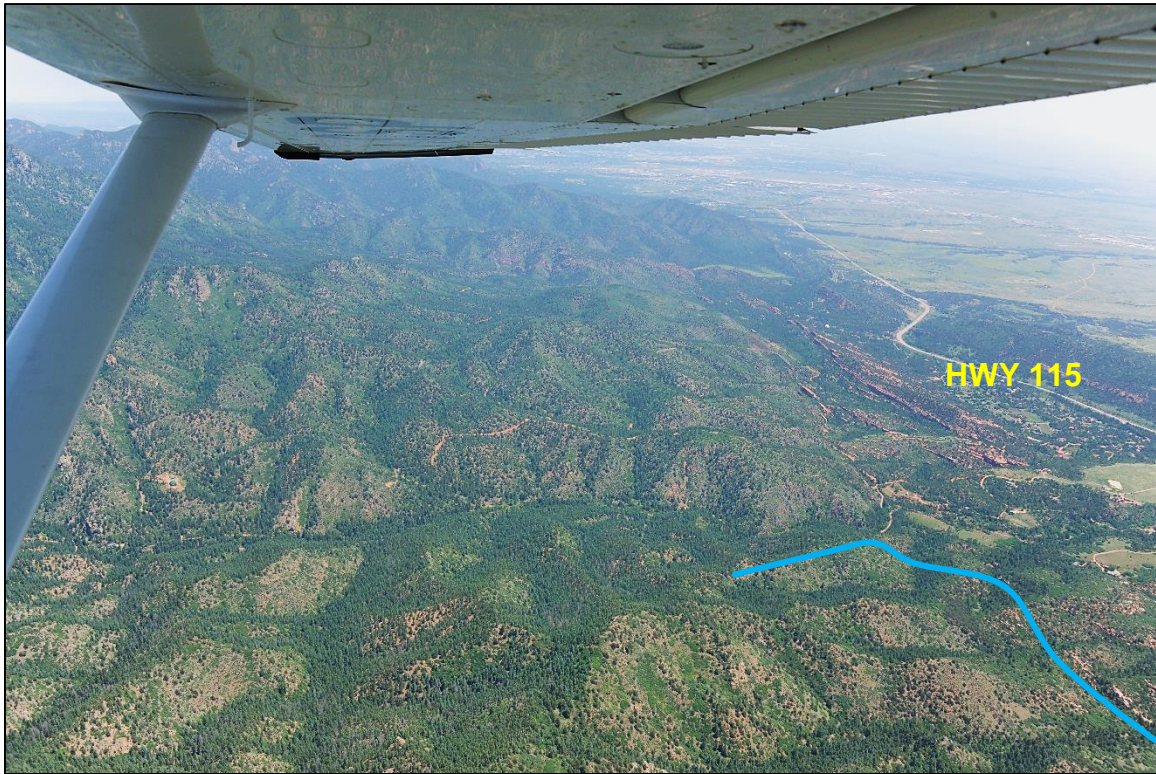
| <b>Photo No.</b> | <b>Shown in Photo</b> | <b>Direction</b> | <b>Notes</b> |
|---|---|---|--|
| <b>5</b> | Proposed affected land; Portion of proposed access road | N/NE | Sandstone outcrops at right, east of fault zone separating granite outcrops to west; Hwy 115 shown |

**Photo 5.** View looking north/northeast across proposed affected land (at center). A portion of proposed access road (not yet constructed) shown at bottom right (approximate location indicated). Sandstone outcrops shown at right, east of fault zone separating granite outcrops to west. Hwy 115 shown at right.

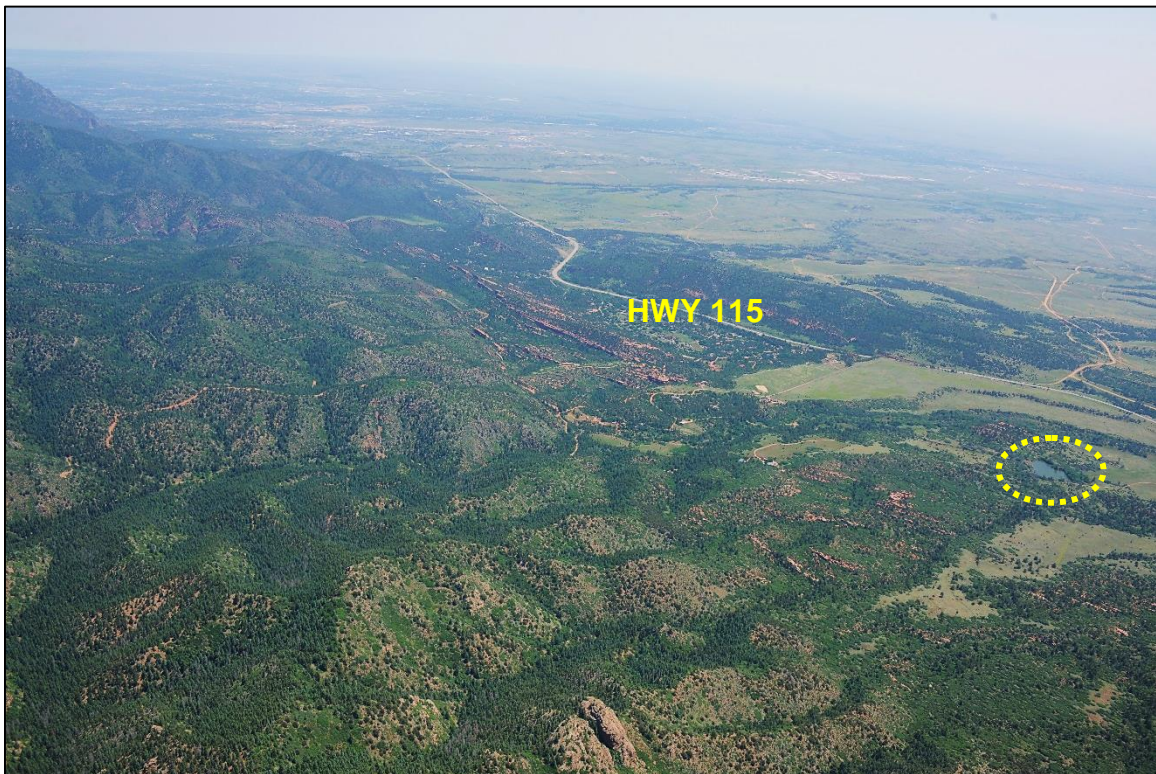
| <b>Photo No.</b> | <b>Shown in Photo</b> | <b>Direction</b> | <b>Notes</b> |
|---|---|---|--|
| <b>6</b> | Proposed affected land; Glen Cairn reservoir located north of proposed access road | N/NE | Slightly closer view and further east than in Photo 5; Hwy 115 shown |

**Photo 6.** View looking north/northeast across proposed affected land (at center, left). Slightly closer view and further east than in **Photo 5**. For reference, Glen Cairn reservoir located north of proposed access road shown at right (circled). Hwy 115 shown at right.

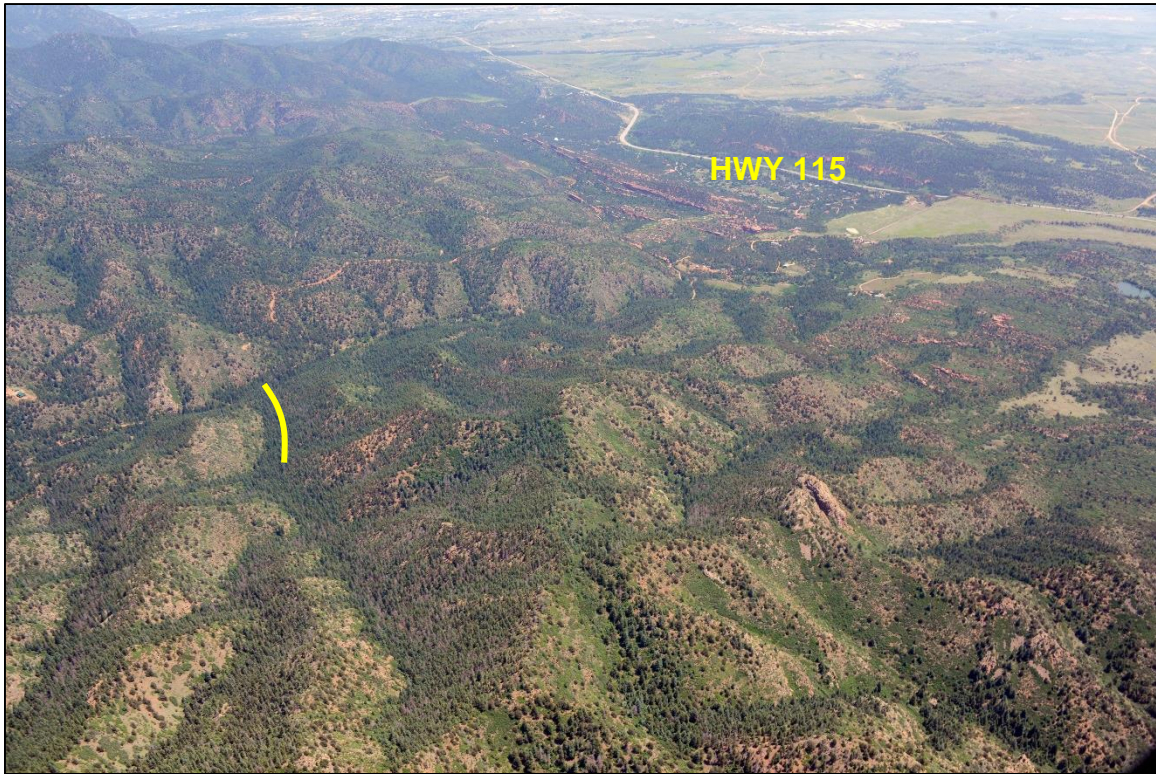
| <b>Photo No.</b> | <b>Shown in Photo</b> | <b>Direction</b> | <b>Notes</b> |
|---|---|---|--|
| <b>7</b> | Proposed affected land; Drill road at western edge of proposed North Pit; Proposed valley for Fines/OB storage in South Pit | NE | Much of land in foreground outside of proposed affected land; Hwy 115 shown |

**Photo 7.** View looking northeast across proposed affected land (at center). Much of land in foreground is outside of proposed affected land. Note drill road along top ridge in proposed North Pit. For reference, proposed valley for fines/overburden storage in South Pit shown at left (indicated). Hwy 115 shown at right.

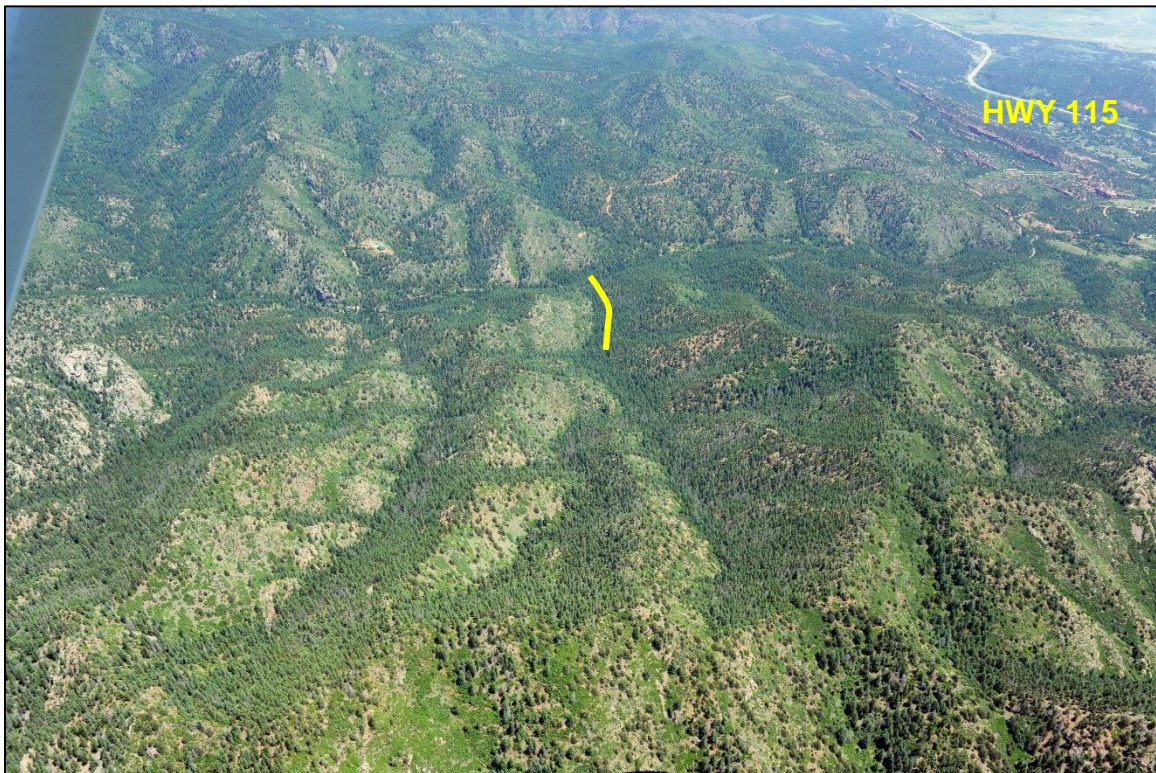
| <b>Photo No.</b> | <b>Shown in Photo</b> | <b>Direction</b> | <b>Notes</b> |
|---|---|---|--|
| <b>8</b> | Proposed affected land; Proposed valley for Fines/OB storage in South Pit | NE | Slightly further south and west than in Photo 7; Much of land in foreground outside of proposed affected land; Hwy 115 shown |

**Photo 8.** View looking northeast across proposed affected land (at center). Slightly further south and west than in **Photo 7**. Much of land in foreground is outside of proposed affected land. For reference, proposed valley for fines/overburden storage shown at center (indicated). Hwy 115 shown at top, right.
