COLORADO DIVISION OF RECLAMATION, MINING AND SAFETY
MINERALS PROGRAM INSPECTION REPORT
PHONE: (303) 866-3567

MINE NAME: Mud Creek Pit	MINE/PROSPECTING ID#: M-2008-010	MINERAL: Sand and gravel	COUNTY: Montezuma
INSPECTION TYPE: Monitoring	INSPECTOR(S): Lucas J. West	INSP. DATE: May 24, 2016	INSP. TIME: 14:00
OPERATOR: Oldcastle SW Group, Inc. dba Four Corners M	OPERATOR REPRESENTATIVE: Matt Carnahan	TYPE OF OPERATION: 112c - Construction Regular Operation

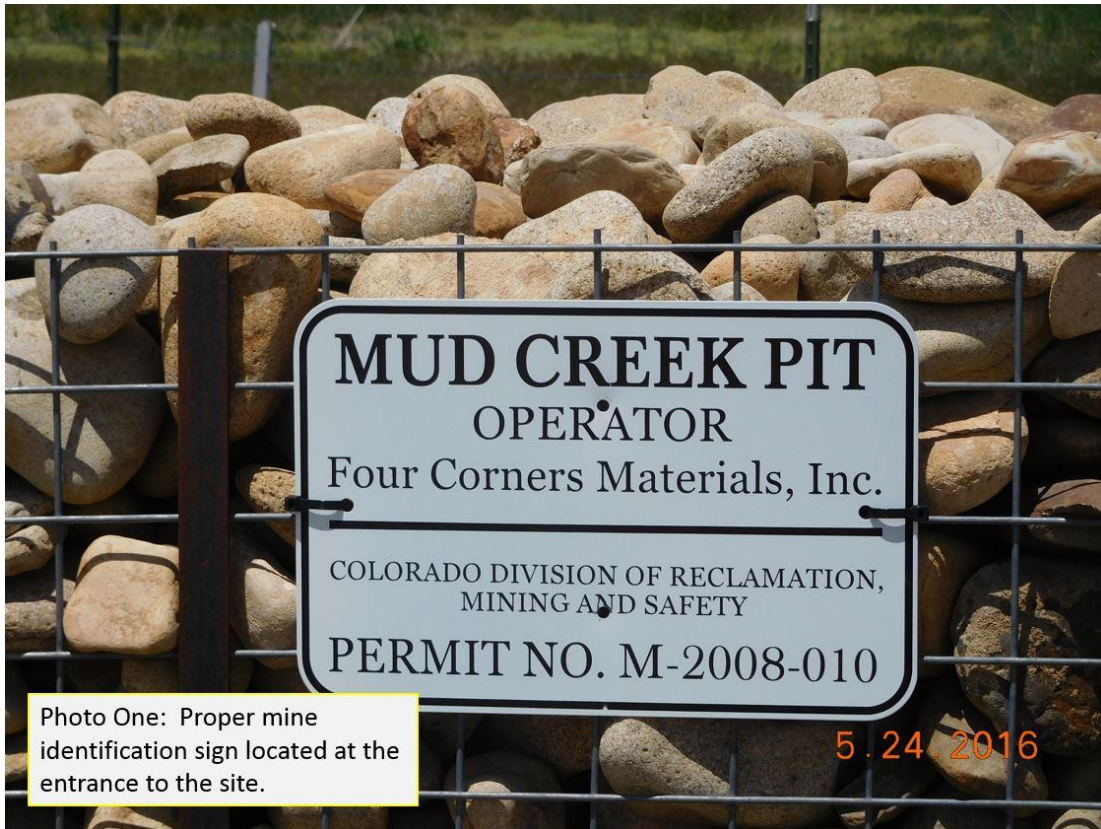
Proper mine identification signage was observed at the entrance to the site and shown in Photo One. The permit boundaries were clearly marked and all disturbance is contained within the permitted areas. The site was not active during this inspection and recent activity mainly consists of hauling from stockpiled materials. The Mining area consist of a highwall approximately 10 feet tall. Photo Two shows the mining area with the overburden stockpiled just above the highwall. Adjacent to the mining area is the processing and stockpile area. Several stockpiles of various sized materials were noted on site. The site does not have a permanent crushing operation so material is crushed and stockpiled in bulk. Photo Three shows the various stockpiles in the area. All stockpiles that were observed appear to be in good condition and appear to be stable.

Photo One: Proper mine identification sign located at the entrance to the site.

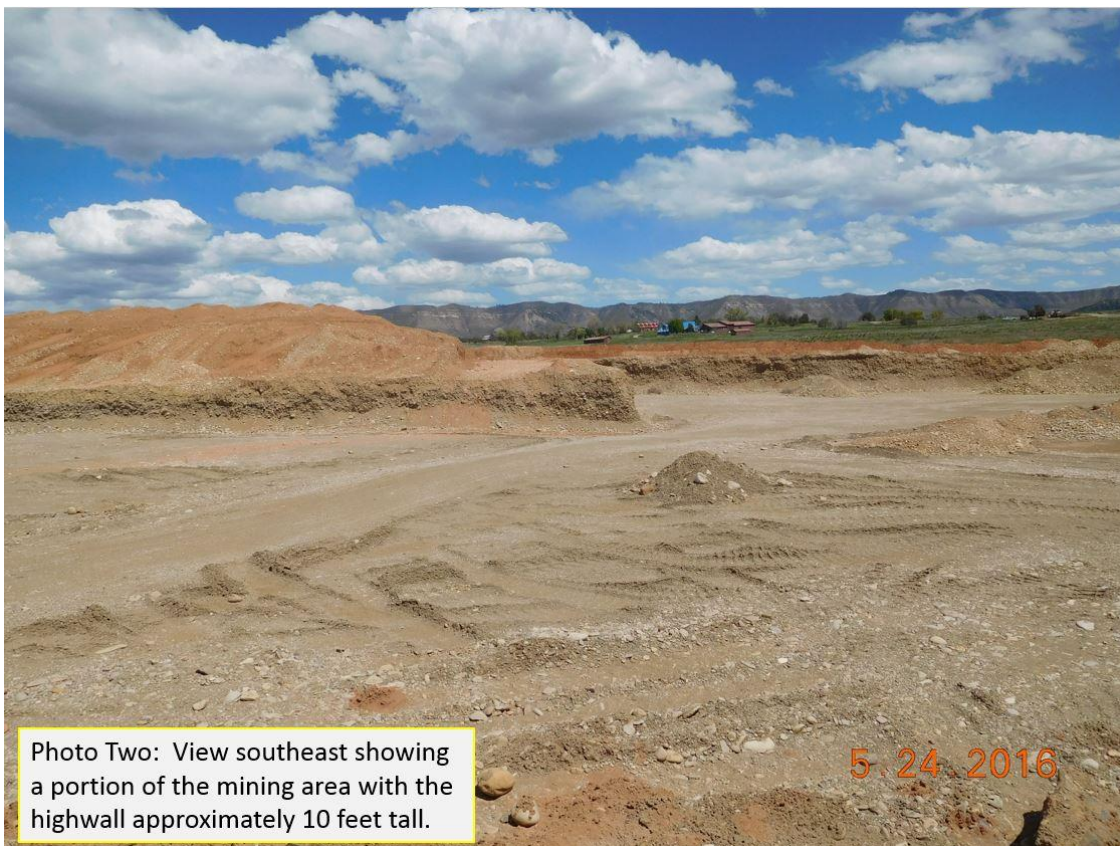
Photo Two: View southeast showing a portion of the mining area with the highwall approximately 10 feet tall.

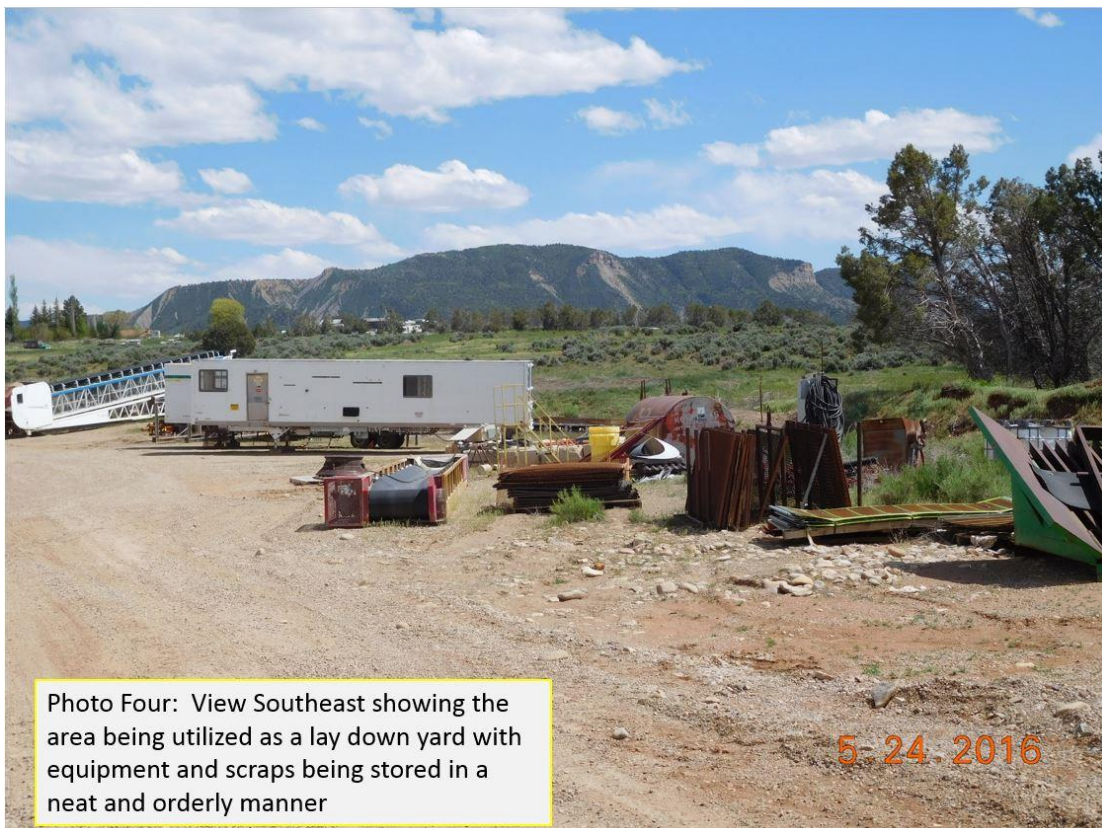
A small area to the South of the stockpile area is being utilized as a lay down yard for various equipment and scrap metal. All equipment is mobile or semi mobile and is being stored in a neat and orderly fashion. Photo Four shows the lay down area with the equipment on site. Approximately 13 acres of the 154 permitted acres is currently disturbed. Photo Five shows the undisturbed area of the site. On-site discussions with the operator indicate that they may wish to combine the Mud Creek Pit with the Simmons Pit, another 112(c) under the same operator. This would need to be addressed through the Amendment process sometime in the future.
