MINERALS PROGRAM INSPECTION REPORT
PHONE: (303) 866-3567

MINE NAME: Alexander Pit	MINE/PROSPECTING ID#: M-1976-032	MINERAL: Sand and gravel	COUNTY: San Miguel
INSPECTION TYPE: Monitoring	INSPECTOR(S): Lucas J. West	INSP. DATE: May 25, 2016	INSP. TIME: 09:45
OPERATOR: Oldcastle SW Group, Inc. dba Telluride Gravel	OPERATOR REPRESENTATIVE: None	TYPE OF OPERATION: 112c - Construction Regular Operation

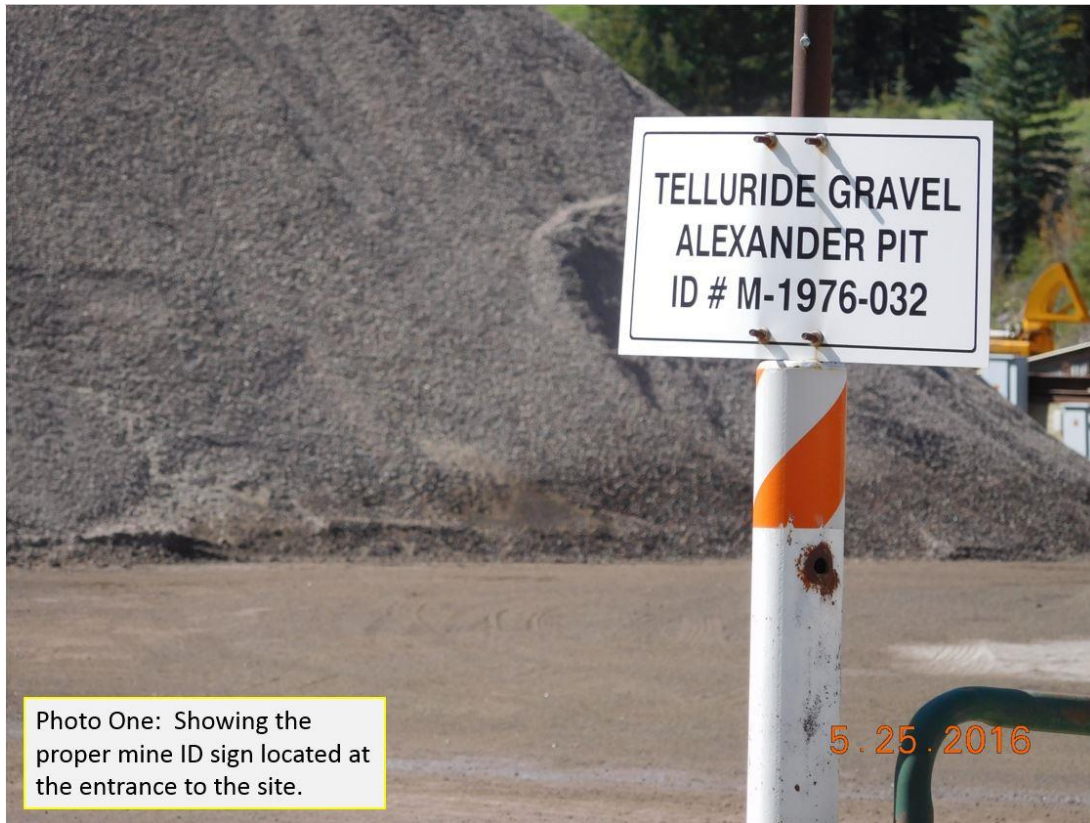
Proper mine identification signs were observed at the entrance to the site shown in Photo One. The permit boundaries were also clearly outlined with signs, markers and fences and all disturbance is contained within the permitted area. The site was minimally active during the inspection, only hauling activities were taking place. The site is no longer being actively mined, it serves as a processing and stockpiling facility only. Photo Two shows the batch plant located on the pit floor, which was not active during the time of the inspection. Several stockpiles of various sized materials were located on site. Photos Three and Four show examples of the stockpiles that were observed. All stockpiles that were observed were in good condition and appeared to be stable. All graded slopes along the edge of the road are well vegetated and appear to be stable.

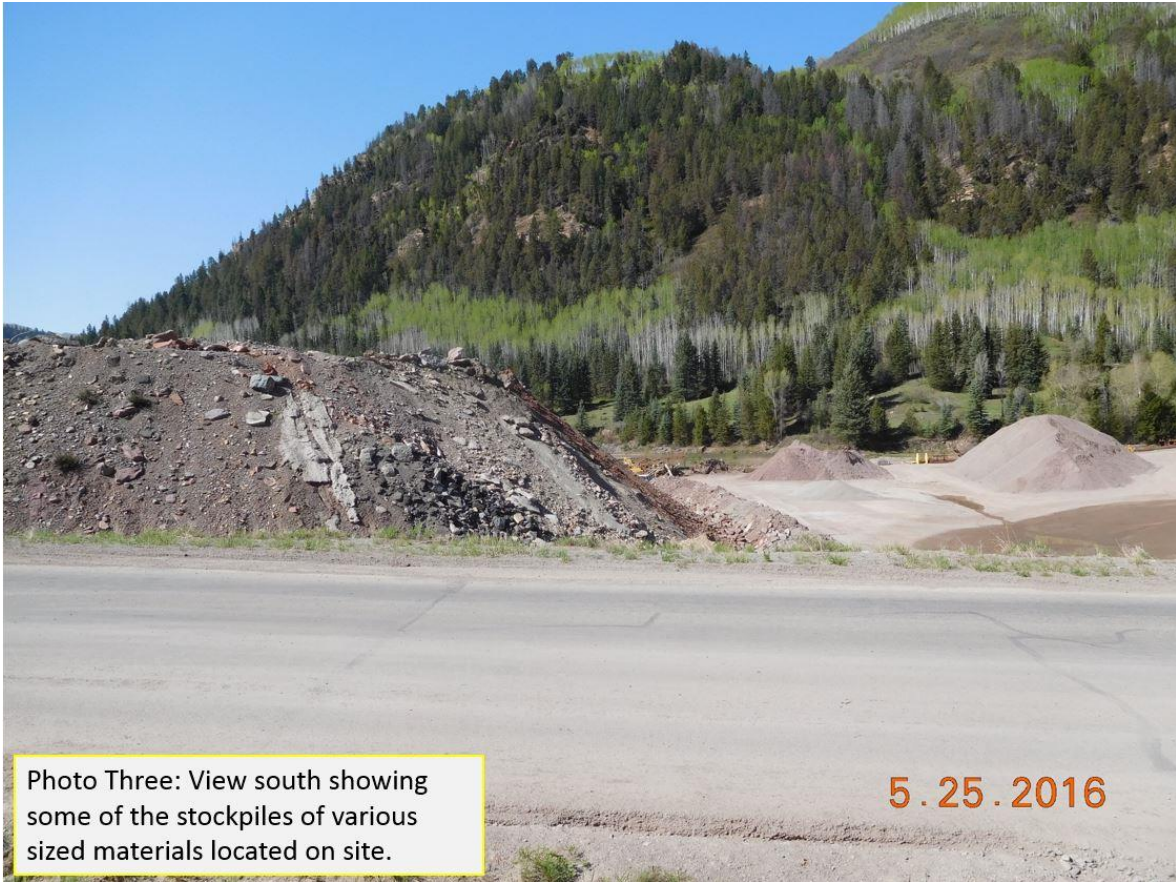
Photo Three: View south showing some of the stockpiles of various sized materials located on site.

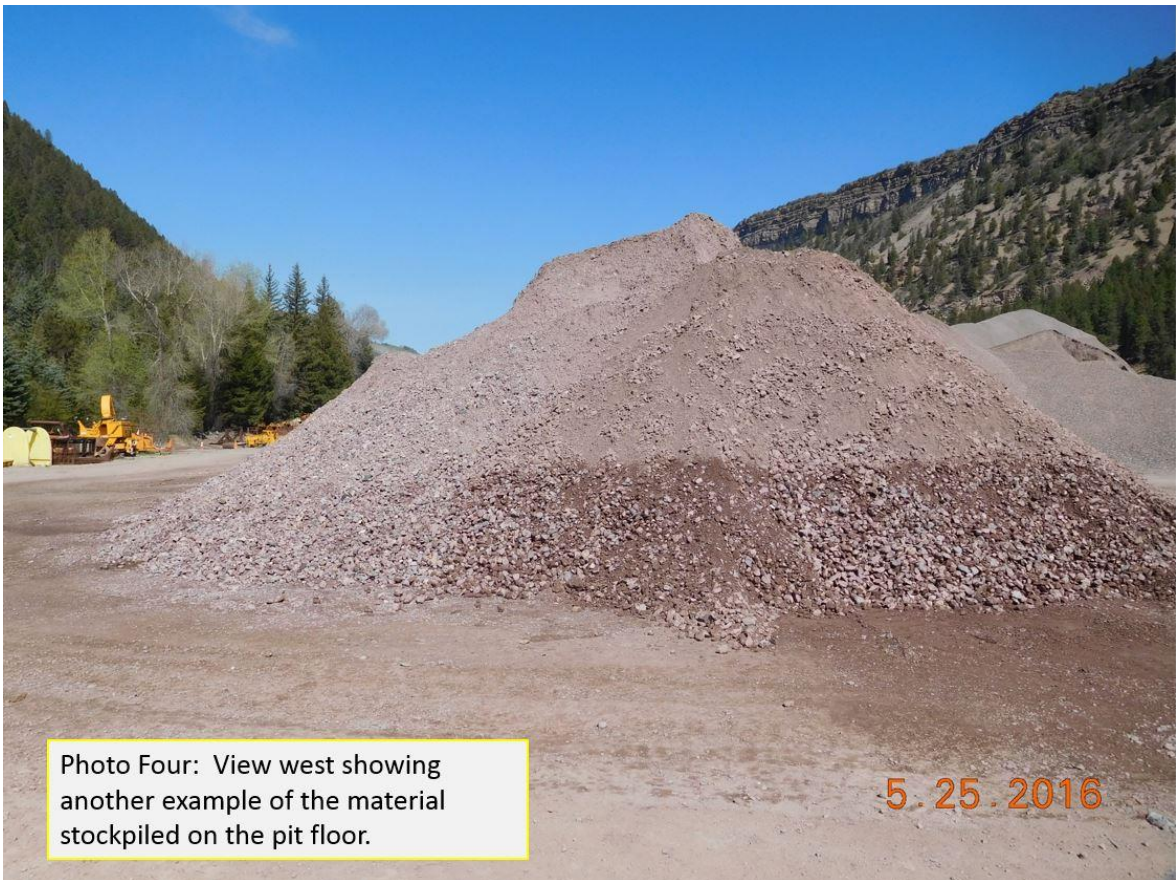
Photo Four: View west showing another example of the material stockpiled on the pit floor.

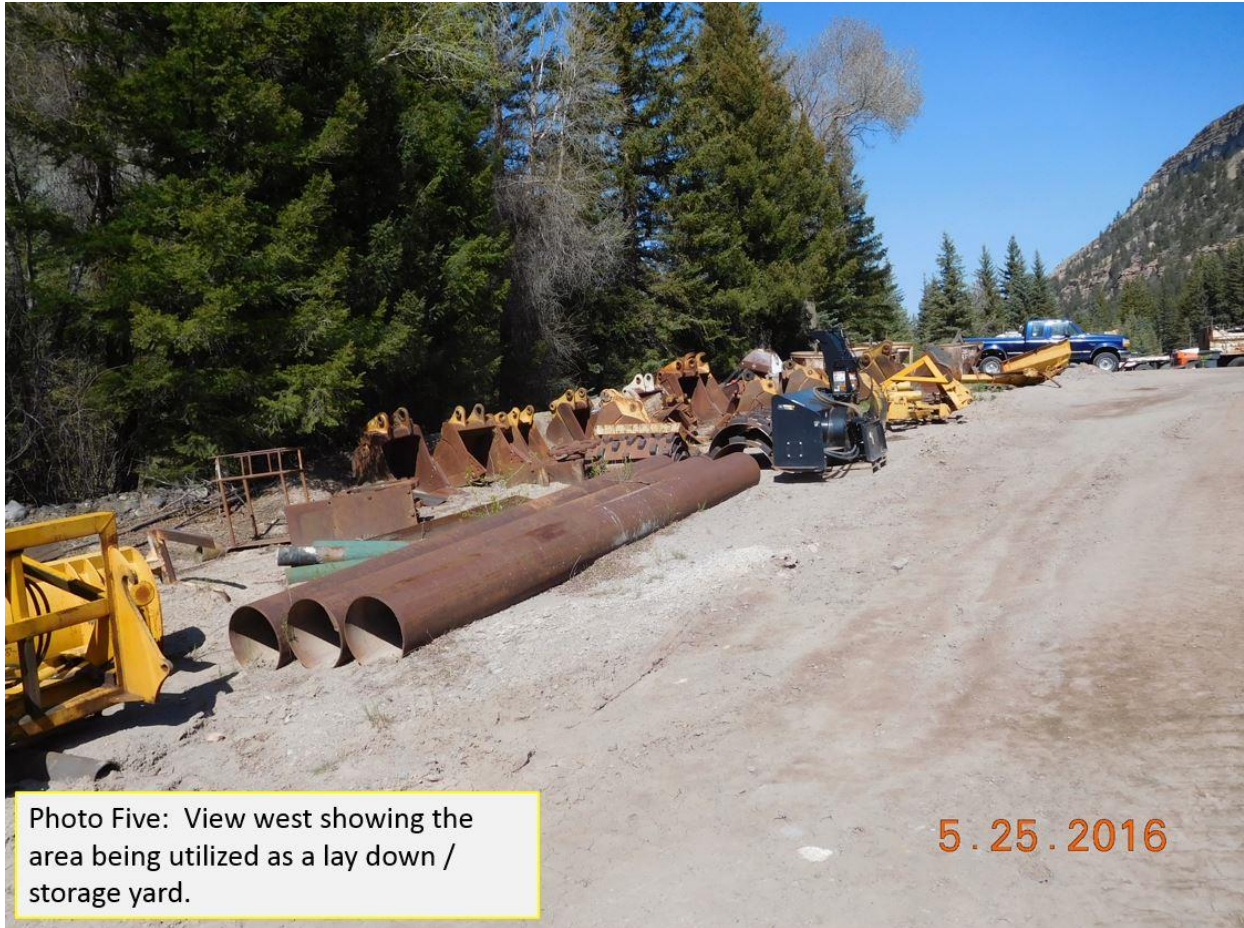
All fuel containers observed on site were in proper secondary containment. A small area along the southern edge of the permitted area as well as the southwestern corner is being used as a lay down yard for the storage of equipment, scrap metal and other various items. An example of the items being stored are shown in Photo Five and are being stored in an orderly fashion. Storm water control features were observed throughout the site and appeared to be functioning as designed. On-site conversations with the operator indicate that noxious weed management is ongoing. No noxious weeds were noted.

Photo Five: View west showing the area being utilized as a lay down / storage yard.
