COLORADO DIVISION OF RECLAMATION, MINING AND SAFETY
MINERALS PROGRAM INSPECTION REPORT
PHONE: (303) 866-3567

MINE NAME: Longmont Operation	MINE/PROSPECTING ID#: M-1994-027	MINERAL: Sand and gravel	COUNTY: Weld
INSPECTION TYPE: Monitoring	INSPECTOR(S): Peter S. Hays	INSP. DATE: June 1, 2016	INSP. TIME: 10:00
OPERATOR: Aggregate Industries - WCR, Inc.	OPERATOR REPRESENTATIVE: Connie Davis	TYPE OF OPERATION: 112c - Construction Regular Operation	
REASON FOR INSPECTION: Normal I&E Program	BOND CALCULATION TYPE: Complete Bond	BOND AMOUNT: \$350,775.00	
DATE OF COMPLAINT: NA	POST INSP. CONTACTS: None	JOINT INSP. AGENCY: None	
WEATHER: Clear	INSPECTOR SIGNATURE:

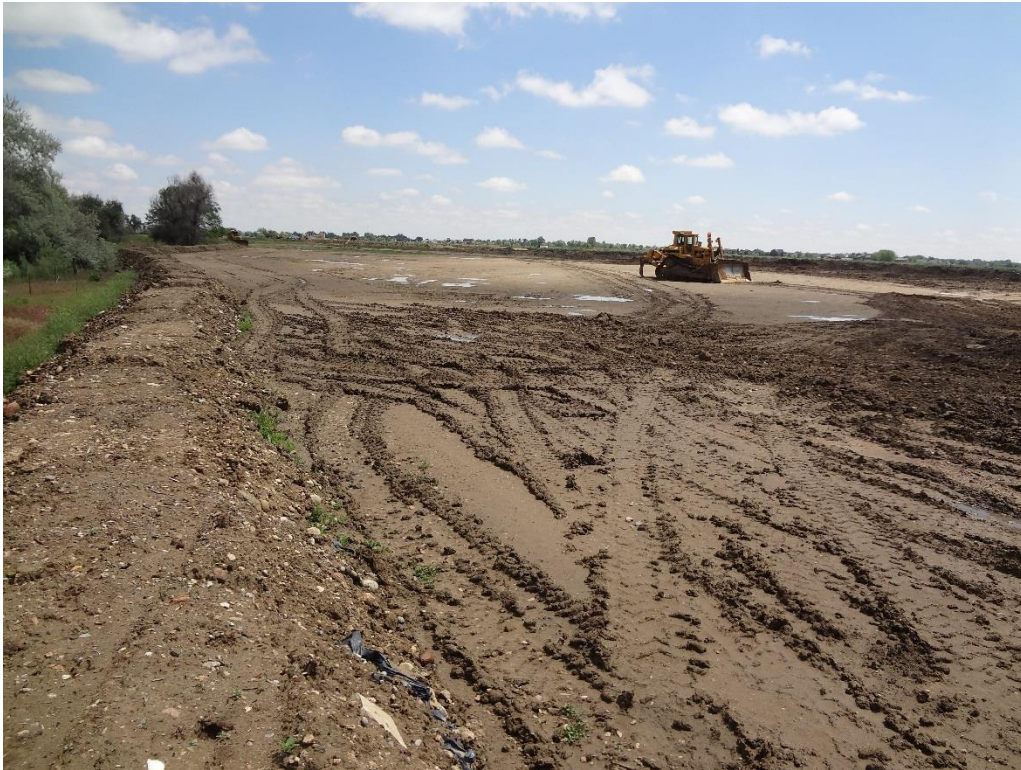
PROBLEM/POSSIBLE VIOLATION: Problem: The site is utilizing off-site fill without prior approval by the Division per 3.1.5(9) of the Rule.

Looking north at backfill area along east side of site

CORRECTIVE ACTIONS: The Operator shall provide a notarized affidavit, stating the fill is inert and addressing all requirements pursuant to Rule 3.1.5(9), which describes the intended use of inert/off-site fill by the corrective action date.

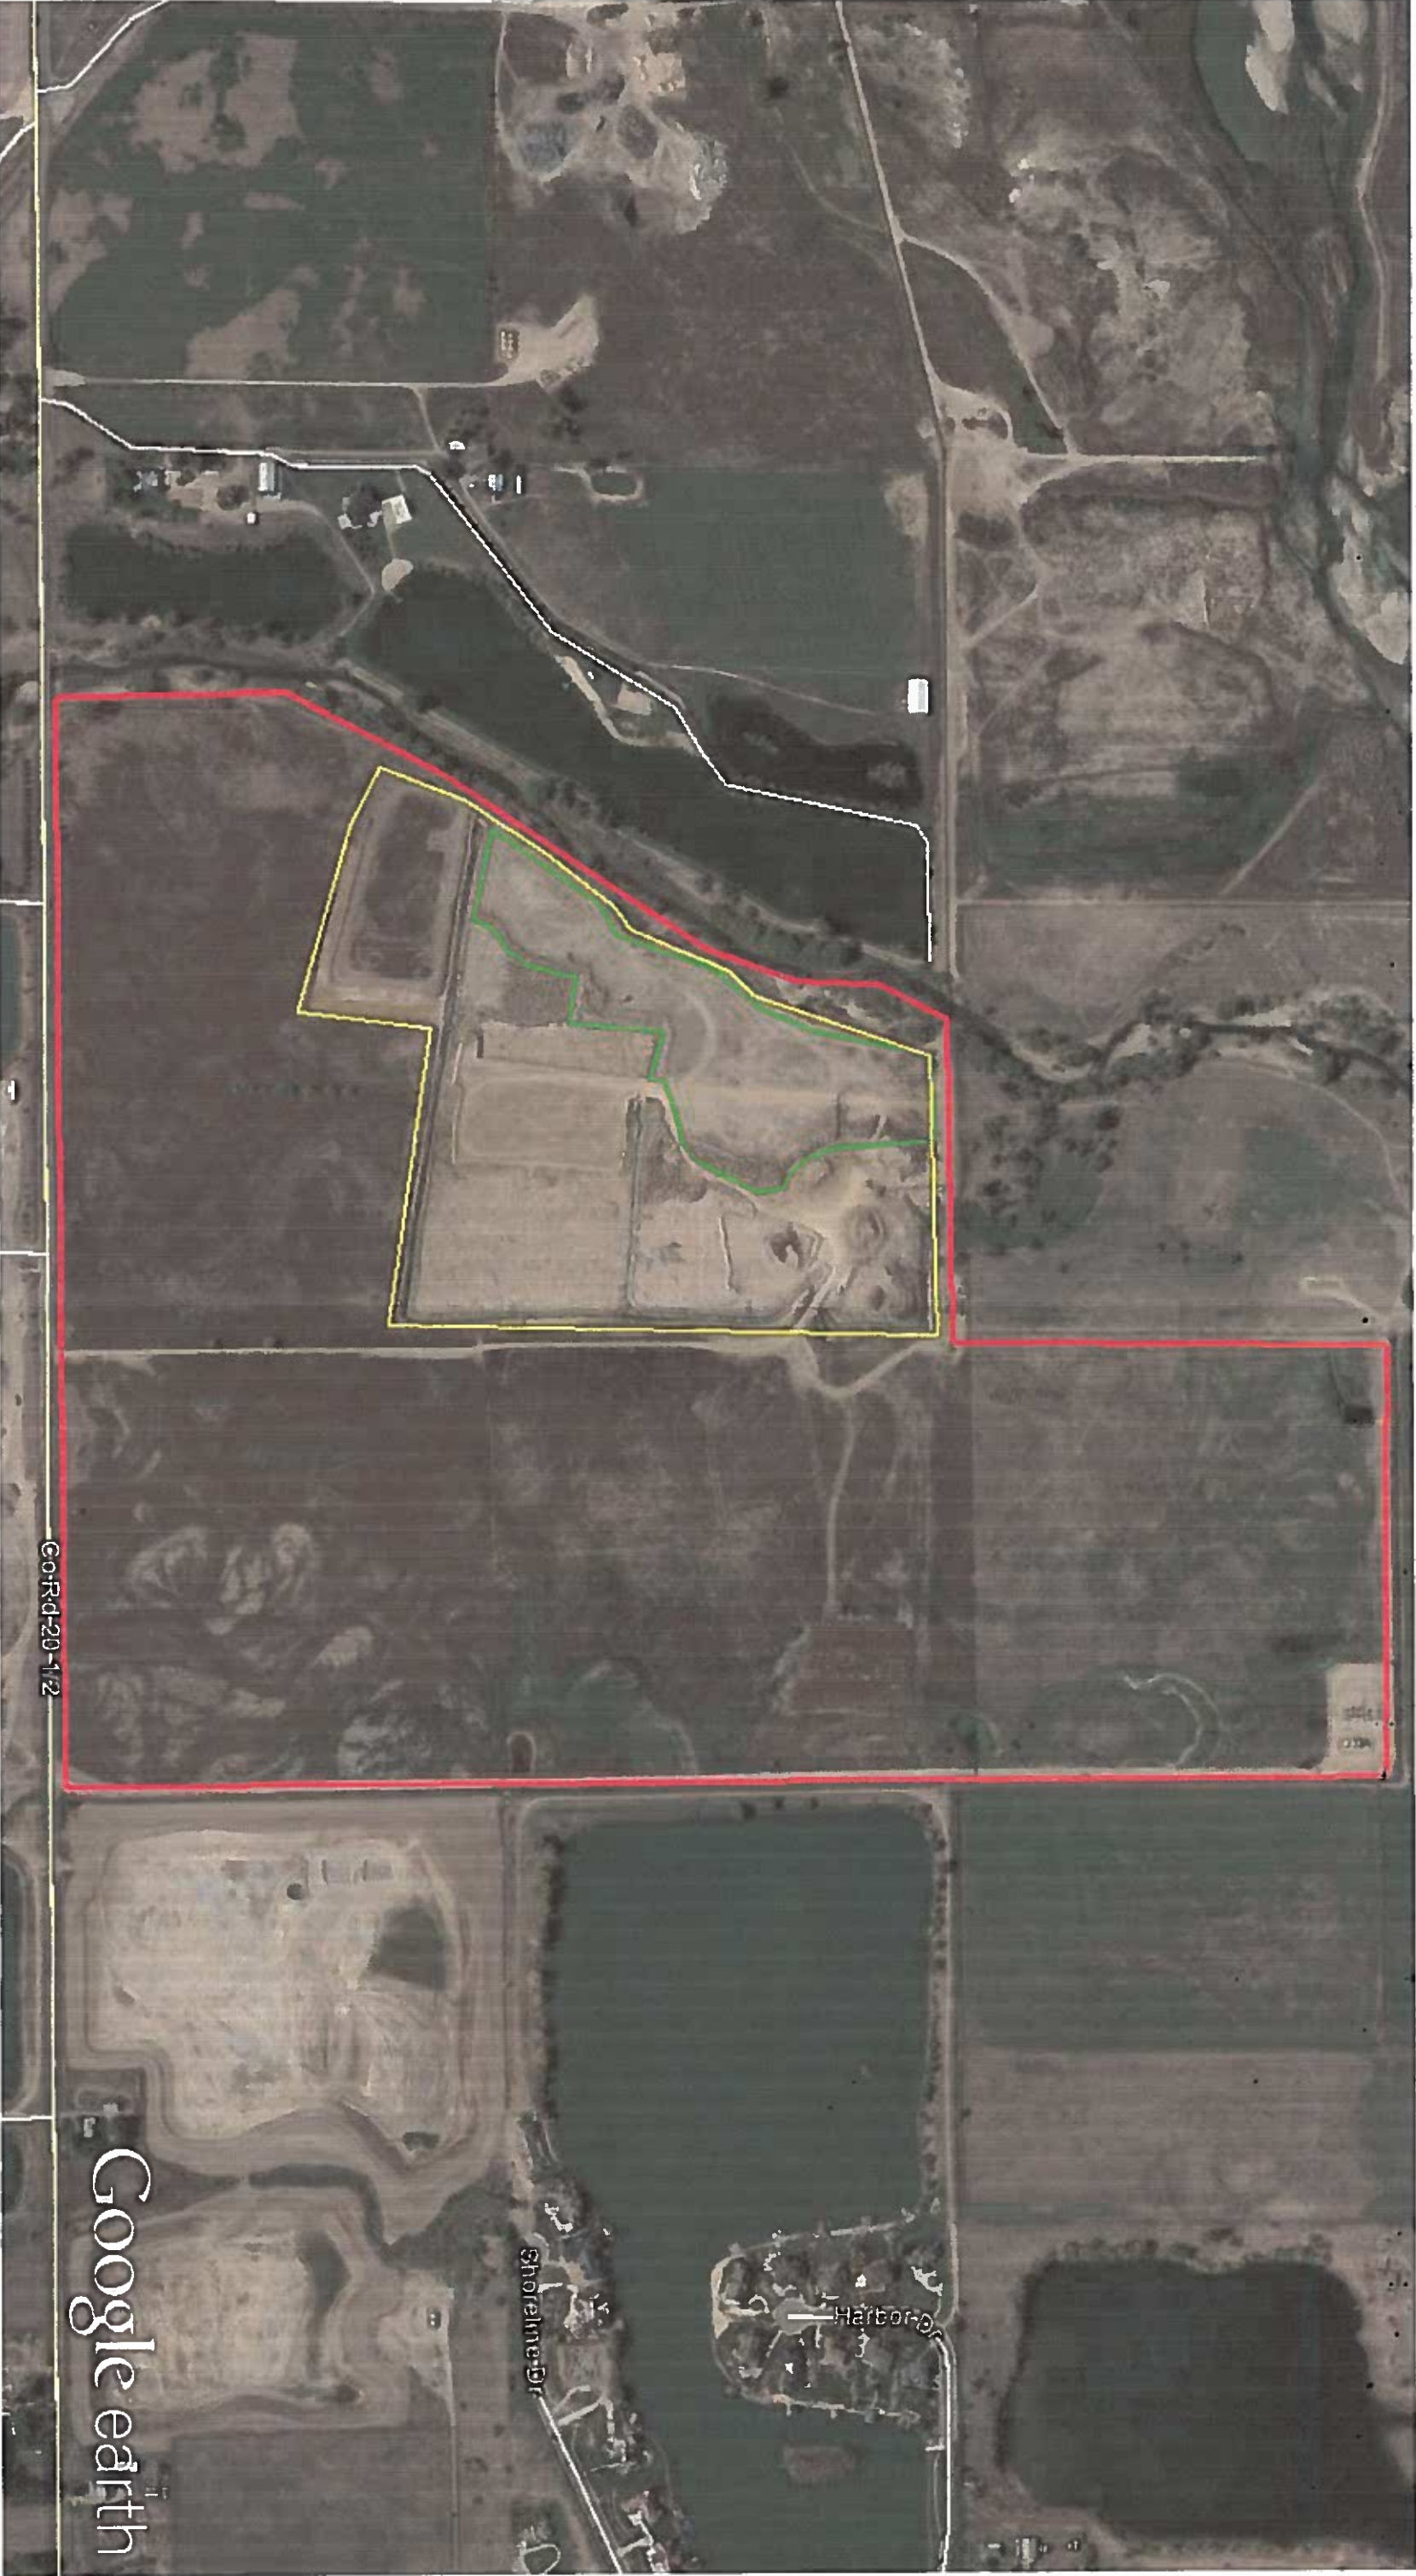
Enclosure – DRMS Inspection Map

An inspection map was created by the Division based on Google Earth Pro images and GPS points collected with a Trimble Juno 3B during the inspection. The results of the map indicate the Operator has disturbed 54.9 acres, which is more than the currently approved 25 acre maximum disturbance. This problem will need to be address by the Operator as part of the required technical revision to the Mine Plan and financial warranty cost estimate.
