COLORADO DIVISION OF RECLAMATION, MINING AND SAFETY
MINERALS PROGRAM INSPECTION REPORT
PHONE: (303) 866-3567

MINE NAME: Longmont Operation	MINE/PROSPECTING ID#: M-1994-027	MINERAL: Sand and gravel	COUNTY: Weld
INSPECTION TYPE: Monitoring	INSPECTOR(S): Peter S. Hays	INSP. DATE: June 1, 2016	INSP. TIME: 10:00
OPERATOR: Aggregate Industries - WCR, Inc.	OPERATOR REPRESENTATIVE: Connie Davis	TYPE OF OPERATION: 112c - Construction Regular Operation	
REASON FOR INSPECTION: Normal I&E Program	BOND CALCULATION TYPE: Complete Bond	BOND AMOUNT: \$350,775.00	
DATE OF COMPLAINT: NA	POST INSP. CONTACTS: None	JOINT INSP. AGENCY: None	
WEATHER: Clear	INSPECTOR SIGNATURE:

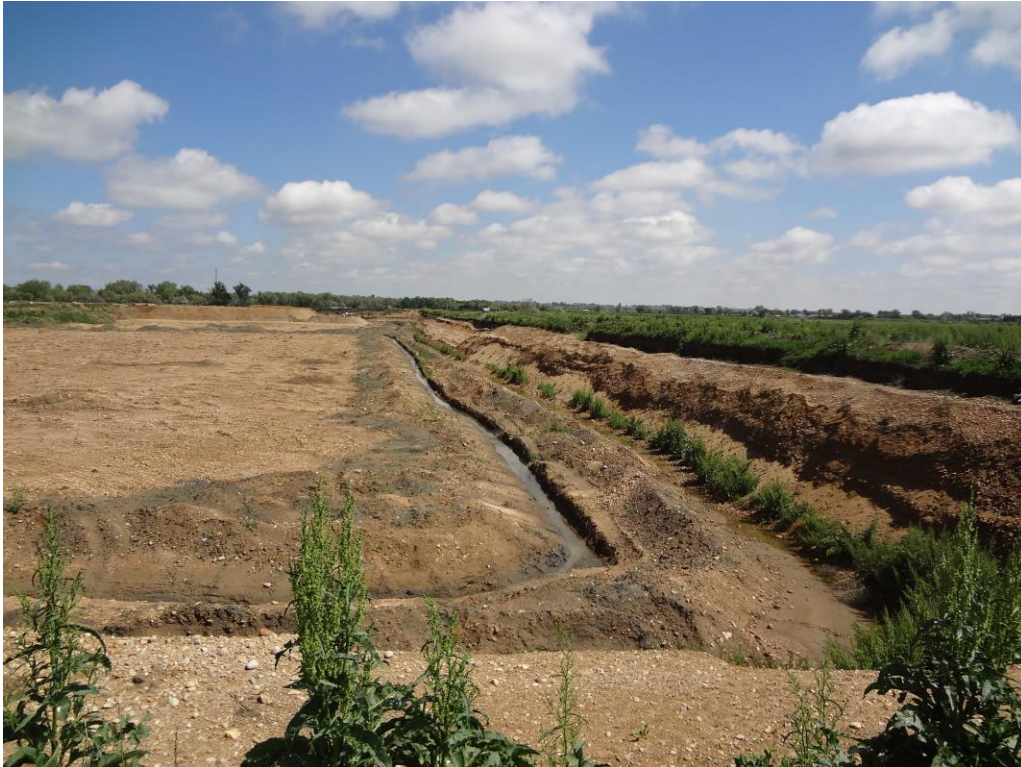
Looking north from SE corner of mining disturbance

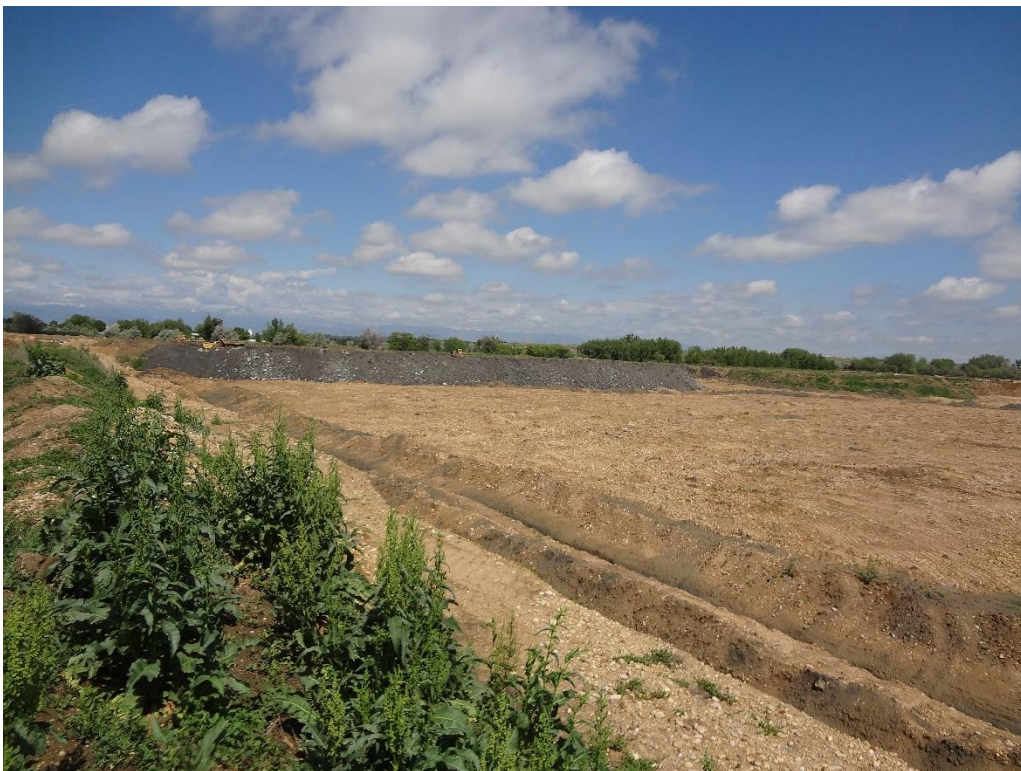
open water pond. Instead, the site will be backfilled with on-site and imported fill material to eliminate any exposed water at the site. As cited as a problem, the Operator must submit an affidavit, as required by Rule 3.1.5(9), for the fill material generated outside of the approved permit area for the material placed in Phase 1 and 2 and for all future imported material at the site. Additionally, the Division will require the Operator to submit an amendment application to change the post mining land use from wildlife habitat to rangeland in the future.

Looking NW from SE corner of mining disturbance at backfill area

CORRECTIVE ACTIONS: The Operator shall provide a notarized affidavit, stating the fill is inert and addressing all requirements pursuant to Rule 3.1.5(9), which describes the intended use of inert/off-site fill by the corrective action date.

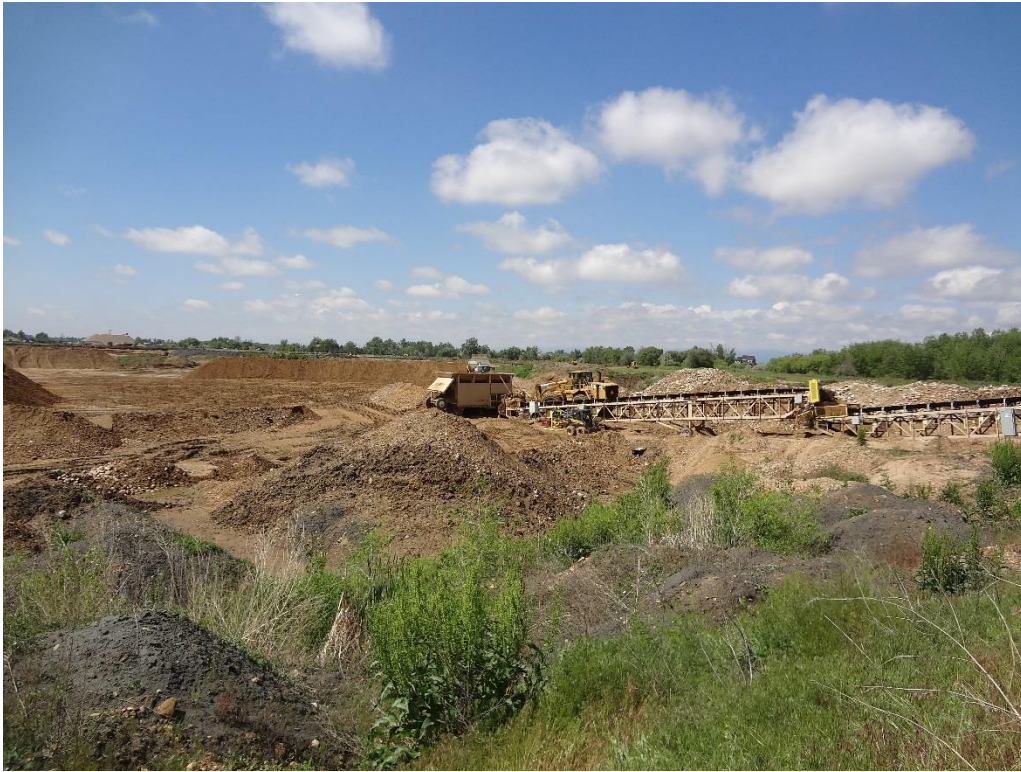
The site was active during the inspection. The site is dry mined by the use of dewatering channels and the water is discharged to Boulder Creek. As cited as a problem, the Operator is not following the approved Mine Plan for the site. Mined material is being conveyed to the adjoining Longmont Distel Operation for processing instead of on-site. The mining excavation started in the northwest corner of Phase 2 and is progressing to the south and east toward Phase 1, which differs from the approved plan. The Operator has disturbed more than the allow 25 acres at one time. The Division will require the Operator to submit a Technical Revision, with the required \$216 revision fee, to update and clarify the current approved Mine Plan to reflect the existing and proposed activities by the corrective action date.

Looking SW from north end of mining disturbance at conveyor

CORRECTIVE ACTIONS: The Operator shall submit a Technical Revision, with the required \$216 revision fee, to update and clarify the current approved mine plan to reflect the existing and proposed activities by the corrective action date.

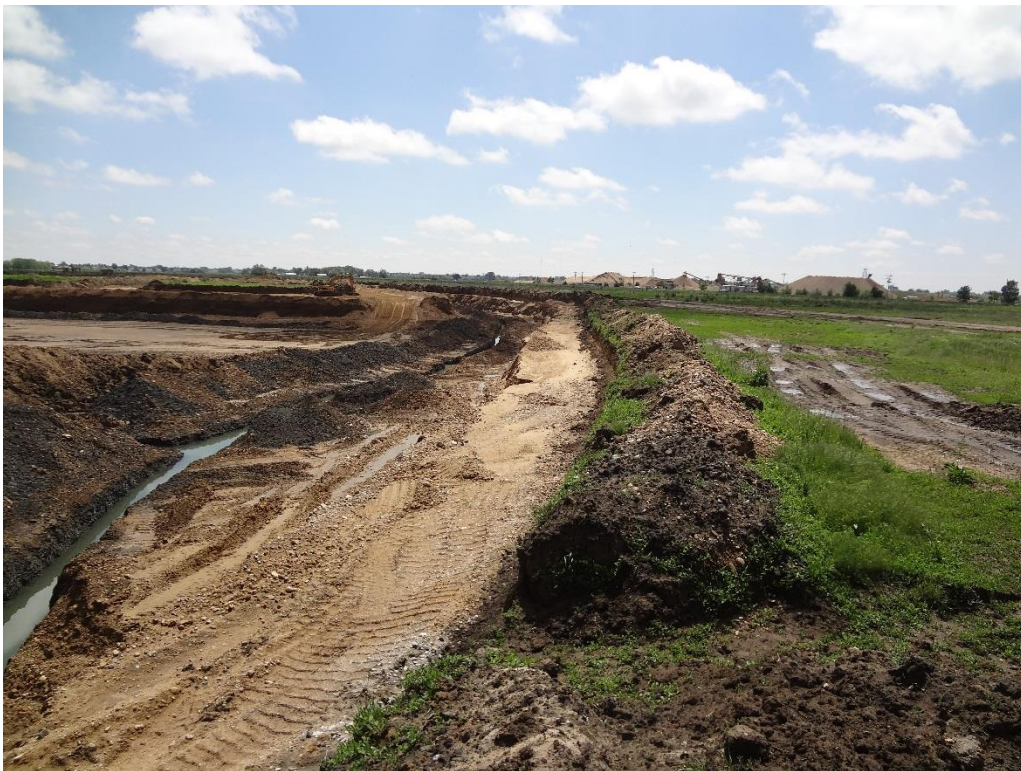
Looking east from SW corner of mining disturbance

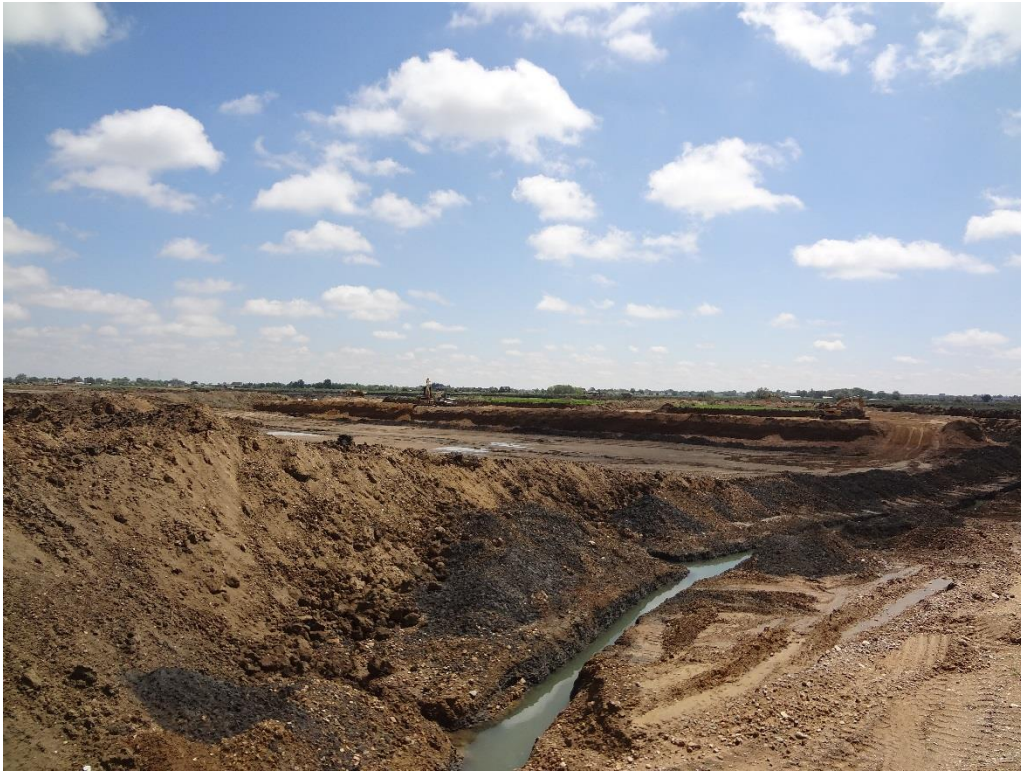
Looking NE from SW corner of mining disturbance

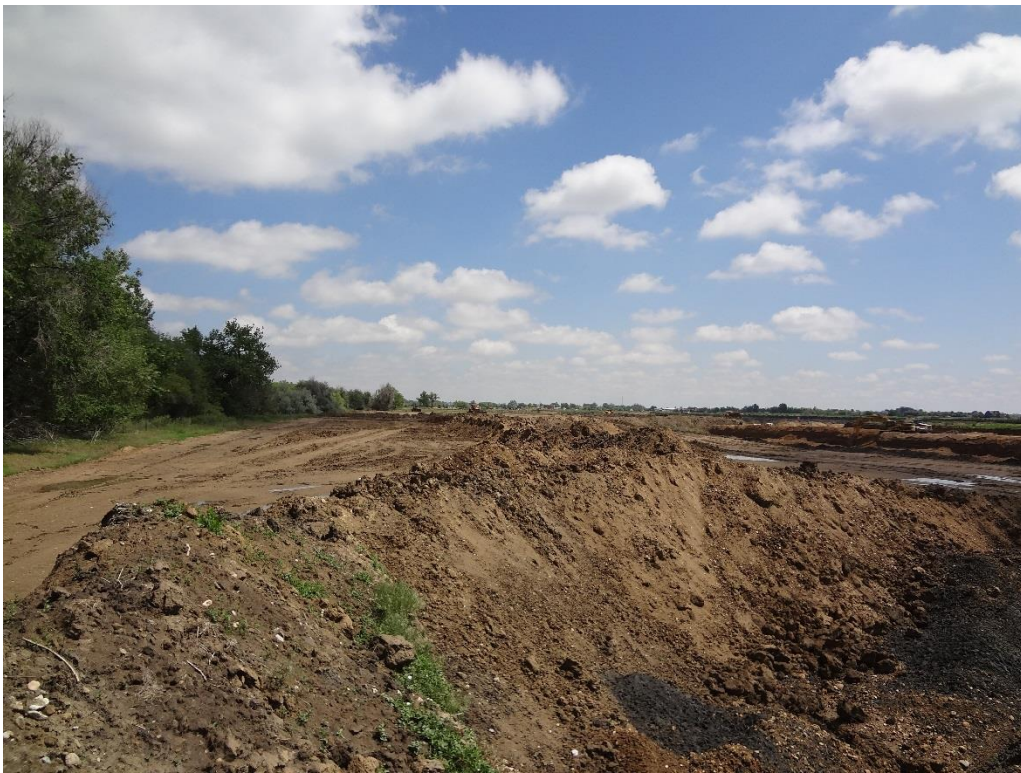
Looking north from SW corner of mining disturbance

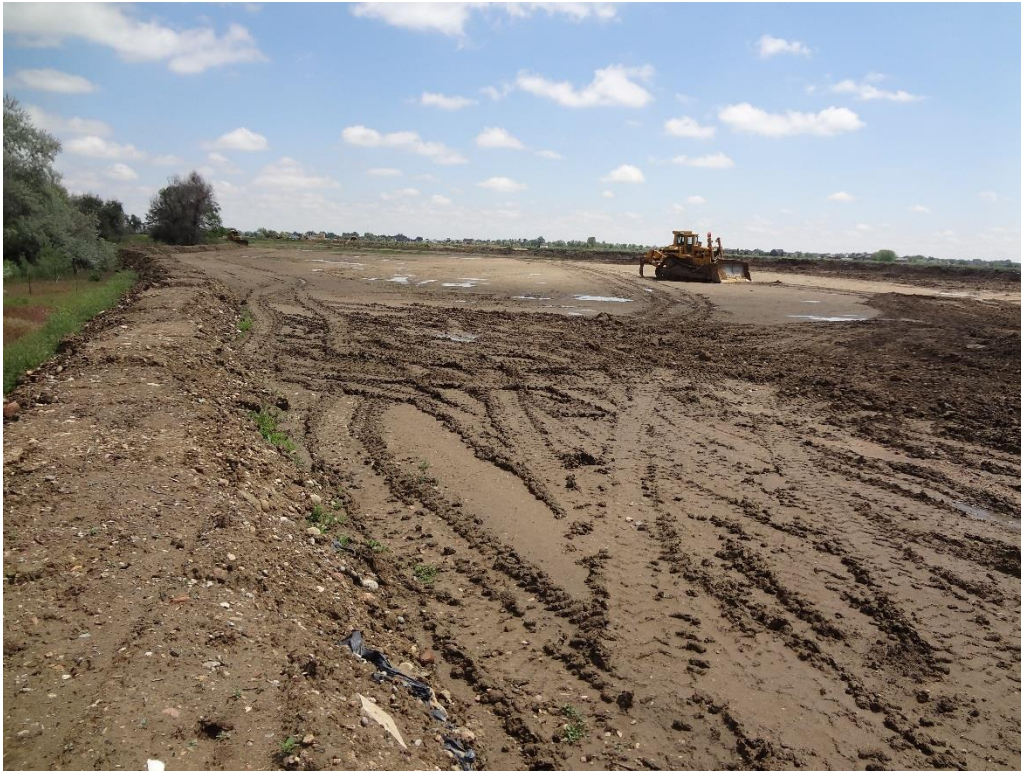
Looking north at backfill area along east side of site

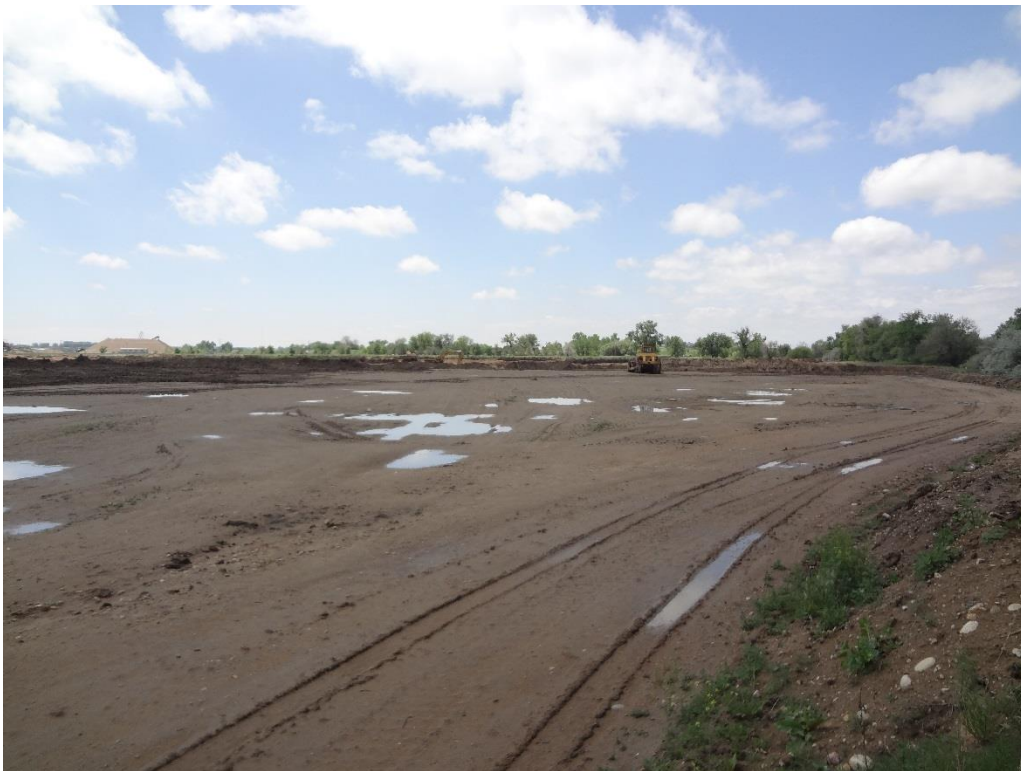
Looking south at backfill area along east side of site

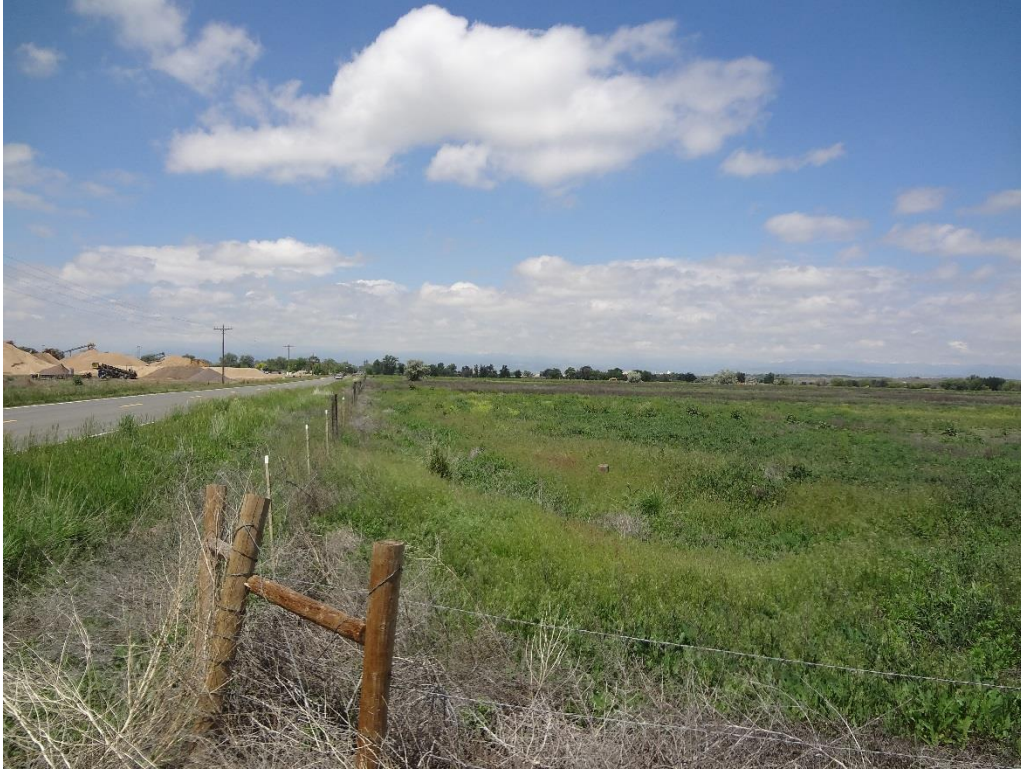
Looking west from east access road

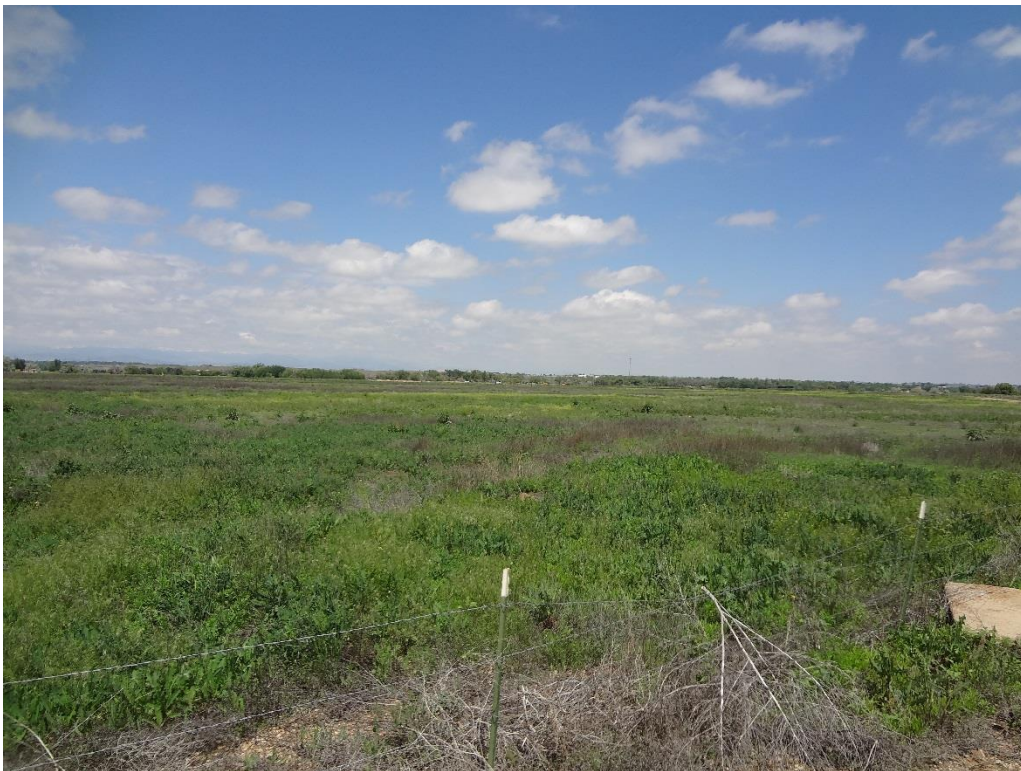
Looking NW from east access road
