MINERALS PROGRAM INSPECTION REPORT**PHONE: (303) 866-3567**

MINE NAME: Tucker Aggregate Pit	MINE/PROSPECTING ID#: M-1980-002	MINERAL: Sand and gravel	COUNTY: Weld
INSPECTION TYPE: Monitoring	INSPECTOR(S): Peter S. Hays	INSP. DATE: June 8, 2016	INSP. TIME: 09:30
OPERATOR: Connell Resources, Inc.	OPERATOR REPRESENTATIVE: Kevin Anderson	TYPE OF OPERATION: 112c - Construction Regular Operation

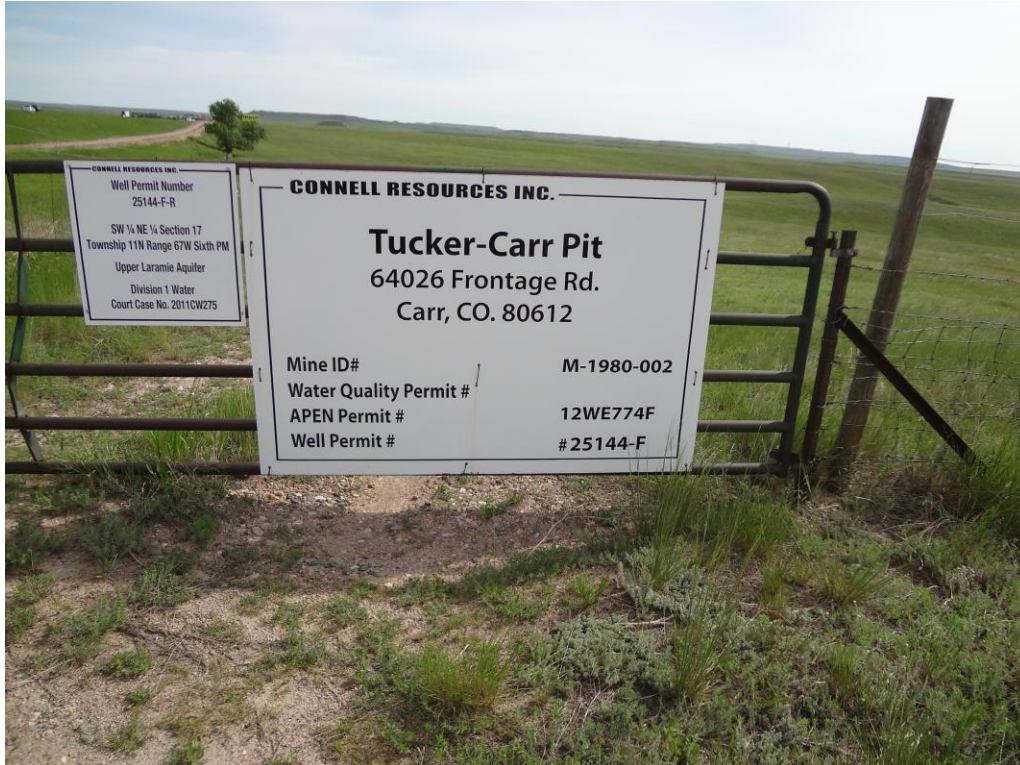
Tucker Aggregate Pit mine sign

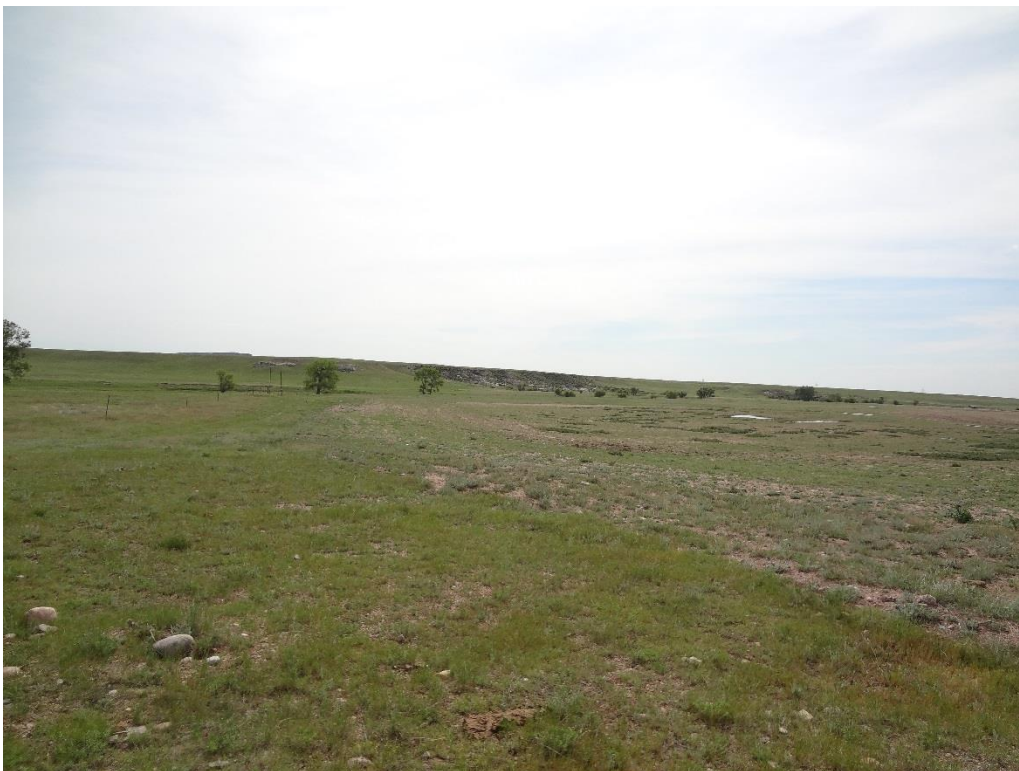
Looking east from NW corner of site

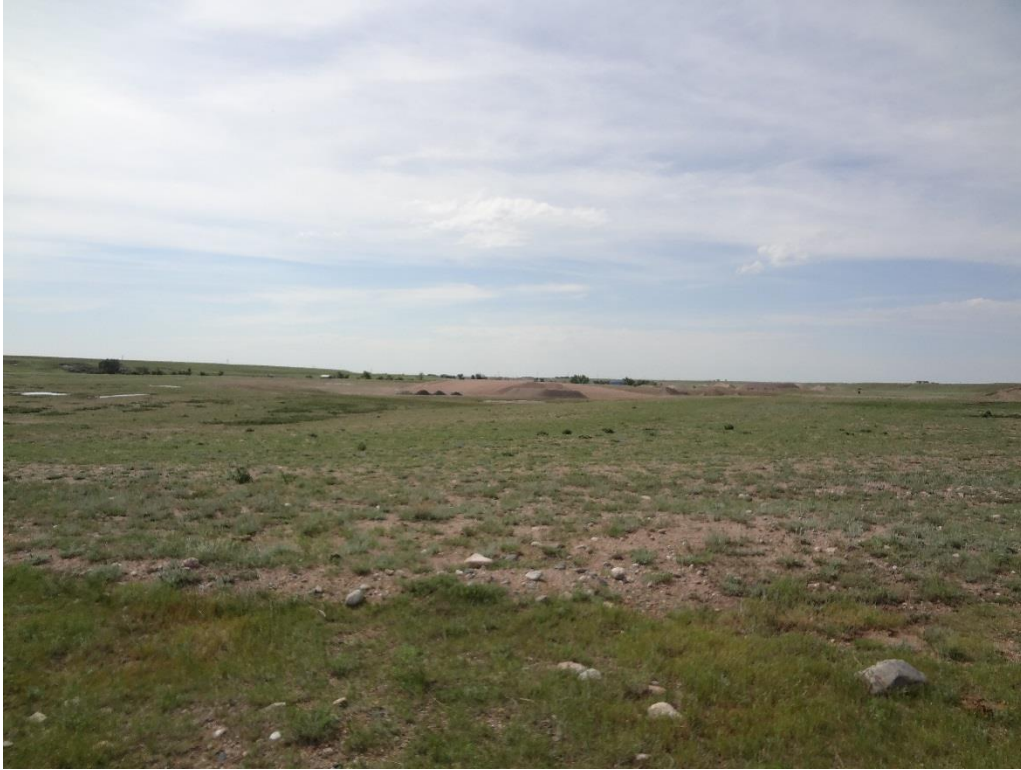
Looking SE from NW corner of site

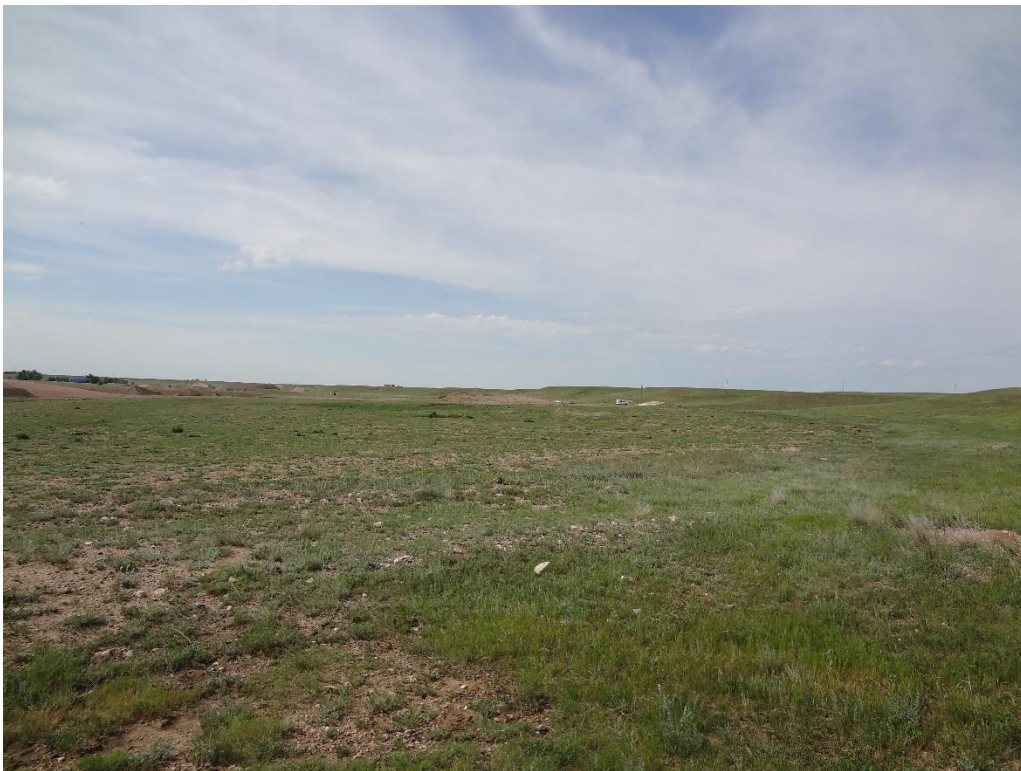
Looking south from NW corner of site

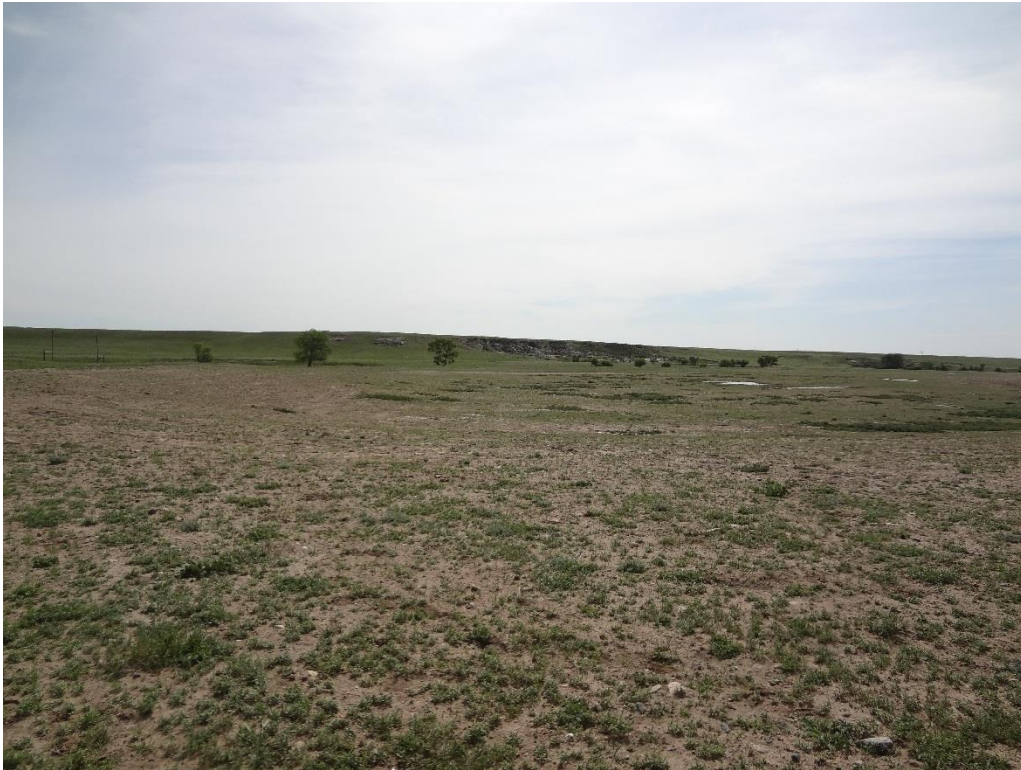
Looking SE at northern pit floor

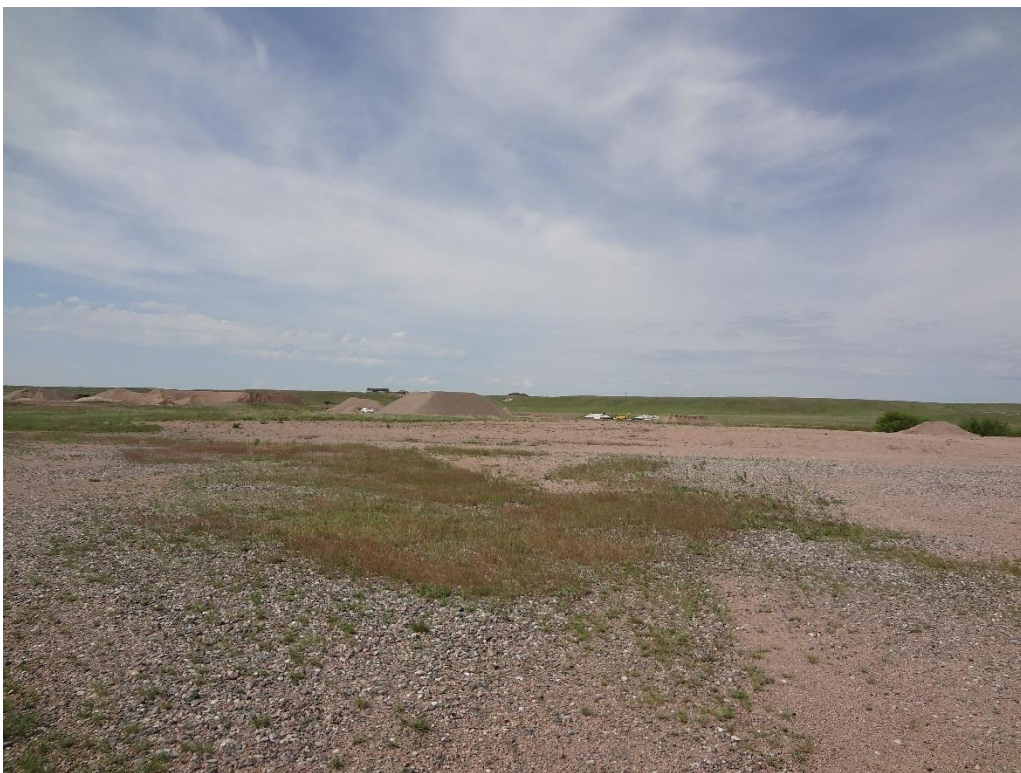
Looking south from middle of site at remaining stockpiles

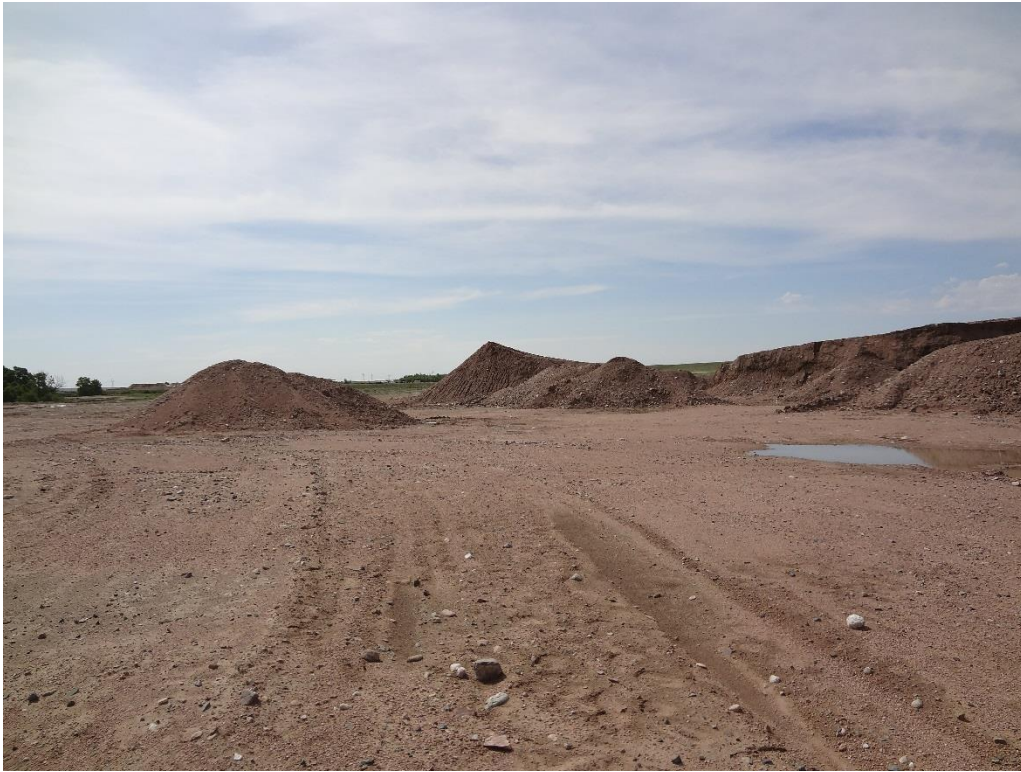
Pit run stockpiles in SW corner of the site

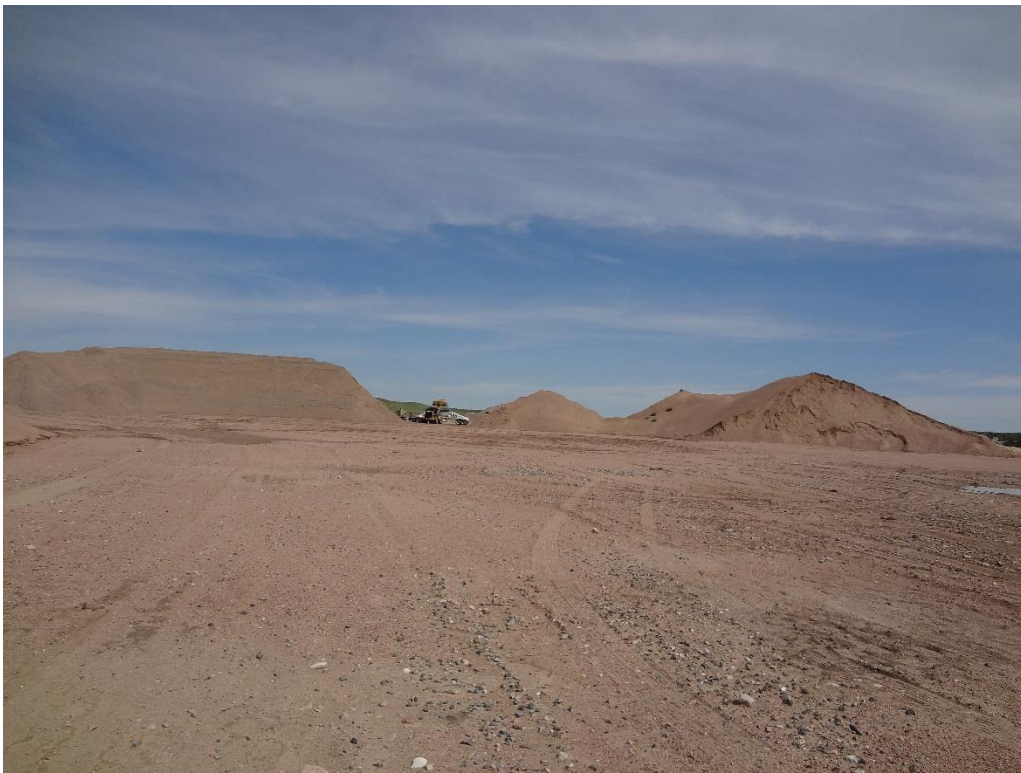
Looking north at stockpile area in southern portion of the site

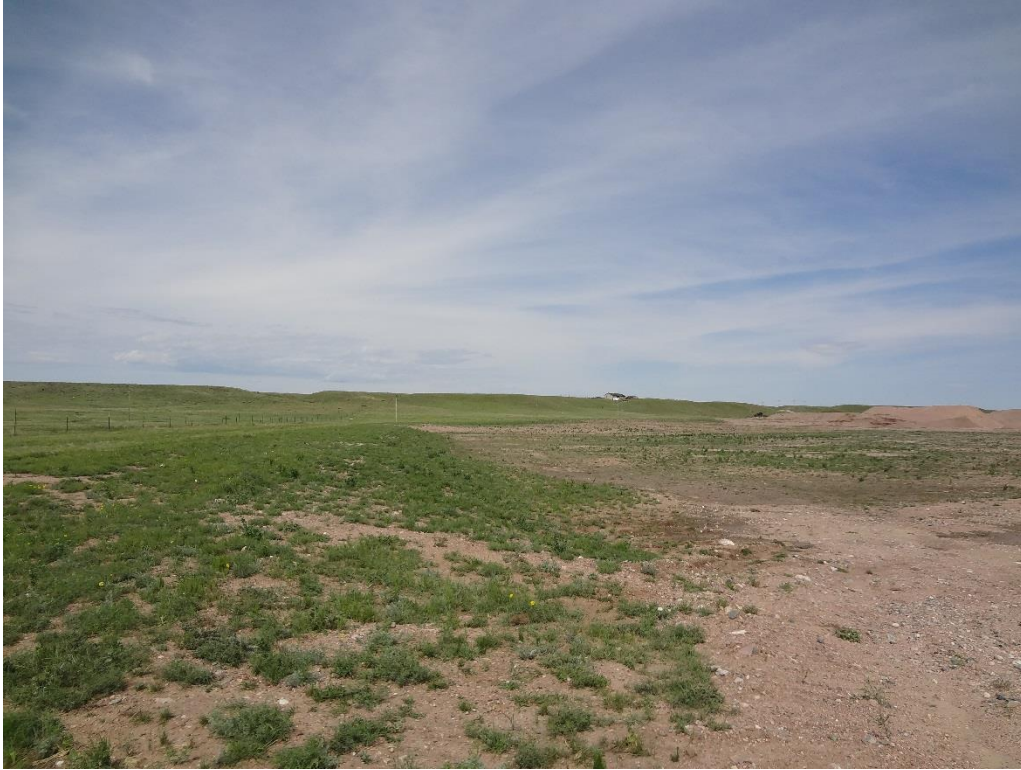
Looking west from SE corner of site

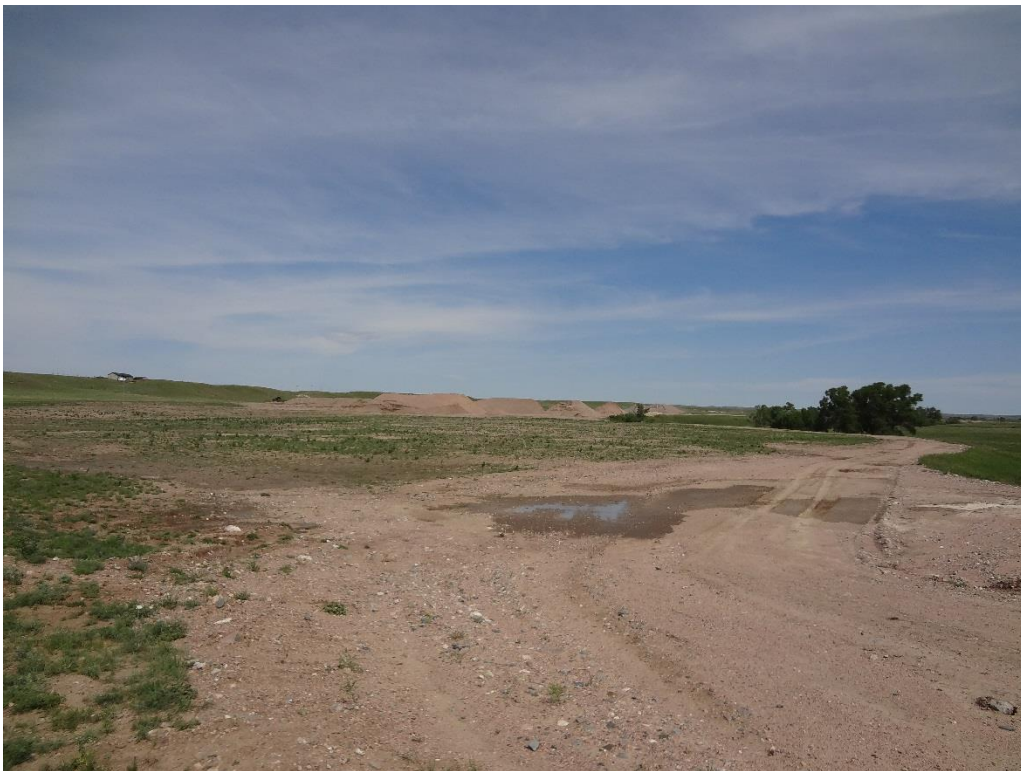
Looking NW from SE corner of site
