MINERALS PROGRAM INSPECTION REPORT
PHONE: (303) 866-3567

MINE NAME: Corkle Construction Pit #2	MINE/PROSPECTING ID#: M-2011-033	MINERAL: Reclamation only pe	COUNTY: Jackson
INSPECTION TYPE: Monitoring	INSPECTOR(S): Peter S. Hays	INSP. DATE: June 24, 2016	INSP. TIME: 11:30
OPERATOR: Harry Corkle Const	OPERATOR REPRESENTATIVE: Harry Corkle, Hughie Corkle	TYPE OF OPERATION: 110c - Construction Limited Impact

Harry Corkle Const
M-2011-033
SL-01 Inspection Map
June 24, 2016

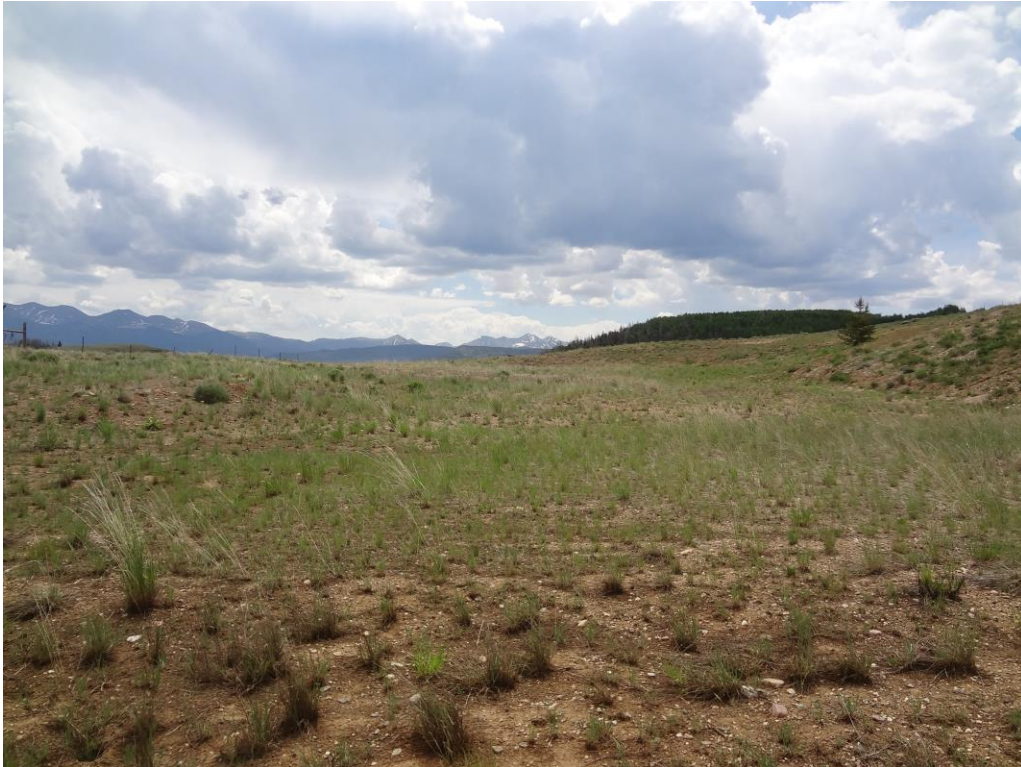
Looking south from NW corner of site

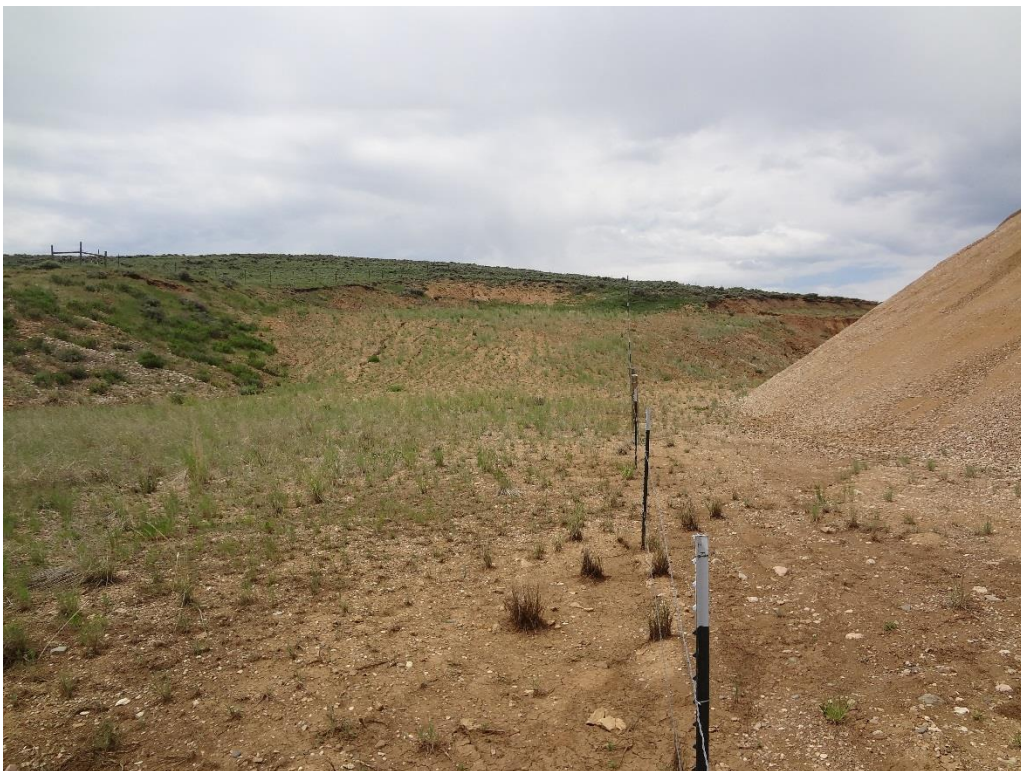
The final release request will be denied by the Division based on the presence of two (2) erosion areas, lack of well-established vegetation in portions of the site and presence of noxious weeds. The Canada thistle, a List B Colorado Noxious Weed, observed during the previous inspection were sprayed by the Operator. New patches of Canada thistle were observed at the site. The Operator stated the weeds would be sprayed and the site would be broadcast reseeded in the fall to promote additional native vegetation. The plant believed to be hoary cress during the inspection was identified as tansy yarrow following the inspection. Two areas of erosion gullies were observed in the southwest peninsula of the permit boundary. These area will require stabilization and vegetation prior to release of the site. Areas of sparse vegetation were observed throughout the site, except for in the northern corner of the site. The vegetative cover of the site needs to be increased prior to release of the site. An inspection map indicating the erosion areas, areas requiring reseeding and weed control and the well vegetated area is attached for reference.

Looking uphill at two erosion areas on the slopes

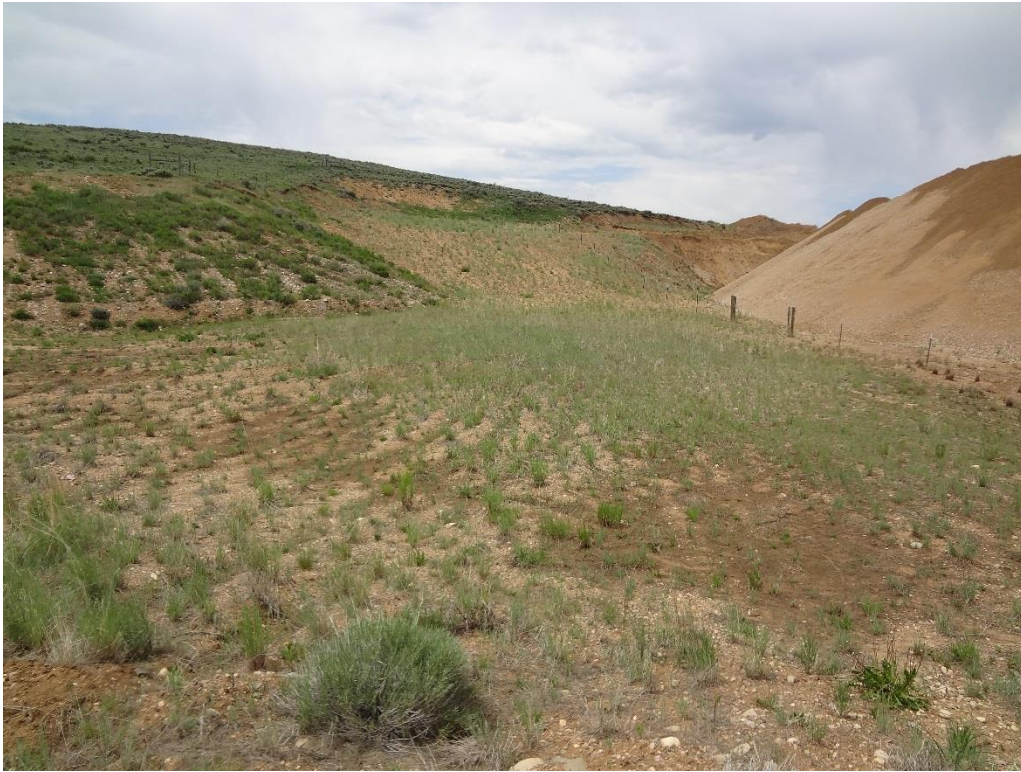
Looking west from east side of site

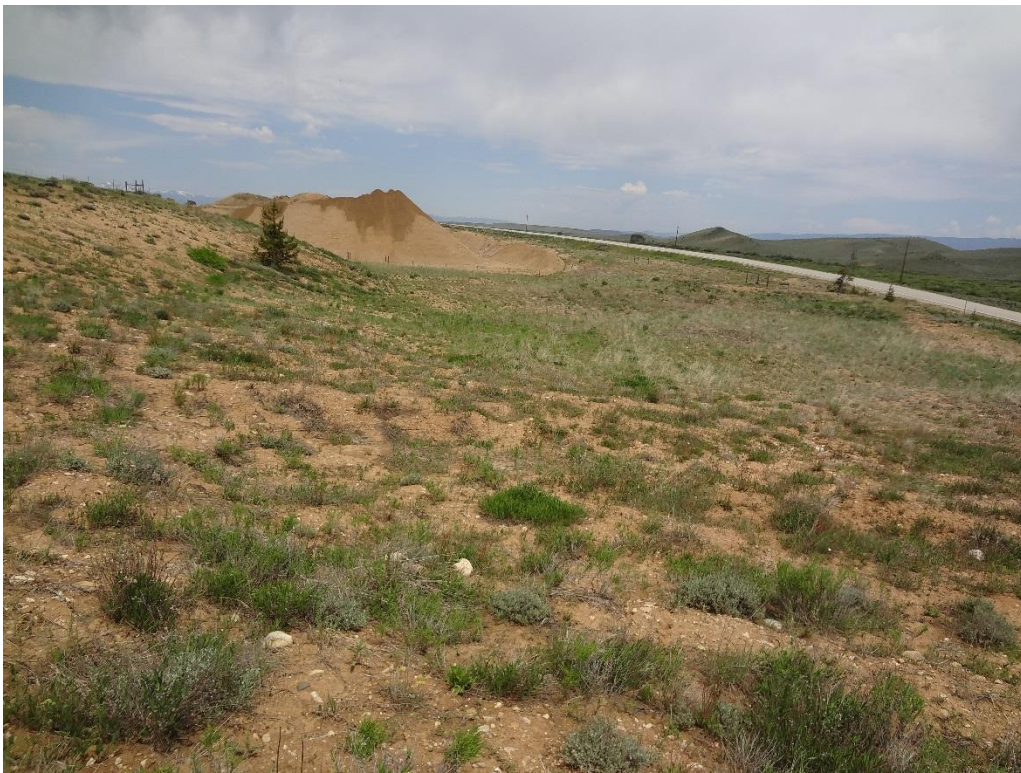
Looking NW from SE end of site

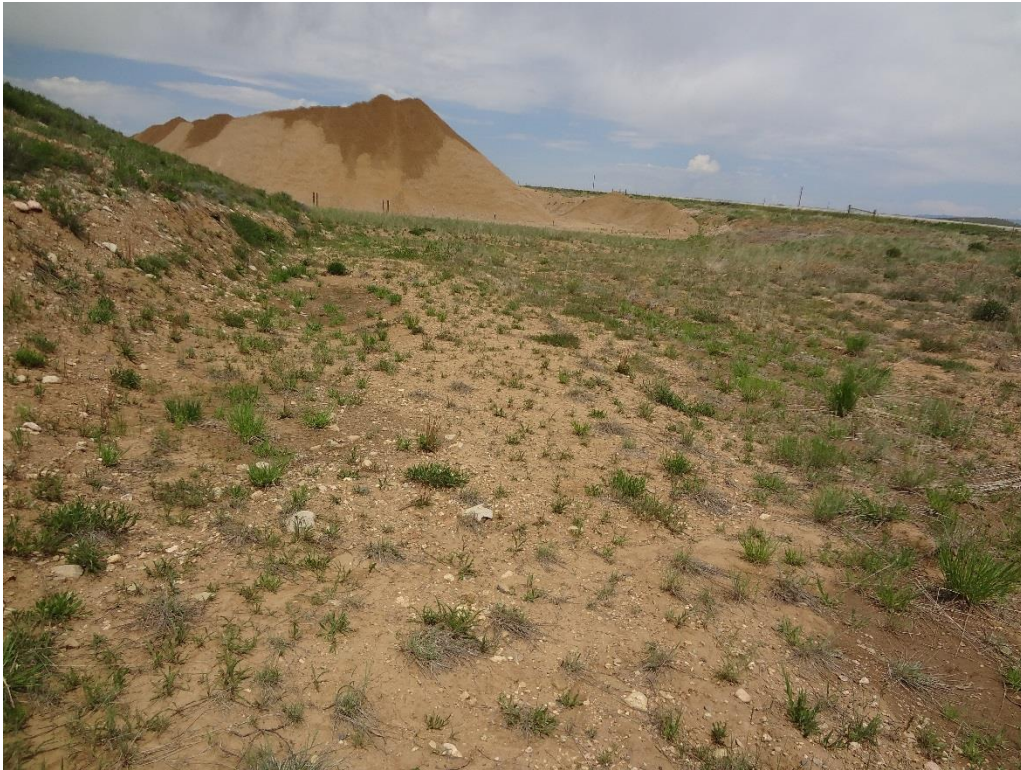
Looking NW along west boundary in south portion of site

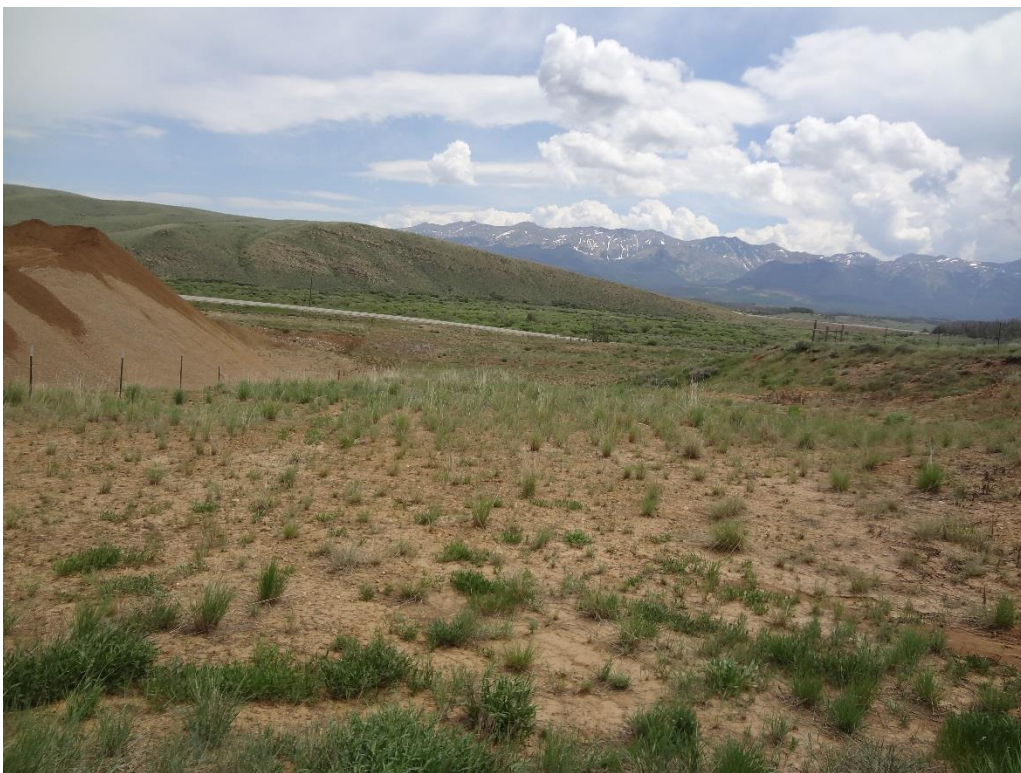
Looking east from the NW corner of site
