MINERALS PROGRAM INSPECTION REPORT

MINE NAME: Belvedere Stone Quarry	MINE/PROSPECTING ID#: M-1991-147	MINERAL: Limestone (general)	COUNTY: Douglas
INSPECTION TYPE: Monitoring	INSPECTOR(S): Tyler V. O'Donnell	INSP. DATE: June 17, 2016	INSP. TIME: 14:00
OPERATOR: Belvedere Stone, LLC	OPERATOR REPRESENTATIVE: William Johannsen	TYPE OF OPERATION: 110c - Construction Limited Impact

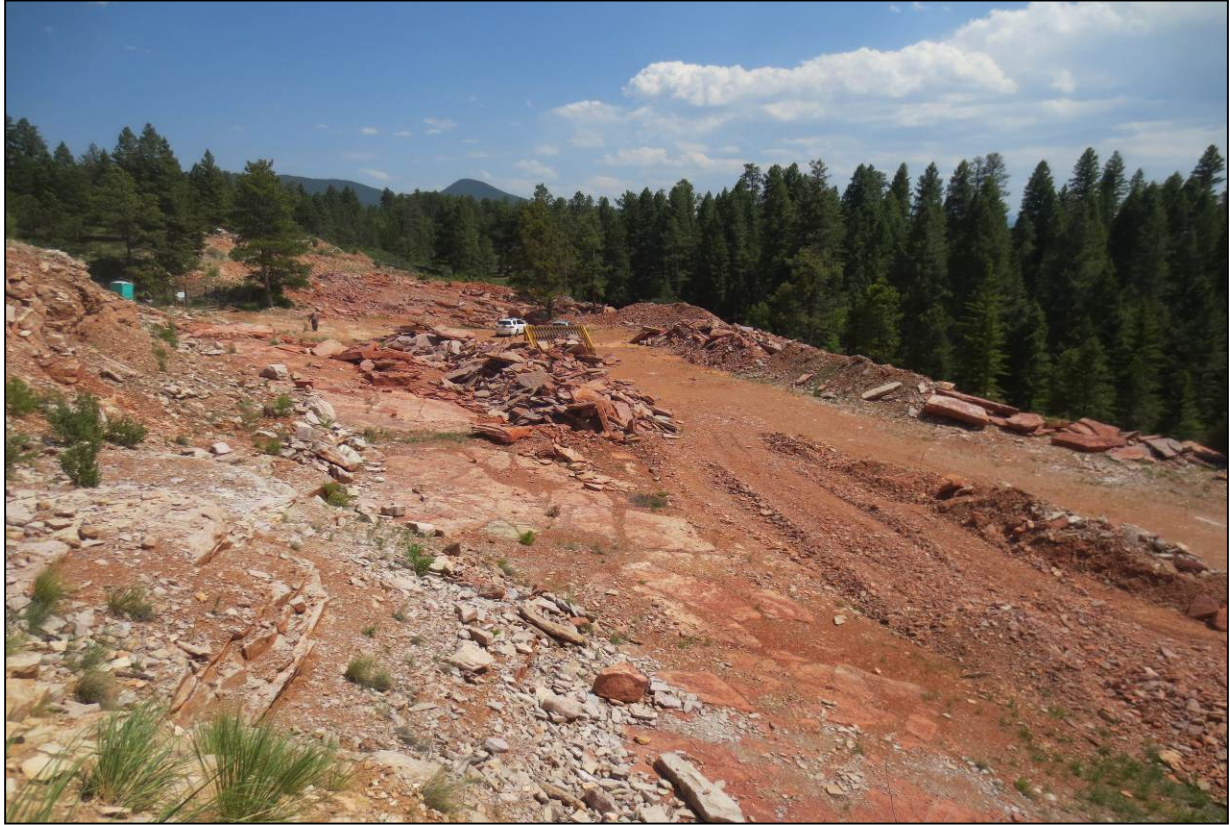
Photo 1: Stockpiling area. Portions of the highwall are visible along the lefthand side of the photo.

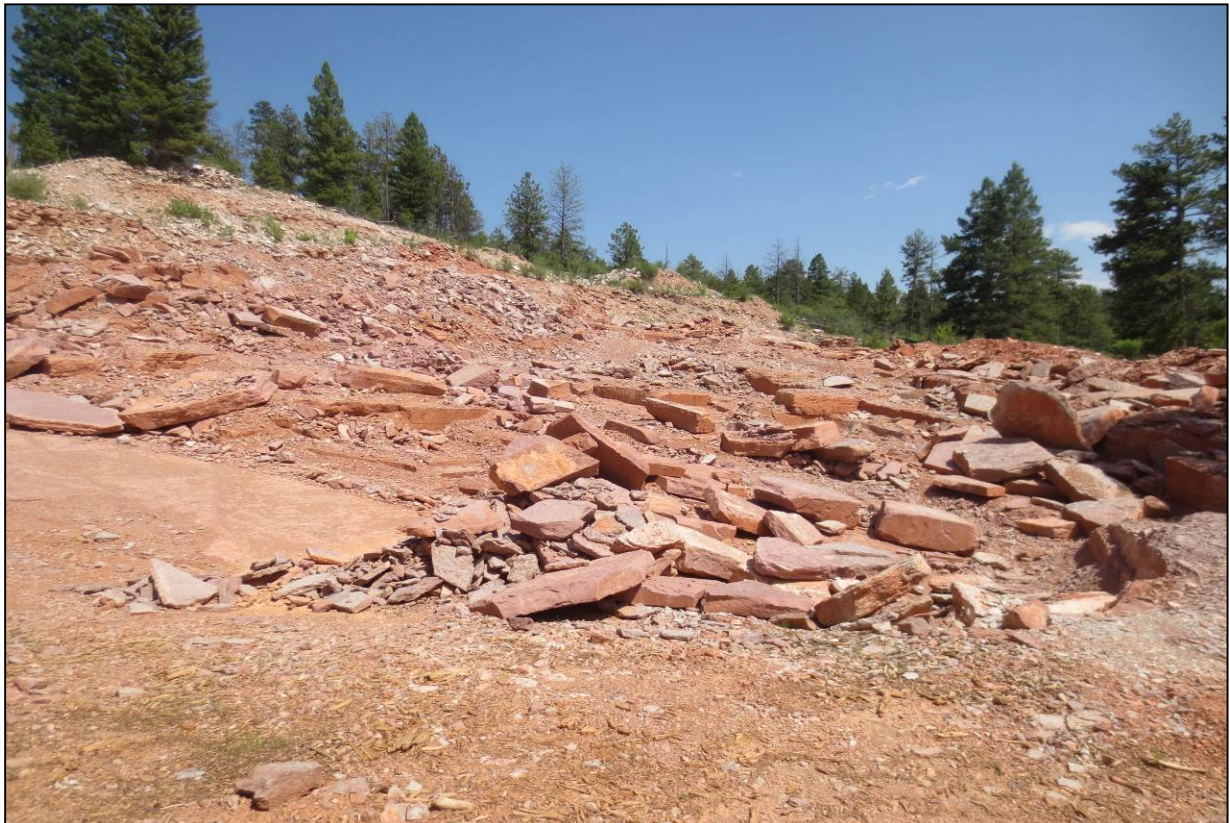
Photo 2: Recent mining area in the southeast corner. The operator is beginning to form a shallow pit on the mined bench.

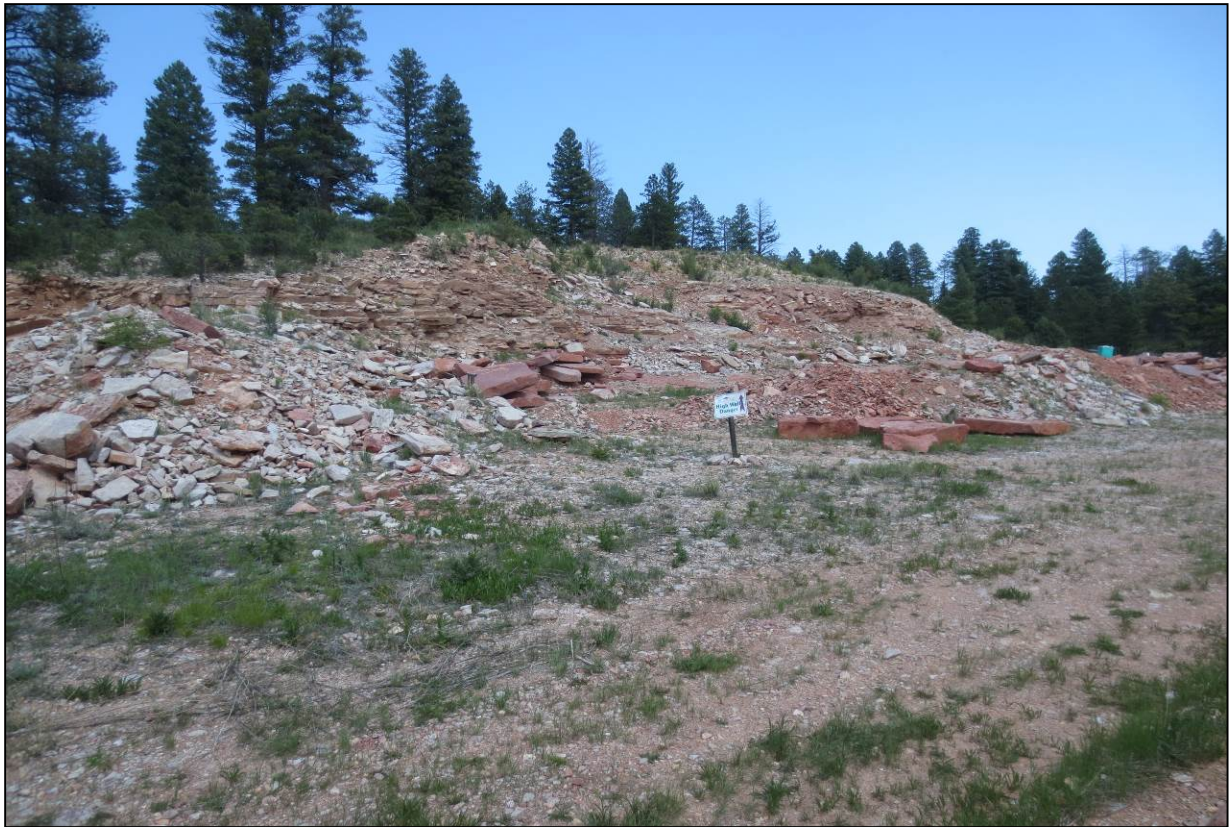
There was a highwall around the entire northern perimeter of the affected land boundary. The highwall varied in height, there were sections of highwall 5 to 20 feet high. The average height of the highwall was approximately 10 feet high. The highwall was approximately 750 feet long. A lot of waste rock had been cast off the active working face into the drainage to the southwest (photos 4). The slope of the cast off rock was near 2H:1V. The waste rock cast off the bench was as high as approximately 40 feet in some areas. All slopes appeared to be structurally stable.

Photo 3: Highwall along the northern portion of the disturbed lands.

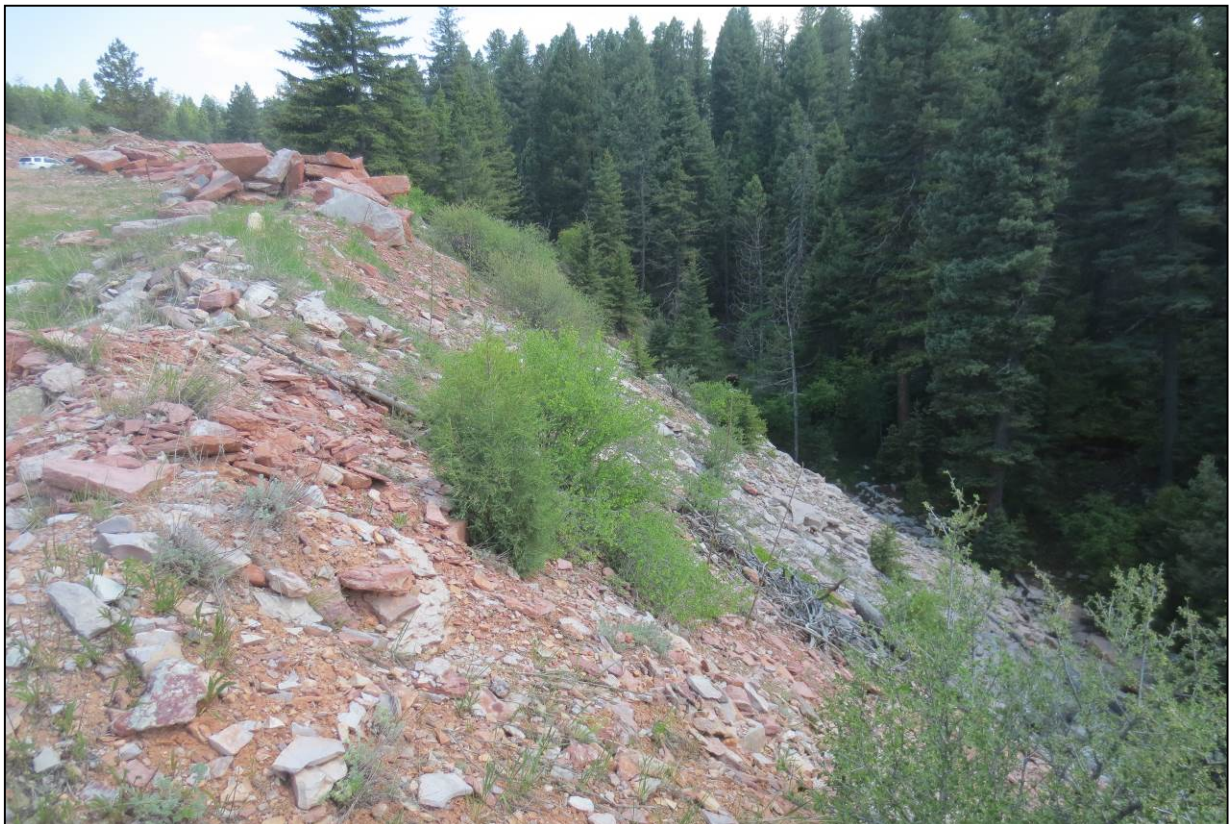
Photo 4: Wasterock cast from the quarry to the drainage to the south.

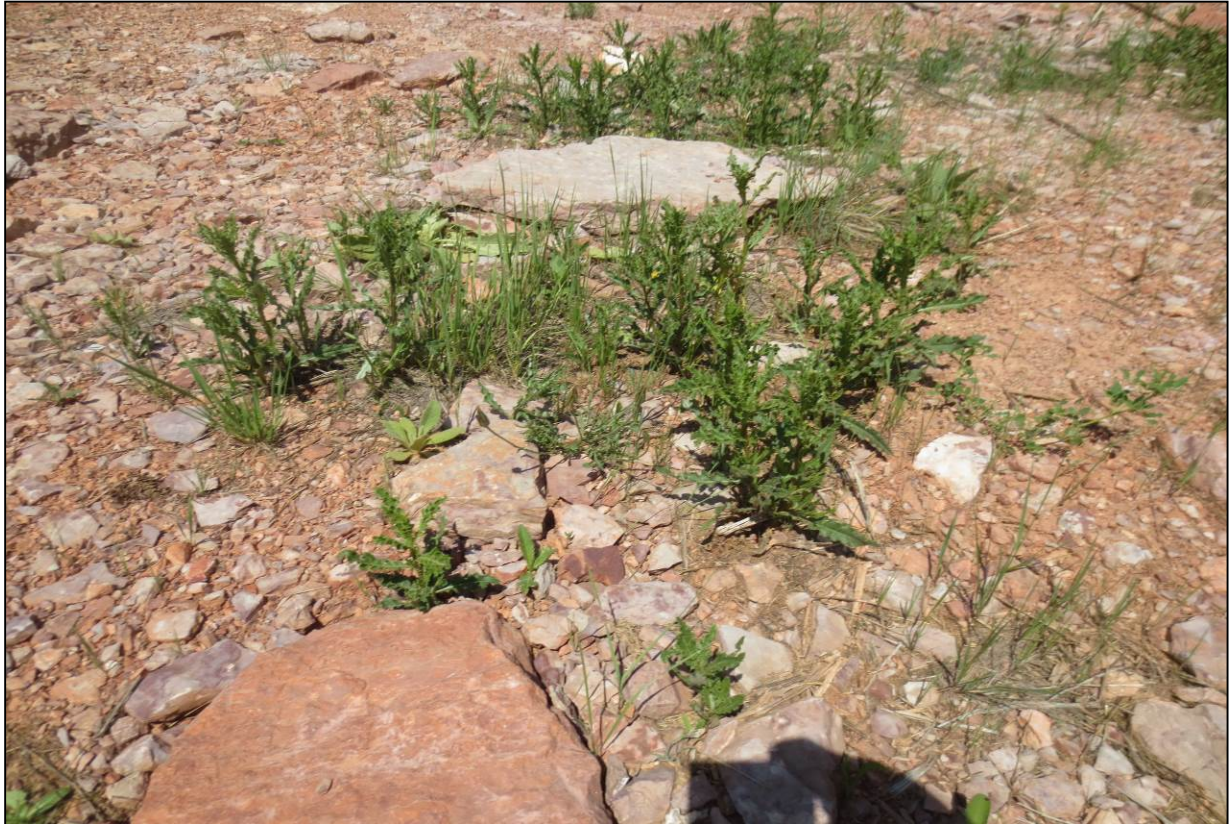
PROBLEM: Musk thistle and common mullein are present within or have volunteered into the permit area and are becoming established. This is a problem for failure to employ weed control methods for a state listed noxious weeds species within the permitted area, and to reduce the spread of weeds to nearby areas as required by Section 3.1.10 (6) of the Rule.

Musk thistle and common mullein are present within the affected lands. The musk thistle and mullein have begun to establish, given a few growing seasons, the site could become completely infested with noxious weeds. This is a problem for failure to implement weed control methods for a state listed noxious weed species within the permitted area, and to reduce the spread of weeds to nearby areas as required by Section 3.1.10 (6) of the rule.

Photo 5: Mush thistle and common mullien on top of the active mining bench.

CORRECTIVE ACTIONS: The Operator shall either implement a weed control plan, provide photographic evidence demonstrating that the noxious weeds have been eradicated, OR develop a weed control and management plan in accordance with Rule 3.1.10 (6). This plan should be developed in consultation with the county extension agency, or weed control district office and should include specific control measures to be applied, a schedule for when control measures will be applied and a post-treatment monitoring plan. This weed control plan shall be submitted to the Division as a Technical Revision to the approved plan with the appropriate Technical Revision fee of \$216.00 by the corrective action date.
