MINERALS PROGRAM INSPECTION REPORT

MINE NAME: Corkle Pit	MINE/PROSPECTING ID#: M-1995-023	MINERAL: Sand and gravel	COUNTY: Jackson
INSPECTION TYPE: Monitoring	INSPECTOR(S): Peter S. Hays	INSP. DATE: June 24, 2016	INSP. TIME: 12:00
OPERATOR: Corkle Construction	OPERATOR REPRESENTATIVE: Harry Corkle	TYPE OF OPERATION: 110c - Construction Limited Impact

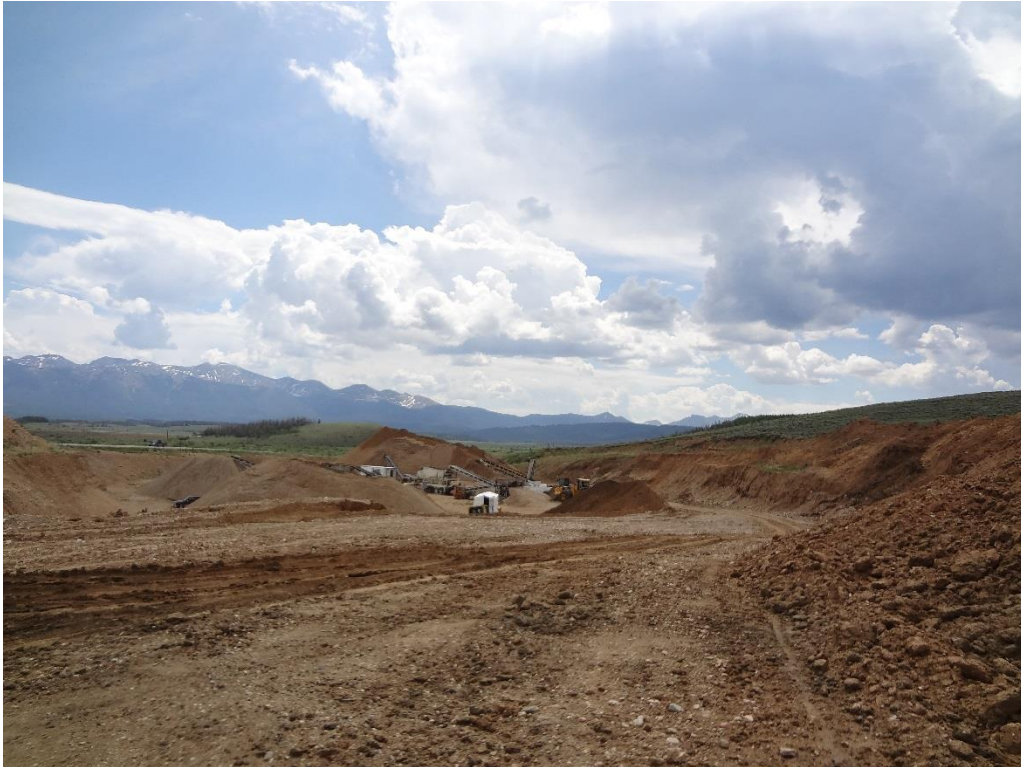
Looking SE at pit floor and processing plant

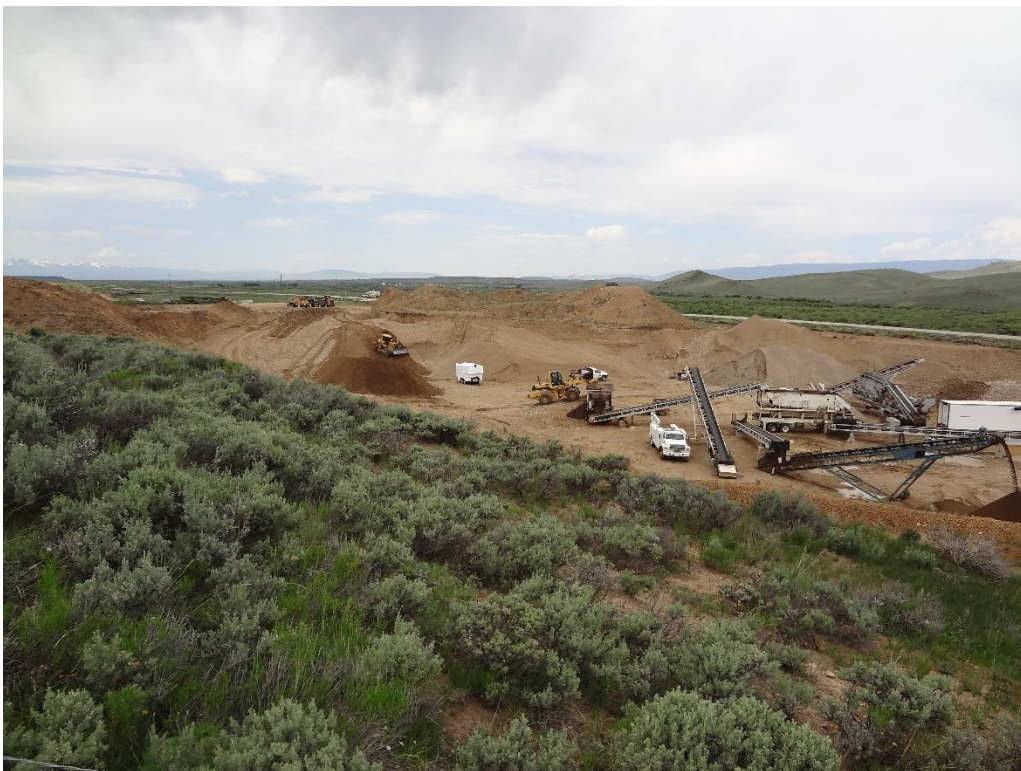
Looking NW at mining activity

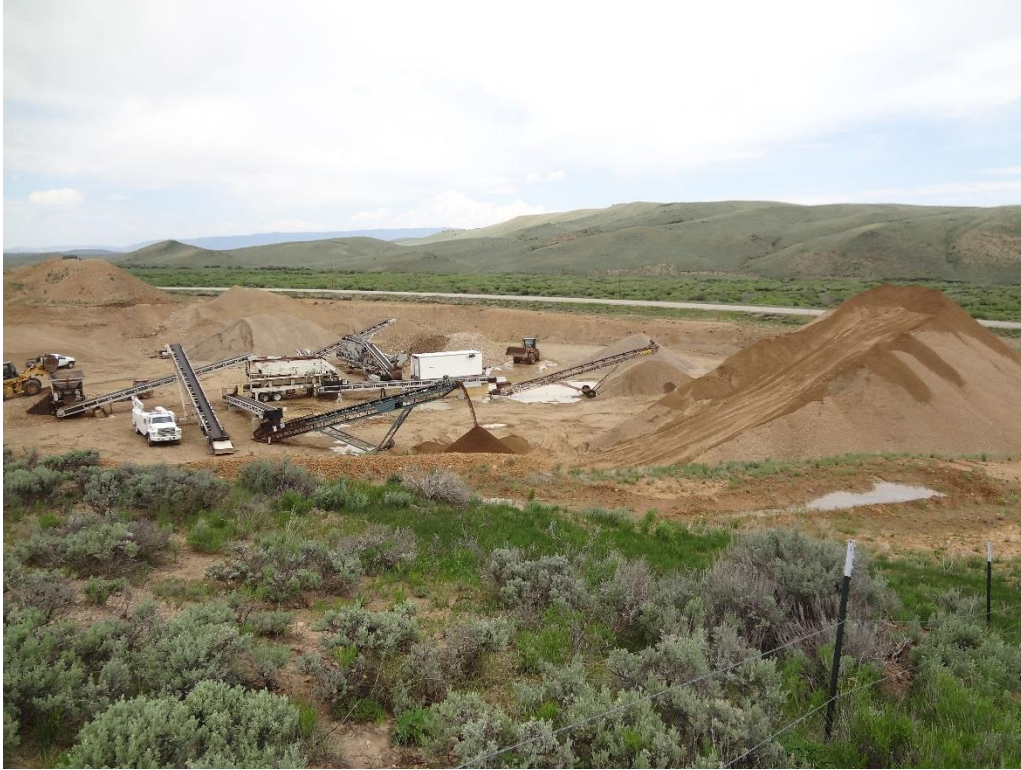
Looking processing plant and stockpiles on pit floor
