**COLORADO**Division of Reclamation,  
Mining and Safety

**MINERALS PROGRAM INSPECTION REPORT****PHONE: (303) 866-3567**

<b>MINE NAME:</b> Buffalo Hunter Load	<b>MINE/PROSPECTING ID#:</b> M-2016-015	<b>MINERAL:</b> Sand and gravel	<b>COUNTY:</b> Custer
<b>INSPECTION TYPE:</b> Preoperation Inspection	<b>INSPECTOR(S):</b> Tyler V. O'Donnell	<b>INSP. DATE:</b> March 15, 2016	<b>INSP. TIME:</b> 07:30
<b>OPERATOR:</b> Lucky VI Quarry	<b>OPERATOR REPRESENTATIVE:</b> Ed Lyons	<b>TYPE OF OPERATION:</b> 110c - Construction Limited Impact

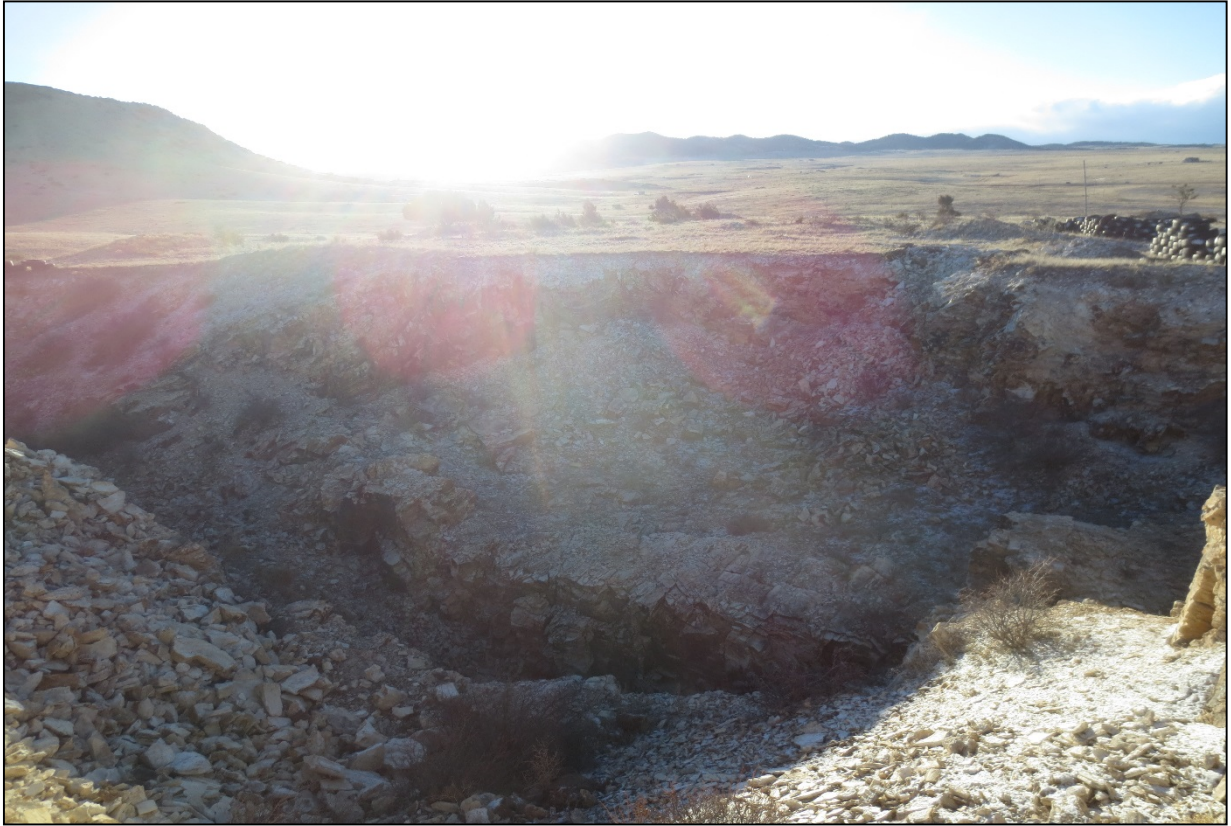
**Photo 1:** Slot where quarrying will beginning. The slot is as deep as 30 feet in a few areas.

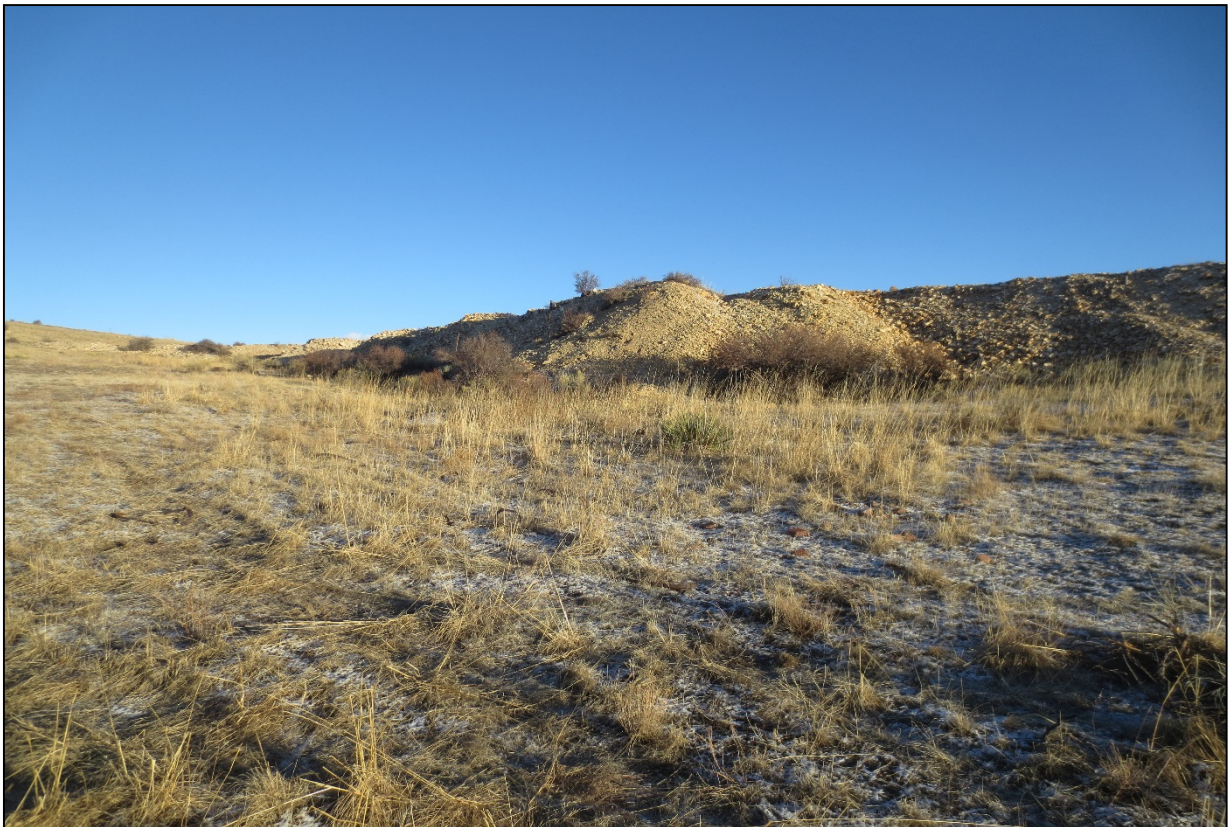
The proposed Buffalo Hunter Load pit sits on top of a historic hard rock mining disturbance. There were several stockpiles of material from the historic hard rock mining, most likely development rock/ waste rock from an attempted adit on site. No hard rock tailings were observed on the proposed site. It appears that the adit has collapsed, thus creating a narrow slot where the current quarrying will begin. No shafts or adits were observed on site. The proposed affected land boundary was marked during the inspection. The affected land boundary consisted of a lot of monuments placed by the BLM to delineate public land and the patented mining claims. The current vegetation on the proposed mine site consisted of: grasses, forbs, shrubs, and annual weeds. The soil consists of large rocks and cobble up to the land surface. The growth medium (topsoil) was very rocky.

**Photo 2:** Stockpile of development rock/ waste rock from the old adit.

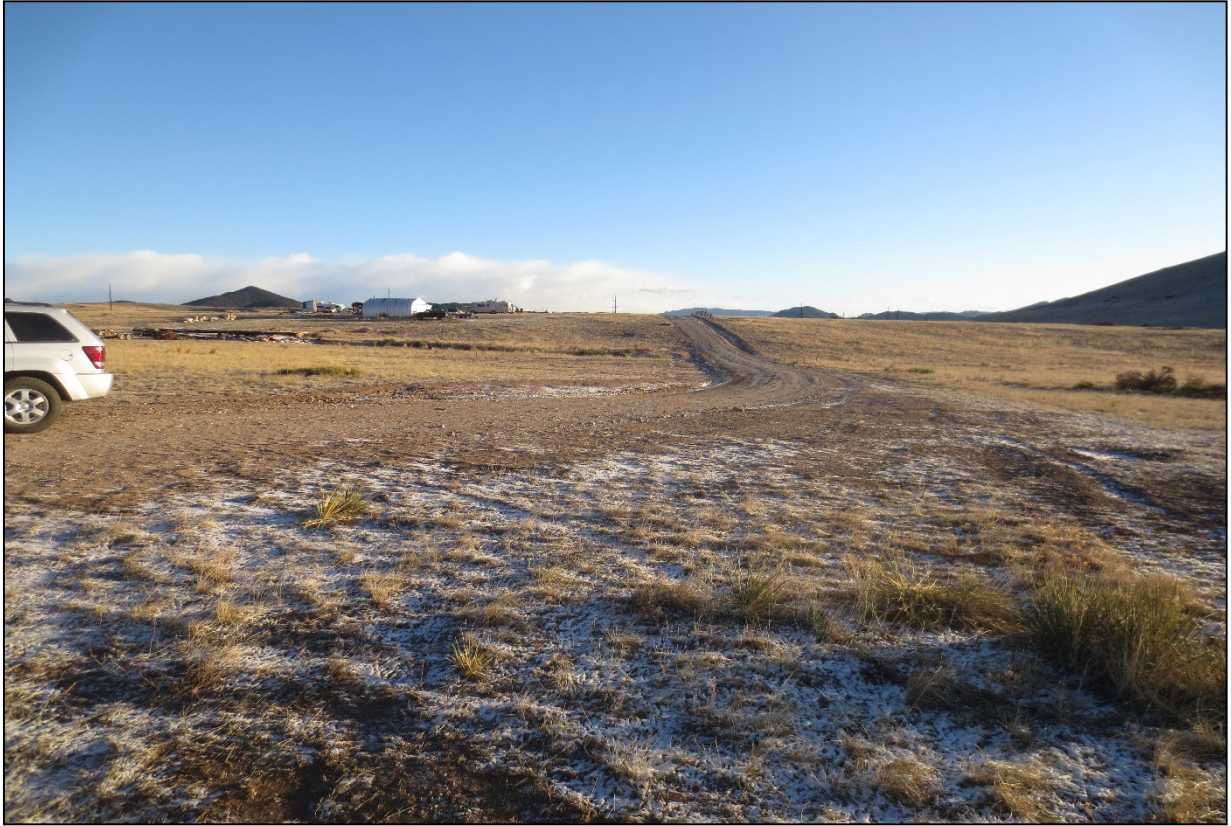
**Photo 3:** Access road to the proposed quarry.

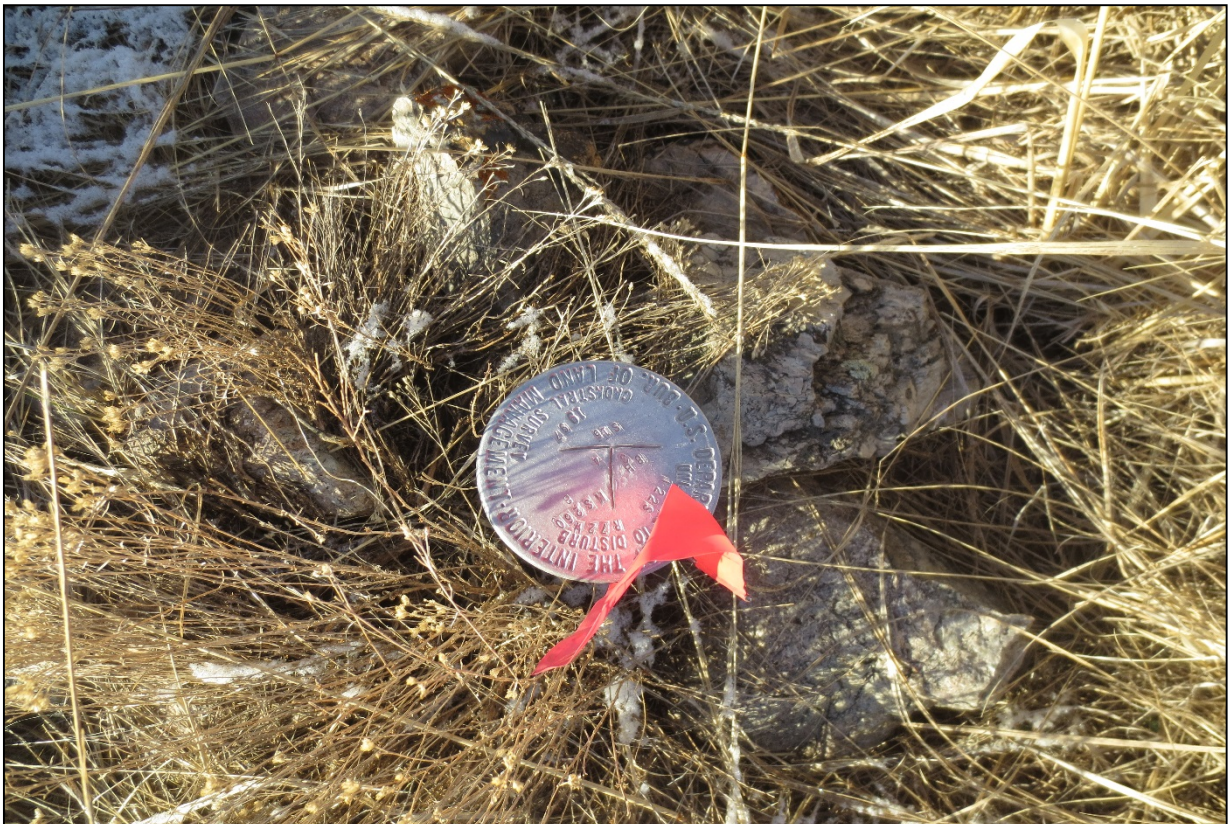
**Photo 4:** BLM monument, which is being used as a affected land boundary marker.
