**MINERALS PROGRAM INSPECTION REPORT****PHONE: (303) 866-3567**

<b>MINE NAME:</b> Hardship Lode Quarry	<b>MINE/PROSPECTING ID#:</b> M-1987-027	<b>MINERAL:</b> Stone	<b>COUNTY:</b> Custer
<b>INSPECTION TYPE:</b> Monitoring	<b>INSPECTOR(S):</b> Tyler V. O'Donnell	<b>INSP. DATE:</b> March 15, 2016	<b>INSP. TIME:</b> 09:00
<b>OPERATOR:</b> Colorado Quarries Inc	<b>OPERATOR REPRESENTATIVE:</b> Aaron Tezak	<b>TYPE OF OPERATION:</b> 112c - Construction Regular Operation

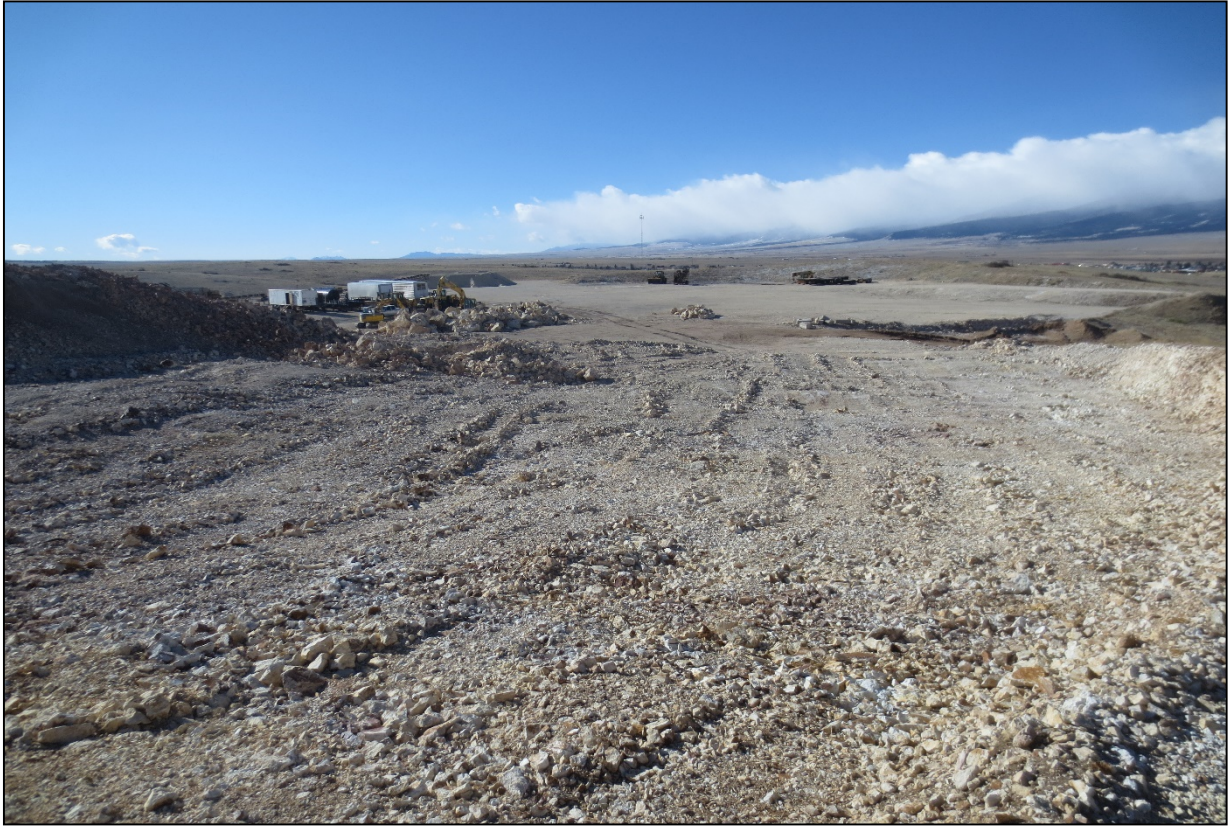
**Photo 1:** Area recently mined, the majority of this area has been sloped at 3H:1V or flatter.

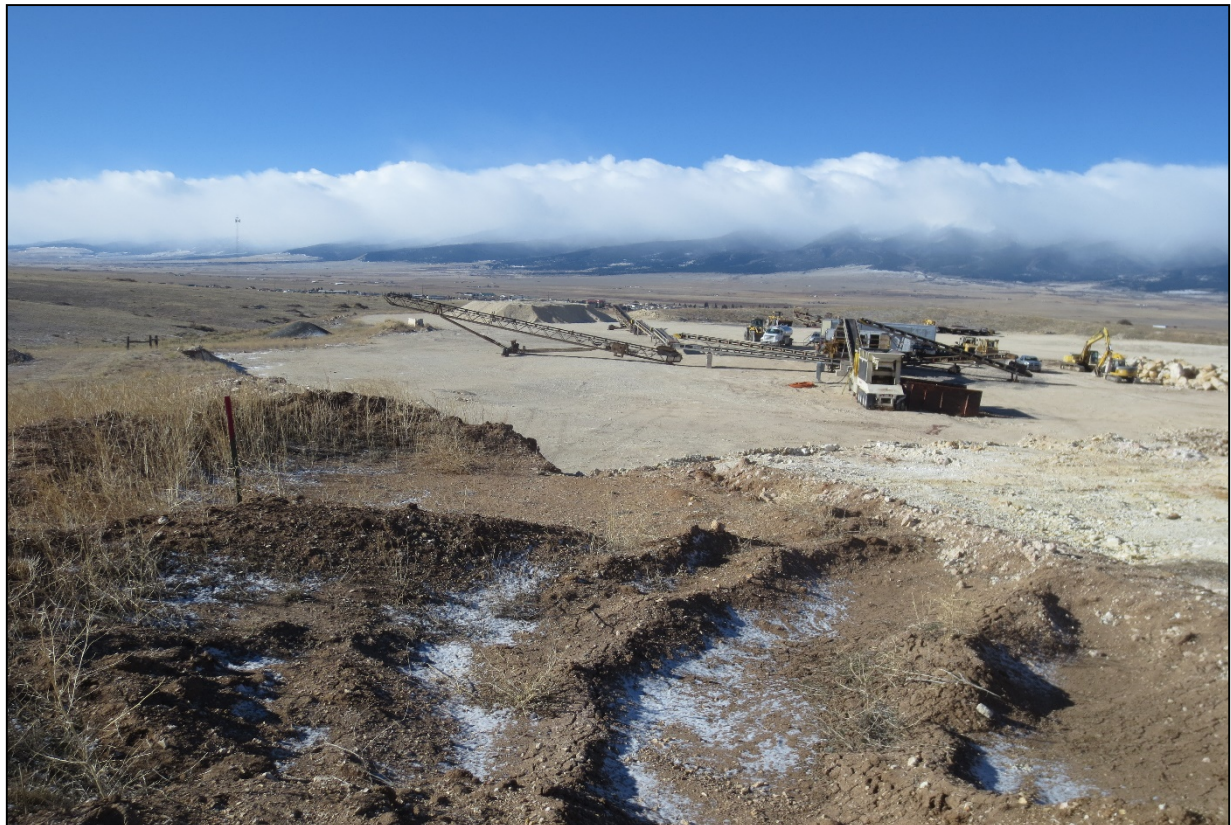
**Photo 2:** Active crushing and screening operation.

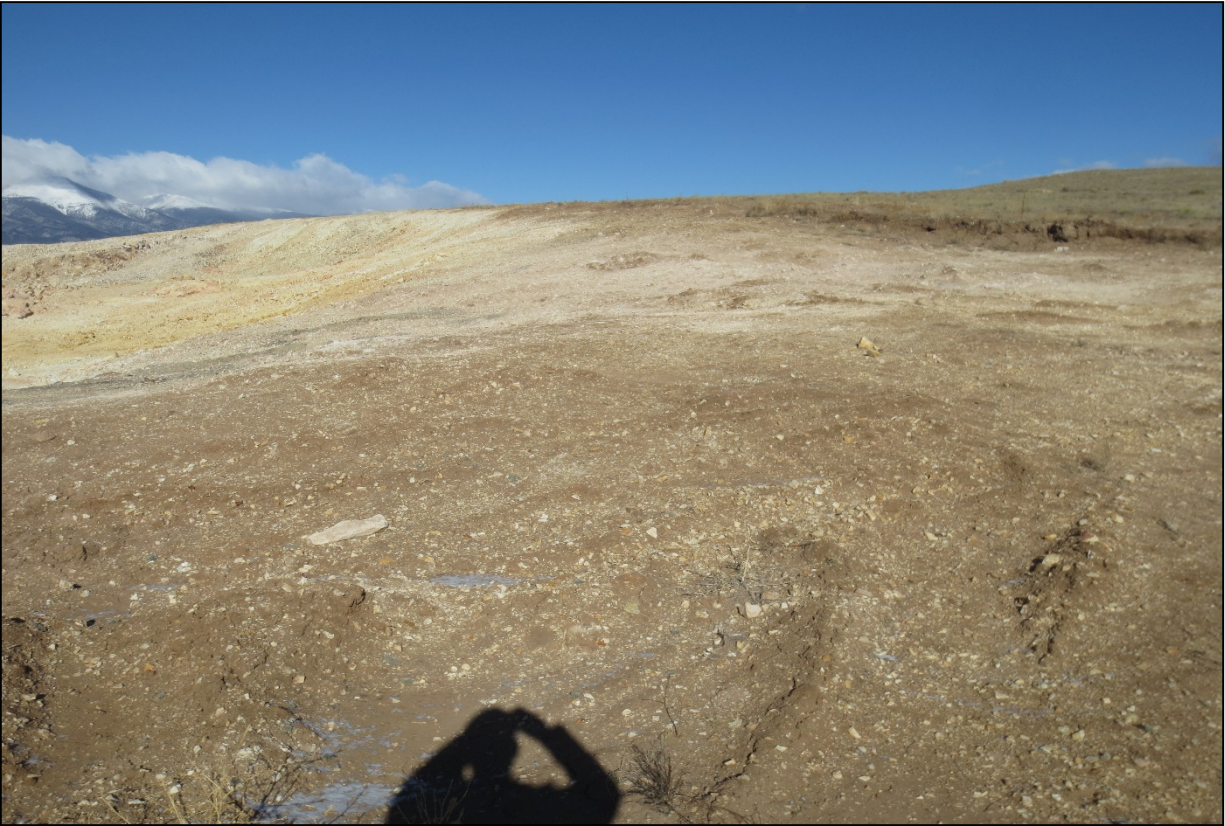
The Operator has been stripping topsoil in advance of mining (photo 3). There were a few topsoil stockpiles along the perimeter of the current affected lands. The main topsoil stockpile is located east of the current mining related disturbance. The topsoil stockpiles have begun to fill in with volunteer vegetation. Vegetative cover on the topsoil stockpiles is composed of annual weeds and native vegetation, mostly grasses. The Operator is encouraged to establish vegetative cover on all topsoil stockpiles that remain longer than a growing season. The vegetative cover on the topsoil stockpiles will help prevent erosion.

**Photo 3:** Area where topsoil has been stripped in advance of mining.

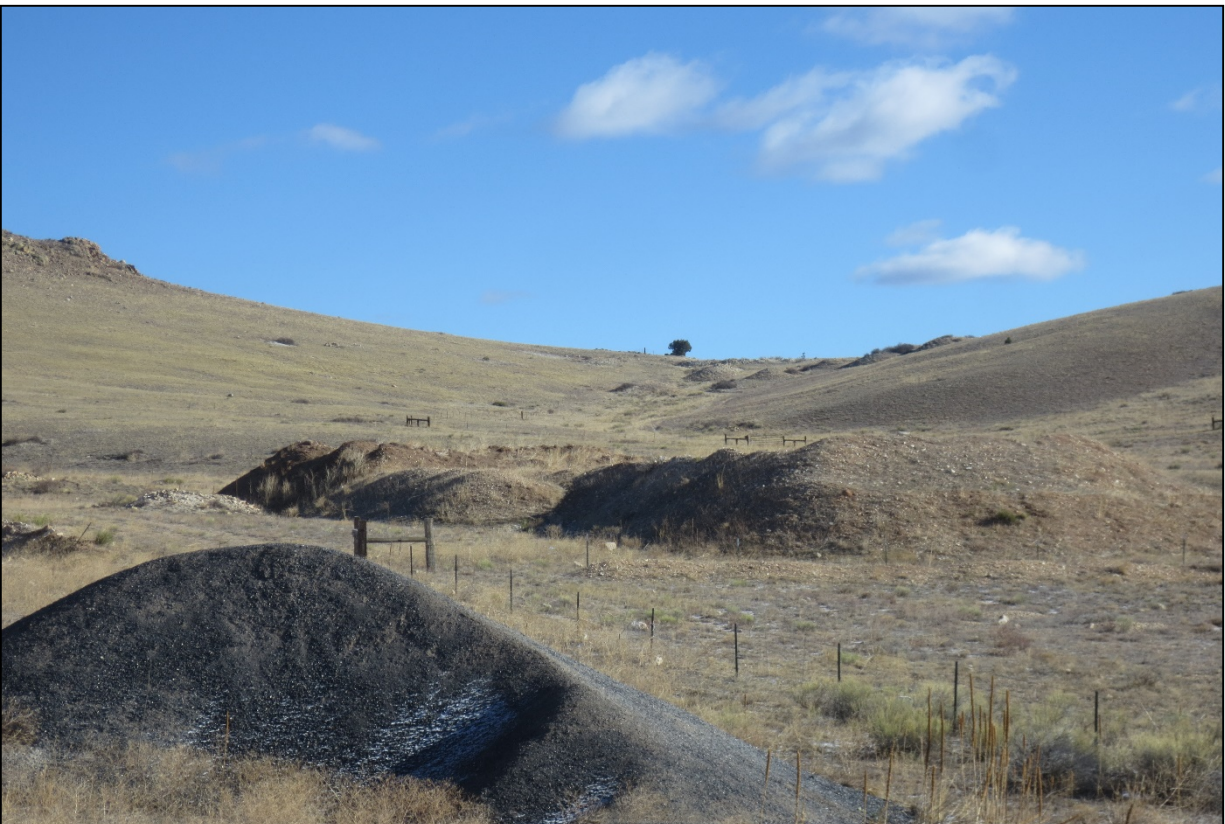
**Photo 4:** Topsoil stockpile area.
