MINERALS PROGRAM INSPECTION REPORT

MINE NAME: Black Obsidian	MINE/PROSPECTING ID#: M-1987-026	MINERAL: Stone	COUNTY: Custer
INSPECTION TYPE: Monitoring	INSPECTOR(S): Tyler V. O'Donnell	INSP. DATE: March 15, 2016	INSP. TIME: 10:00
OPERATOR: Colorado Quarries Inc	OPERATOR REPRESENTATIVE: Aaron Tezak	TYPE OF OPERATION: 110c - Construction Limited Impact

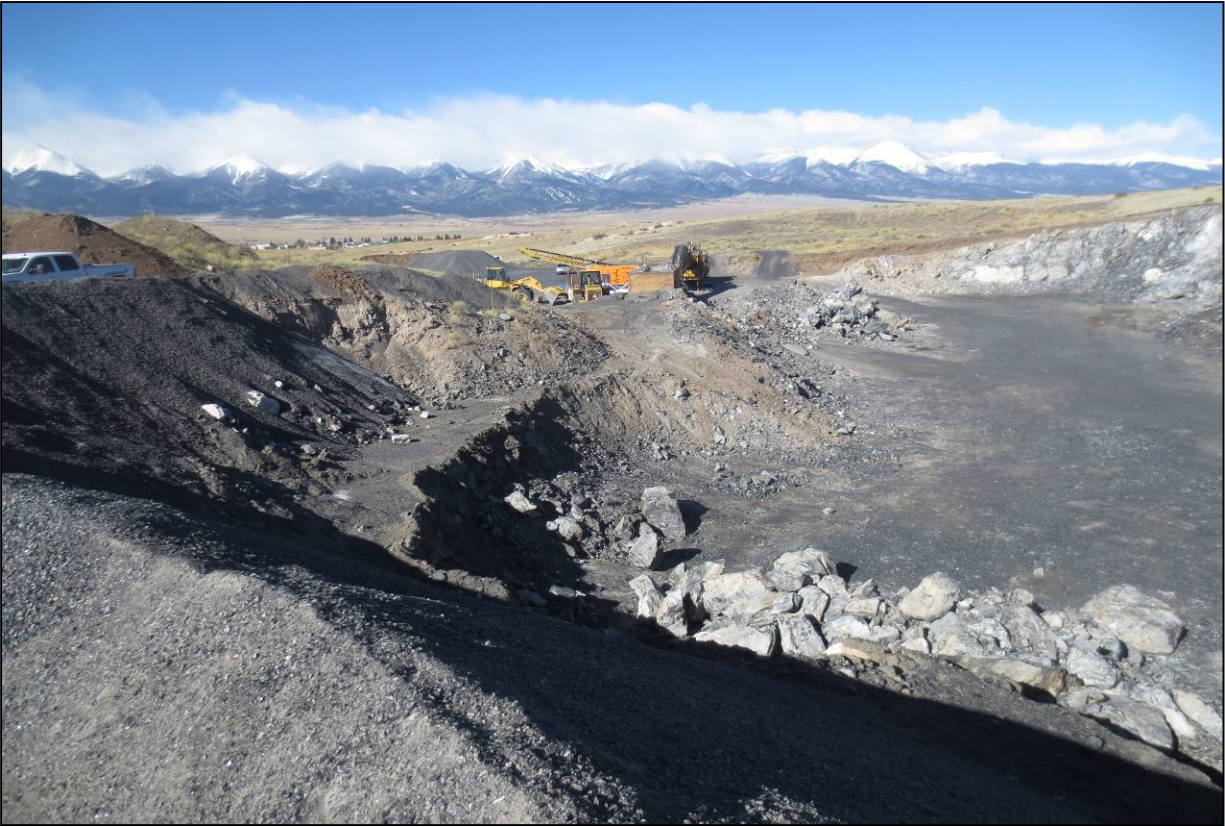
No problems or possible violations were observed during the inspection. During the inspection, the sky was slightly overcast. The ground was dry. The site was not active during the inspection, there was mining equipment on site. The Operator had mobilized in a crusher and had been recently processing and stockpiling material. It appears that the site sees frequent mining activities, mostly hauling out of stockpiles. At the present time it appears that the mining operation had affected approximately 3 acres. Mining was progressing to the north, product was being stockpiled along the southern portion of the current disturbance, near the access road.

Photo 1: Waste Rock in the foreground, crusher in the background.

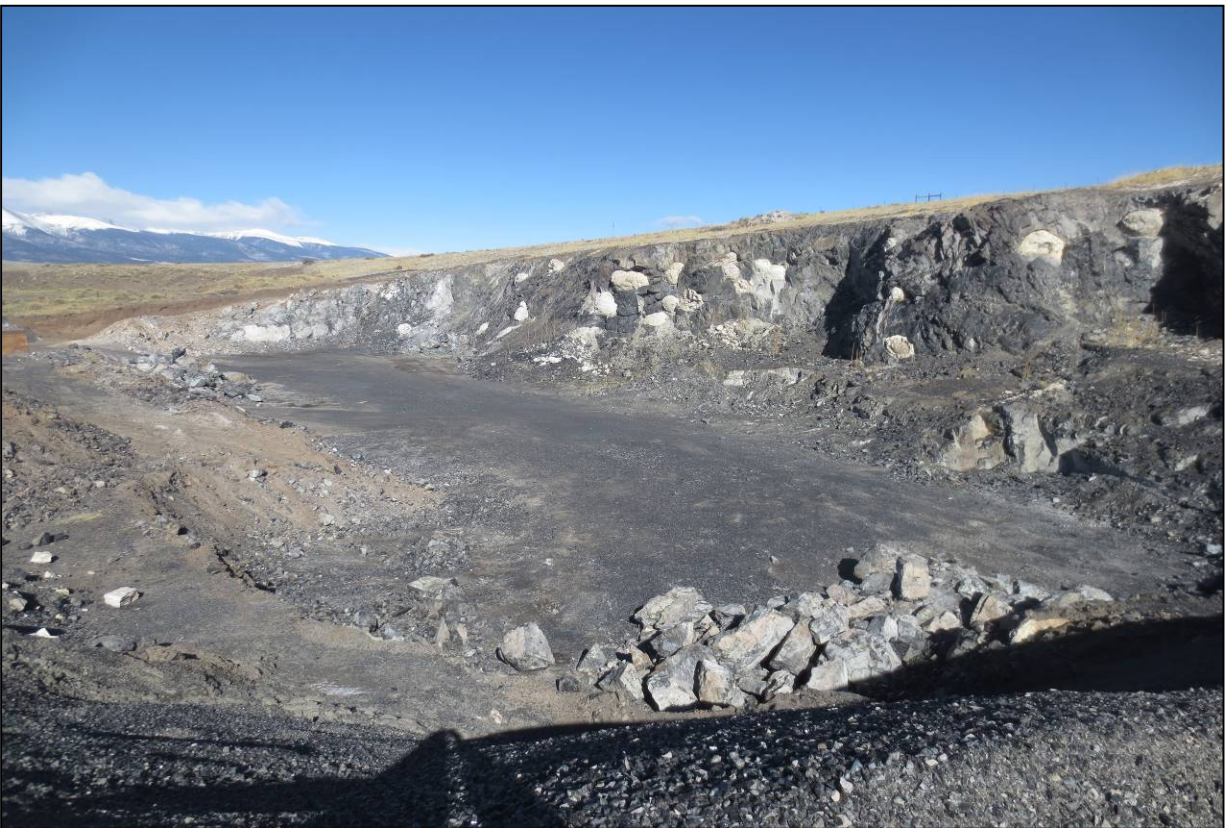
There was a highwall along the northern portion of the site. The highwall was approximately 275 feet long and had an average height of approximately 20 feet. The site currently daylights to the south.

Photo 2: highwall.

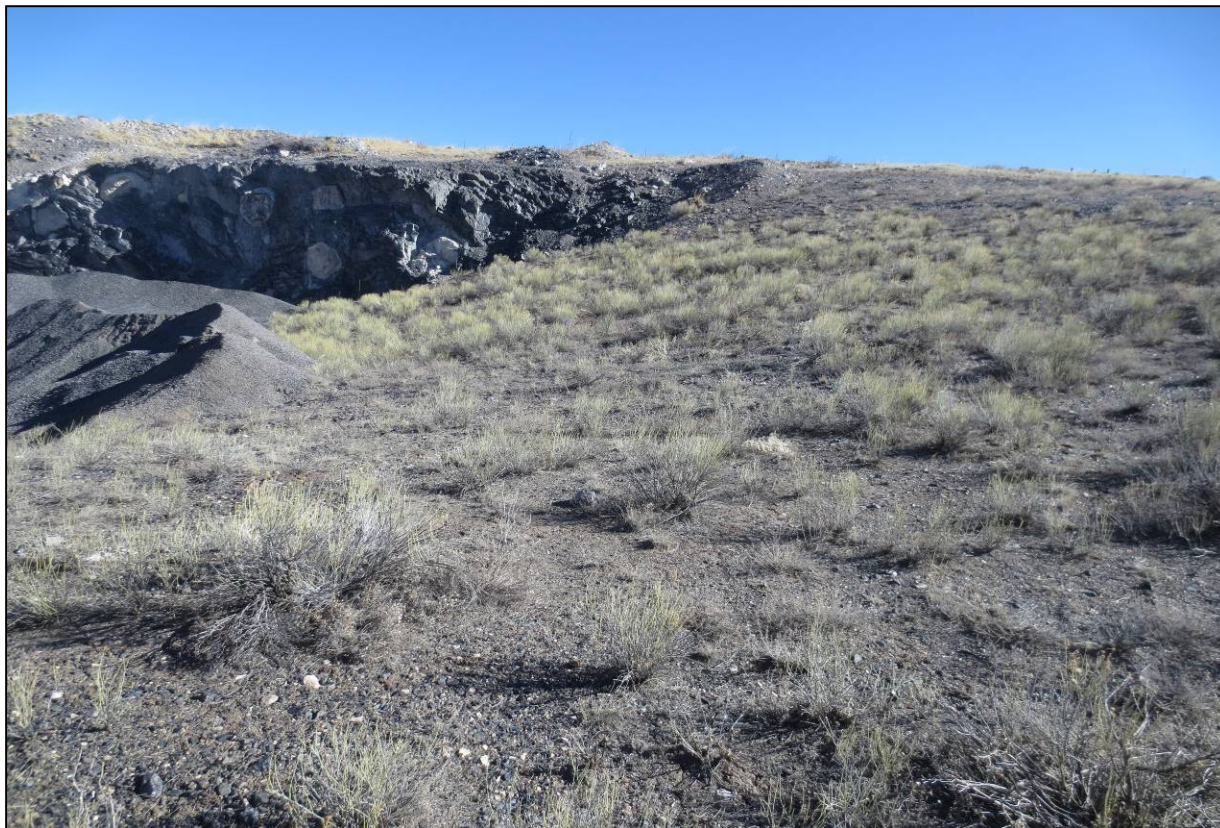
There was an approximate .25 acre area along the eastern side of the pit, where the Operator has begun to complete reclamation. The area has been backfilled, graded, and has had topsoil spread over it. The .25 acre area has begun to establish well will with desired vegetative cover. The area has begun to fill in with rabbit brush, a variety of wheatgrasses and what appears to be sand drop seed. The .25 acres appeared to be stable, no excessive erosion was observed.

Photo 3: Portion of the .25 acre area undergoing reclamation.

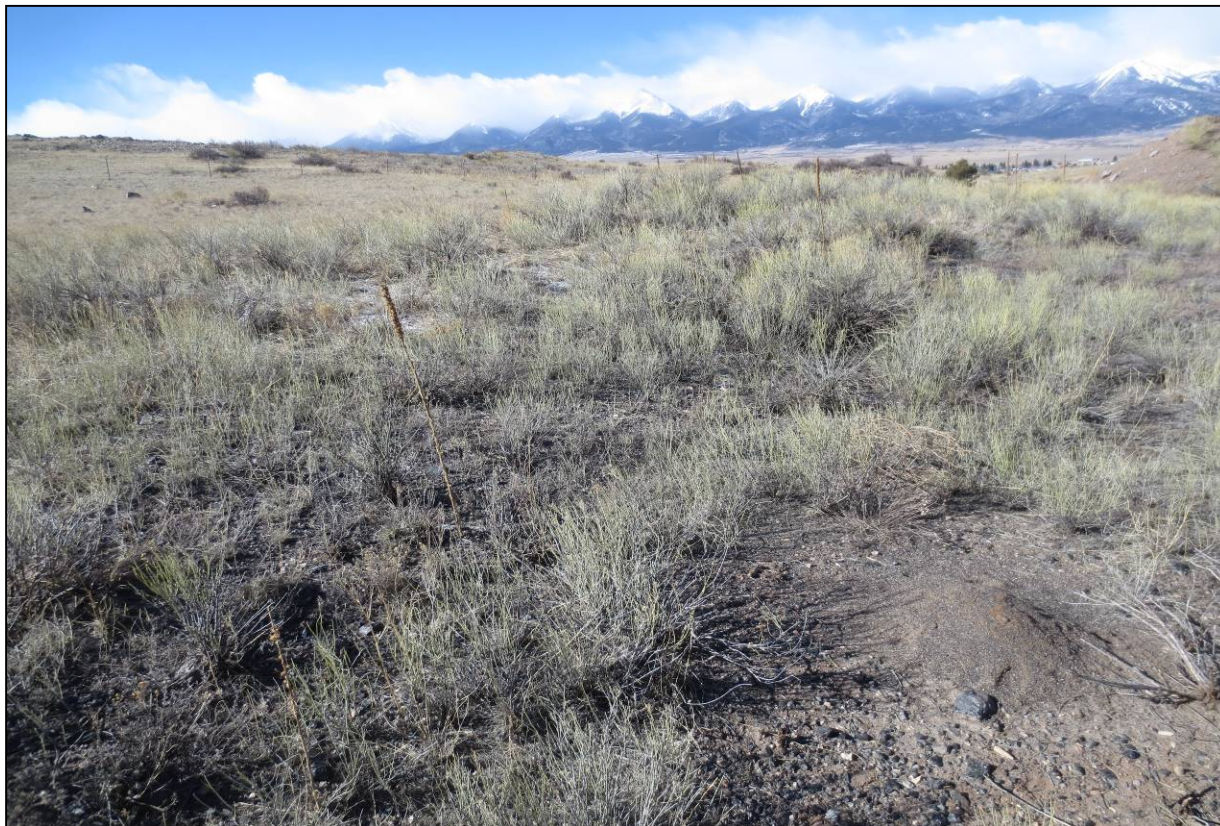
There was sparse plant growth throughout the affected lands, with the exception of the .25 acres where reclamation is taking place. The growth in the affected area appeared to be primarily volunteer vegetation, comprised of native vegetation, native grasses and a few annual weeds. A few common mullein were observed throughout the site. Most of the mullein were growing in the pit, a few plants were observed on the area in reclamation. Due to the limited number of mullein observed, the Division will not cite a problem for failure to control noxious weeds. However, the Operator is encouraged to continue to monitor and treat noxious weeds as they appear in the permit boundary. If the population of mullein increases the Division may cite a problem during a future inspection.

Photo 4: Portion of the .25 acre area undergoing reclamation. Some common mullein have begun to establish.
