**MINERALS PROGRAM INSPECTION REPORT**  
**PHONE: (303) 866-3567**

<b>MINE NAME:</b> Siskin	<b>MINE/PROSPECTING ID#:</b> M-1987-116	<b>MINERAL:</b> Stone	<b>COUNTY:</b> Custer
<b>INSPECTION TYPE:</b> Monitoring	<b>INSPECTOR(S):</b> Tyler V. O'Donnell	<b>INSP. DATE:</b> March 15, 2016	<b>INSP. TIME:</b> 10:30
<b>OPERATOR:</b>	<b>OPERATOR REPRESENTATIVE:</b> Aaron Tezak	<b>TYPE OF OPERATION:</b> 110c - Construction Limited Impact

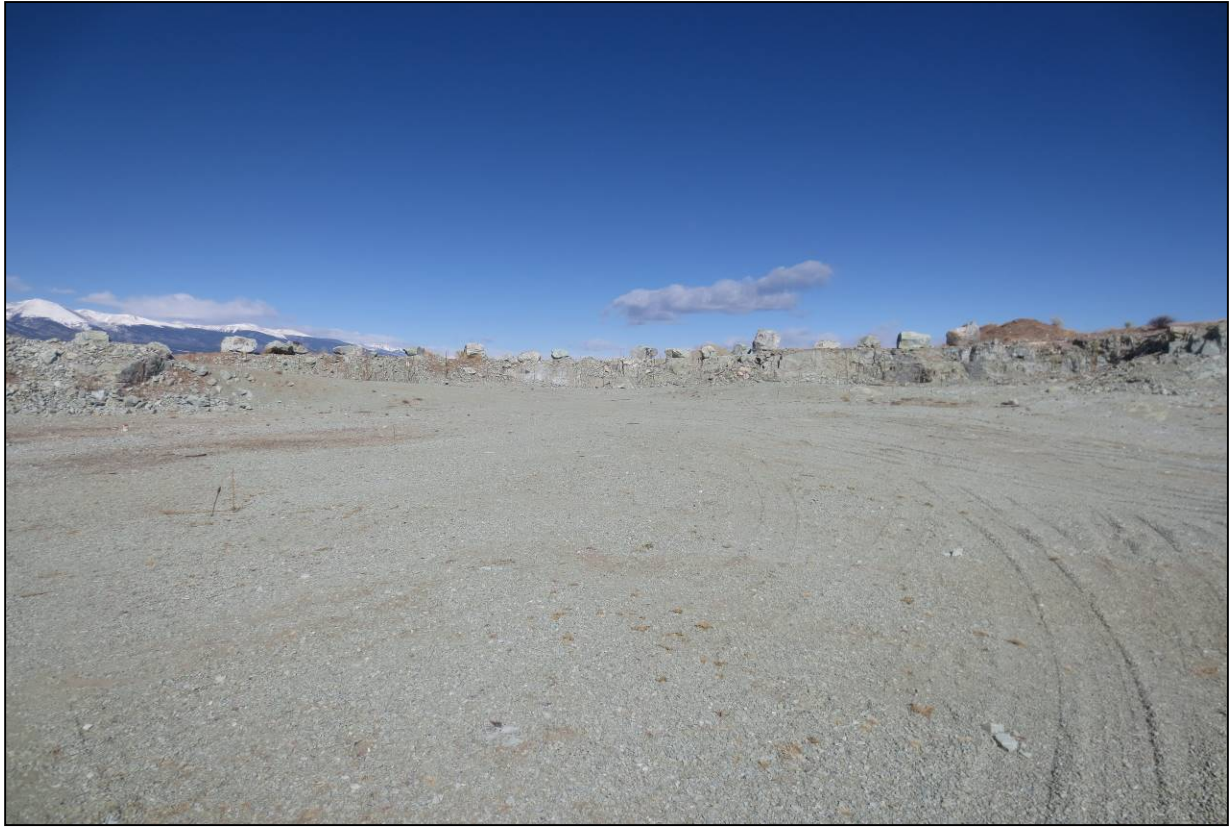
The entire pit is a shallow excavation, no portions of the pit currently daylight. All storm water is captured in the pit. The pit has near vertical highwalls around all 4 sides, for a total linear length of 750 feet of highwalls. The highwalls ranged in height from a few feet to roughly 8 feet high.

**Photo 1:** Shallow highwall along the western portion of the pit.

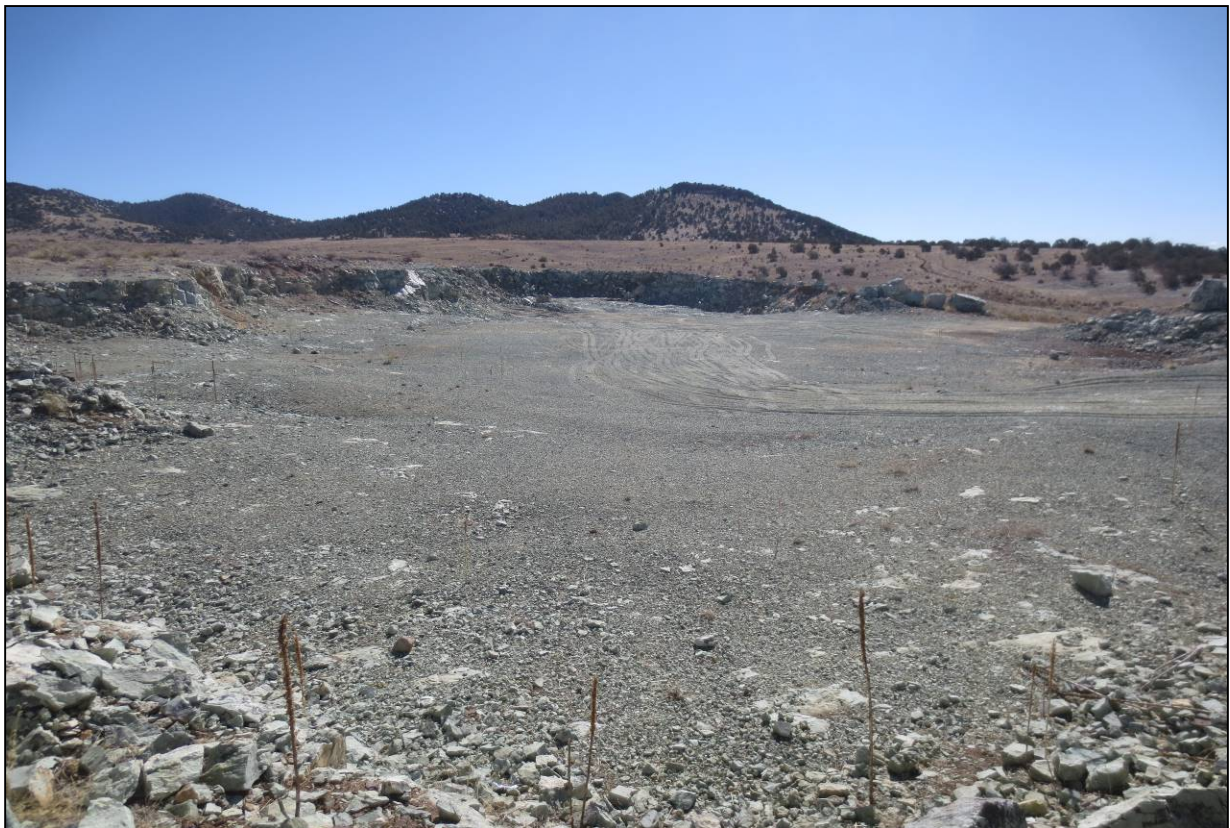
**Photo 2:** Shallow quarry excavation.

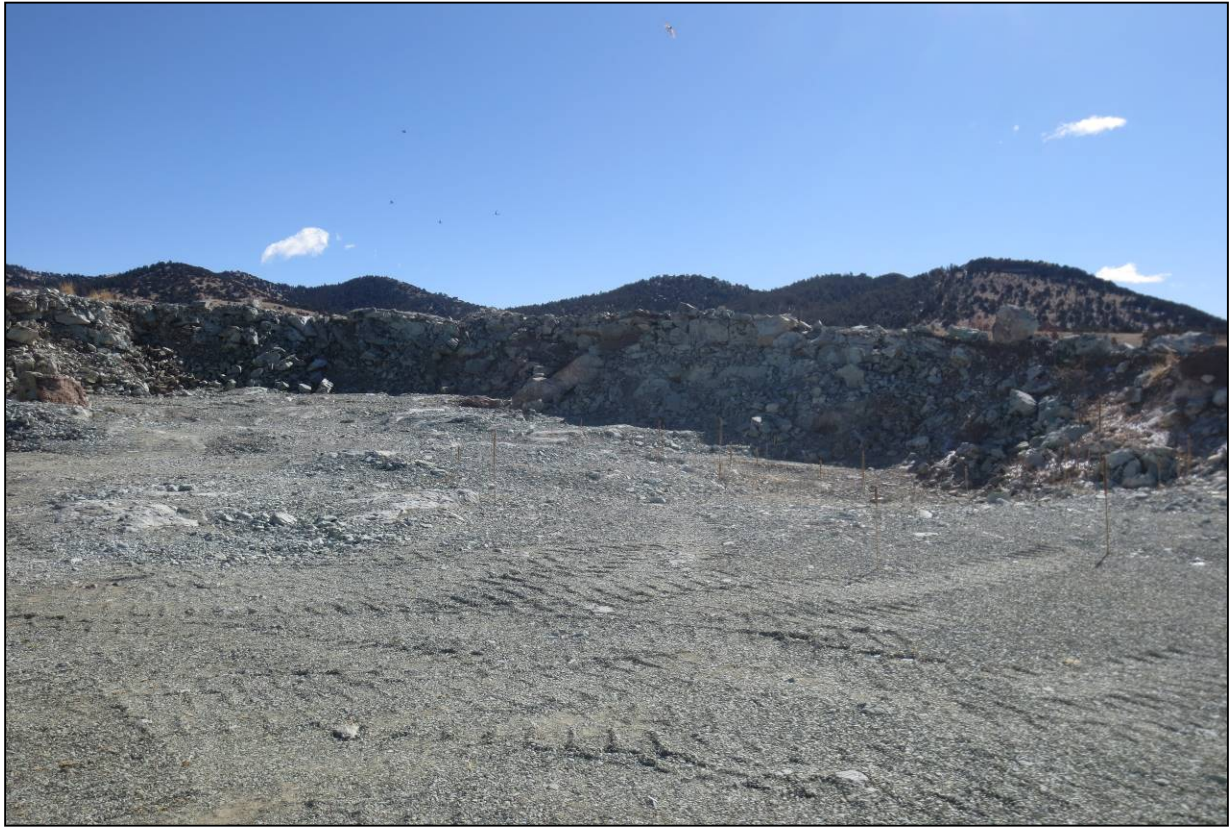
**Photo 3:** Highwall along the eastern side of the pit.

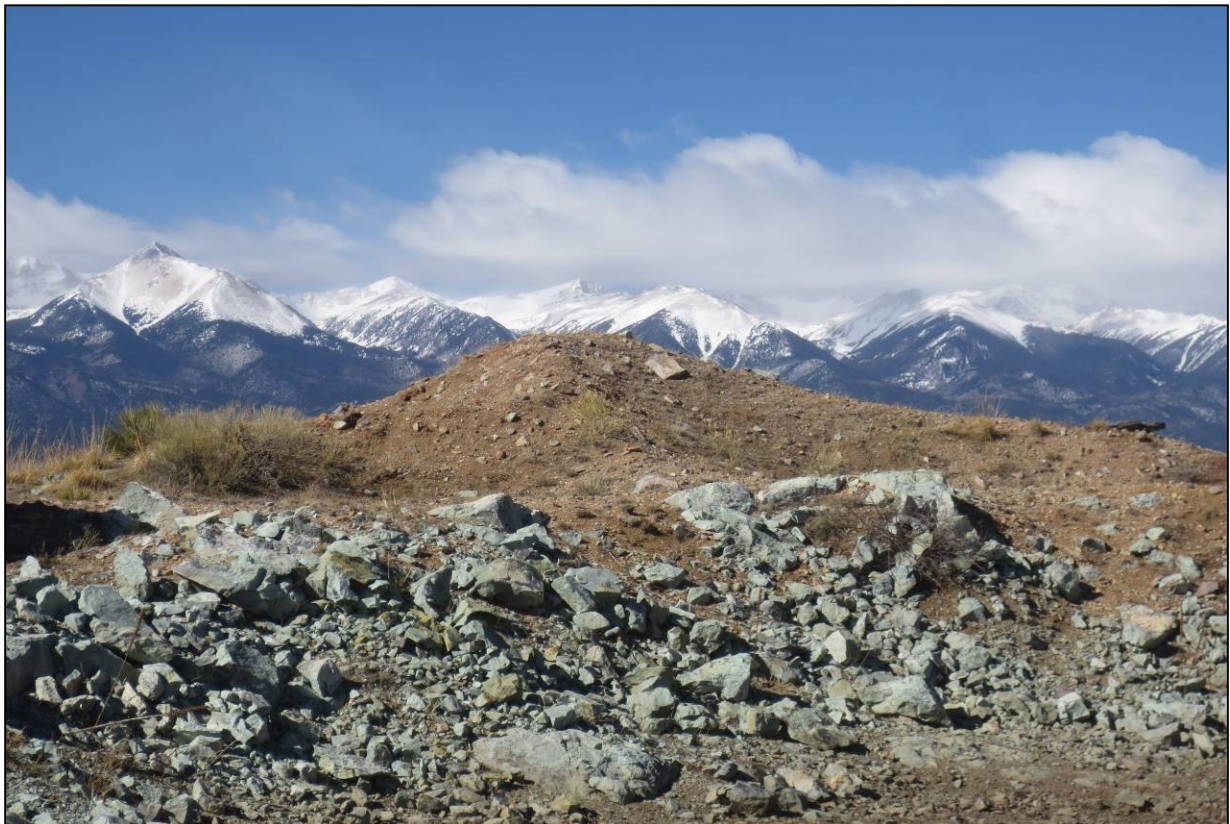
There was a topsoil stockpile located along the southern boundary of the pit.

**Photo 4:** Topsoil stockpile along the southern portion of the affected lands.
