## MINERALS PROGRAM INSPECTION REPORT

<b>MINE NAME:</b> Blue Valley Pit	<b>MINE/PROSPECTING ID#:</b> M-2015-008	<b>MINERAL:</b> Sand and gravel	<b>COUNTY:</b> Grand
<b>INSPECTION TYPE:</b> Monitoring	<b>INSPECTOR(S):</b> Peter S. Hays	<b>INSP. DATE:</b> June 15, 2016	<b>INSP. TIME:</b> 10:00
<b>OPERATOR:</b> Kirkland Construction, L.L.L.P.	<b>OPERATOR REPRESENTATIVE:</b> Joe Provost	<b>TYPE OF OPERATION:</b> 111 - Construction by Government Agency

# Blue Valley Pit

June 15, 2016 Inspection Map

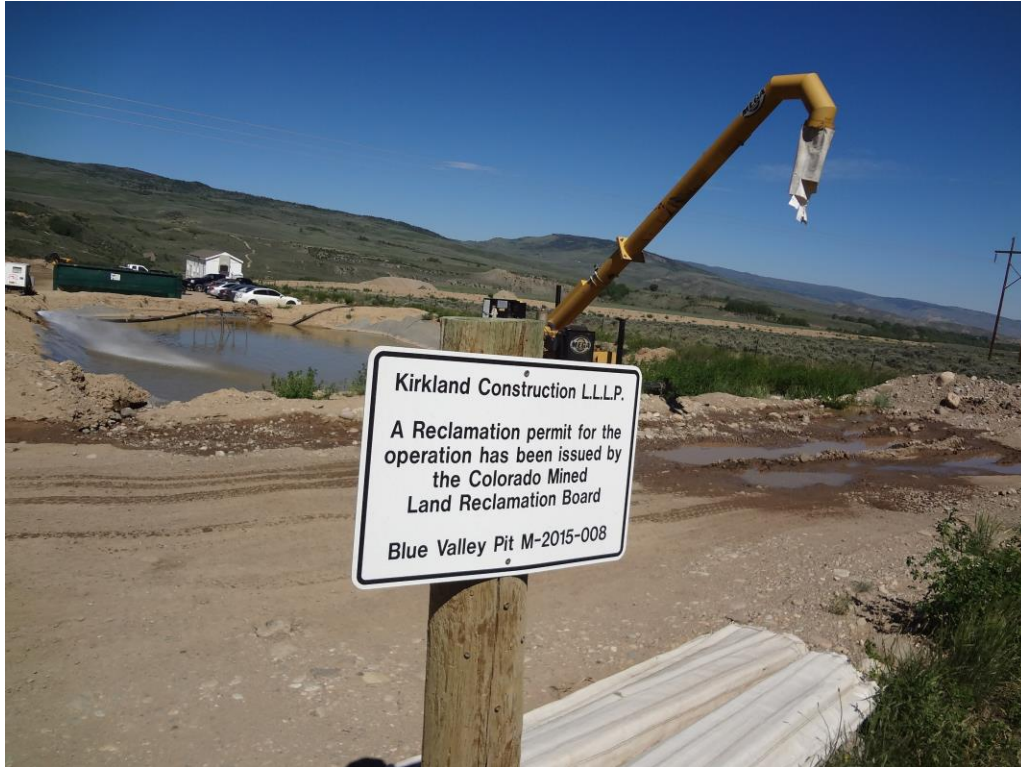
The required mine sign was observed and the boundaries of the affected land were delineated as required by Rule 3.1.12. The Division currently holds a financial warranty in the amount of \$75,000.00, which appears adequate to complete reclamation at the site.

Blue Valley Pit sign

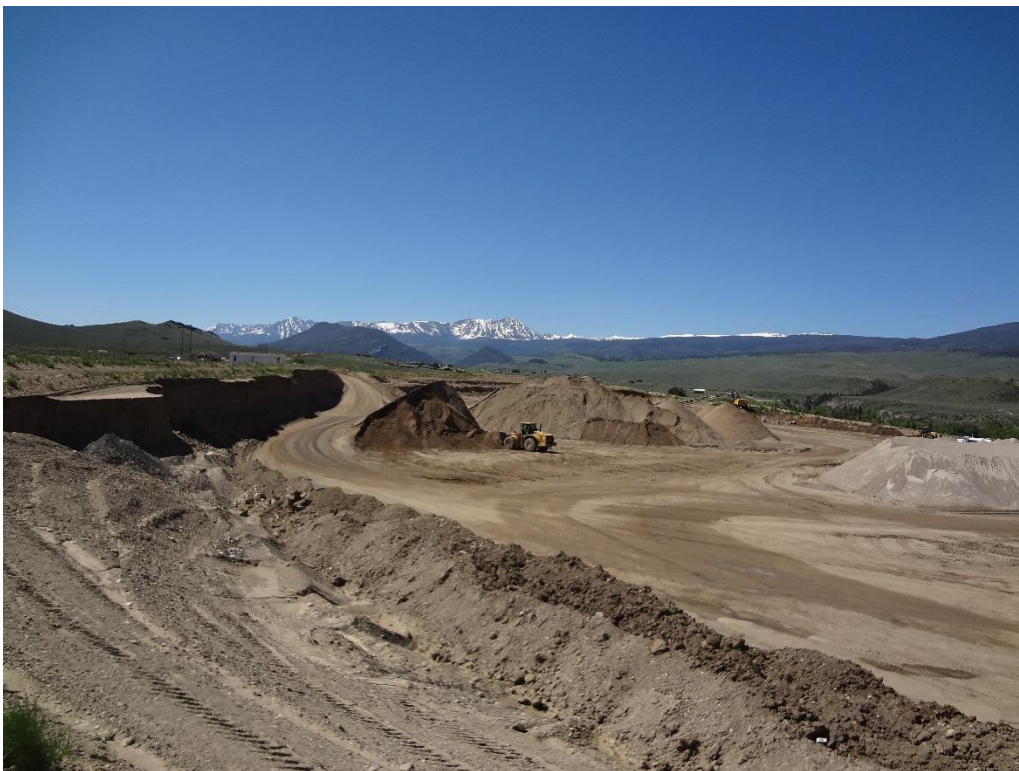
Looking south from NE corner of site

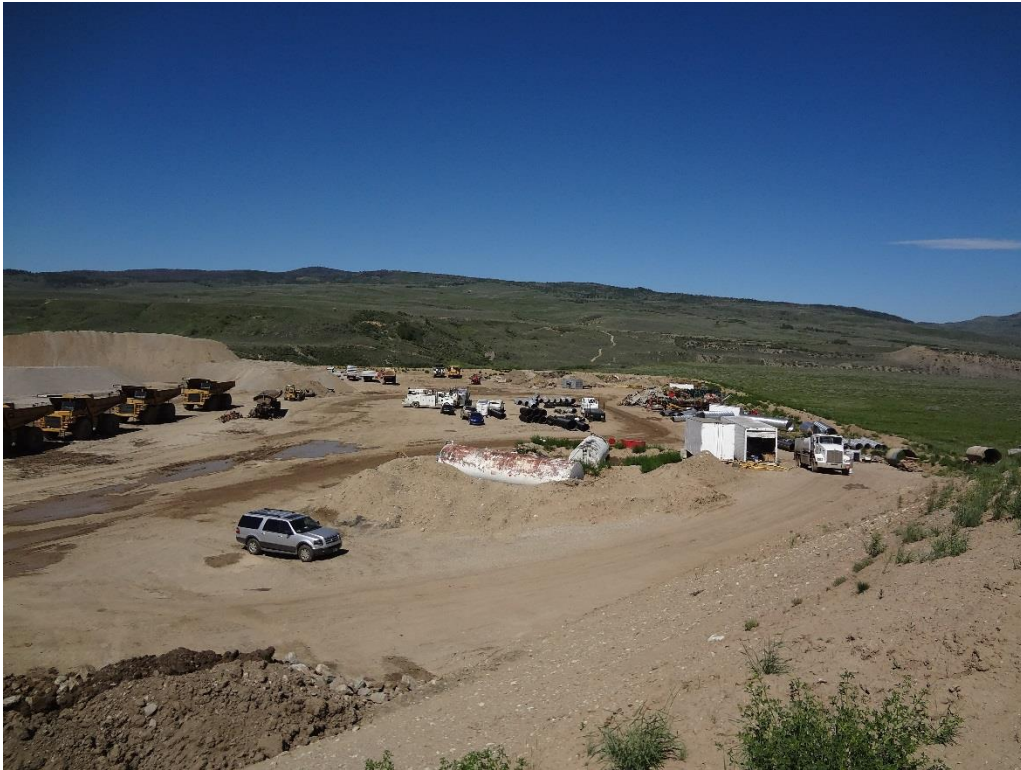
Looking west from NE corner of site

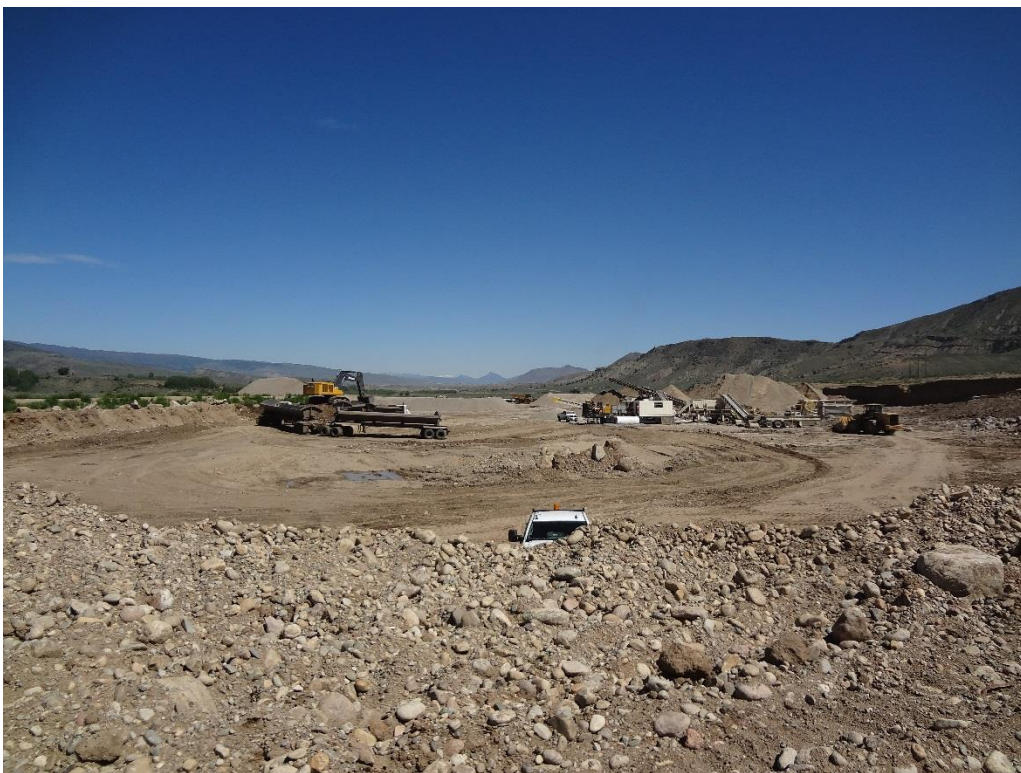
Looking south from highwall in south part of site

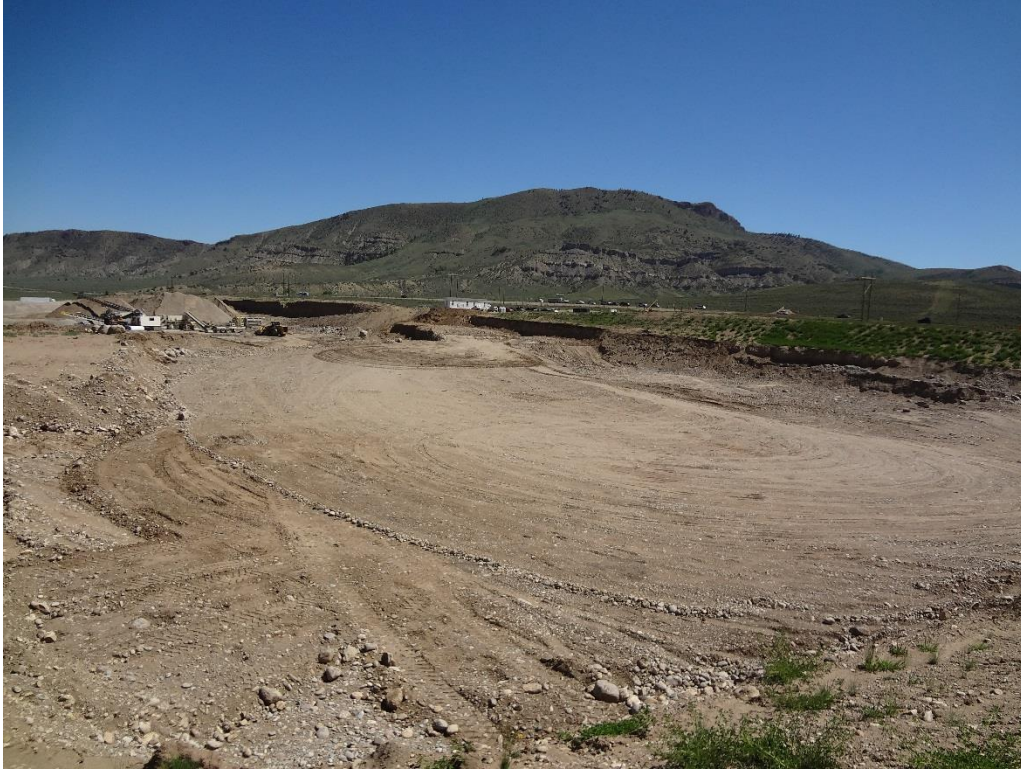
Looking NE from SW corner of site at remaining gravel resource

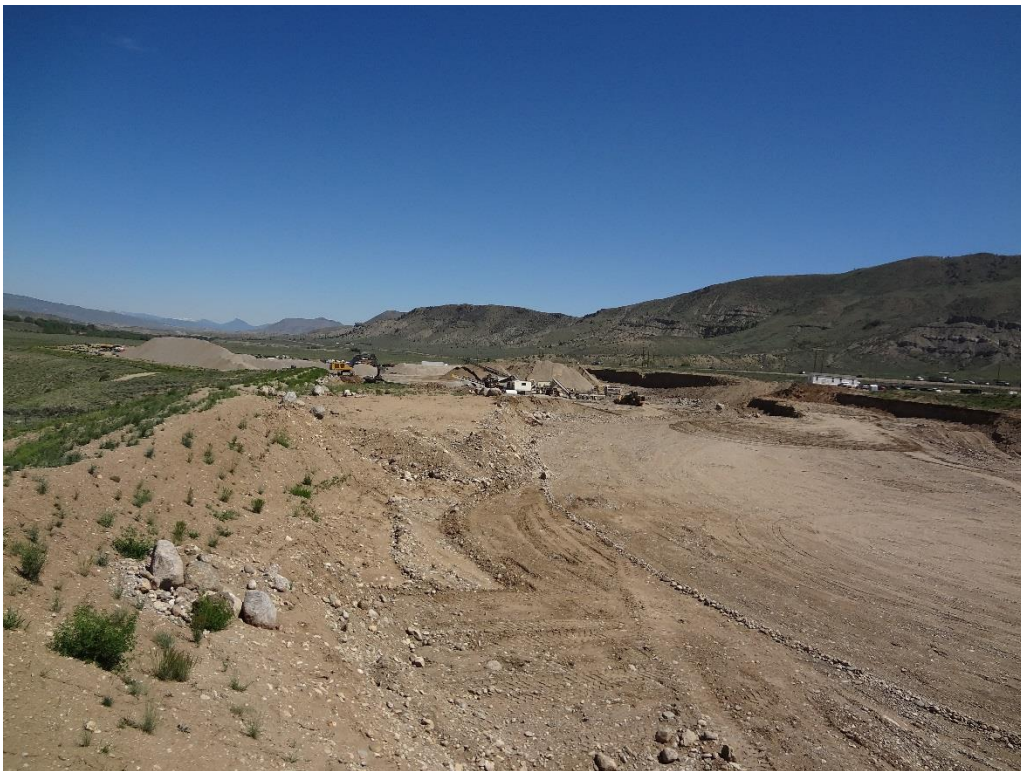
Looking north from SW corner of site at remaining gravel resource and processing plant
