## MINERALS PROGRAM INSPECTION REPORT

<b>MINE NAME:</b> Everhart Pit	<b>MINE/PROSPECTING ID#:</b> M-1997-081	<b>MINERAL:</b> Gravel	<b>COUNTY:</b> Pueblo
<b>INSPECTION TYPE:</b> Monitoring	<b>INSPECTOR(S):</b> Tyler V. O'Donnell	<b>INSP. DATE:</b> March 15, 2016	<b>INSP. TIME:</b> 13:15
<b>OPERATOR:</b> Pueblo County	<b>OPERATOR REPRESENTATIVE:</b> Chuck Colletti and Andrew Ruybal	<b>TYPE OF OPERATION:</b> 112c - Construction Regular Operation

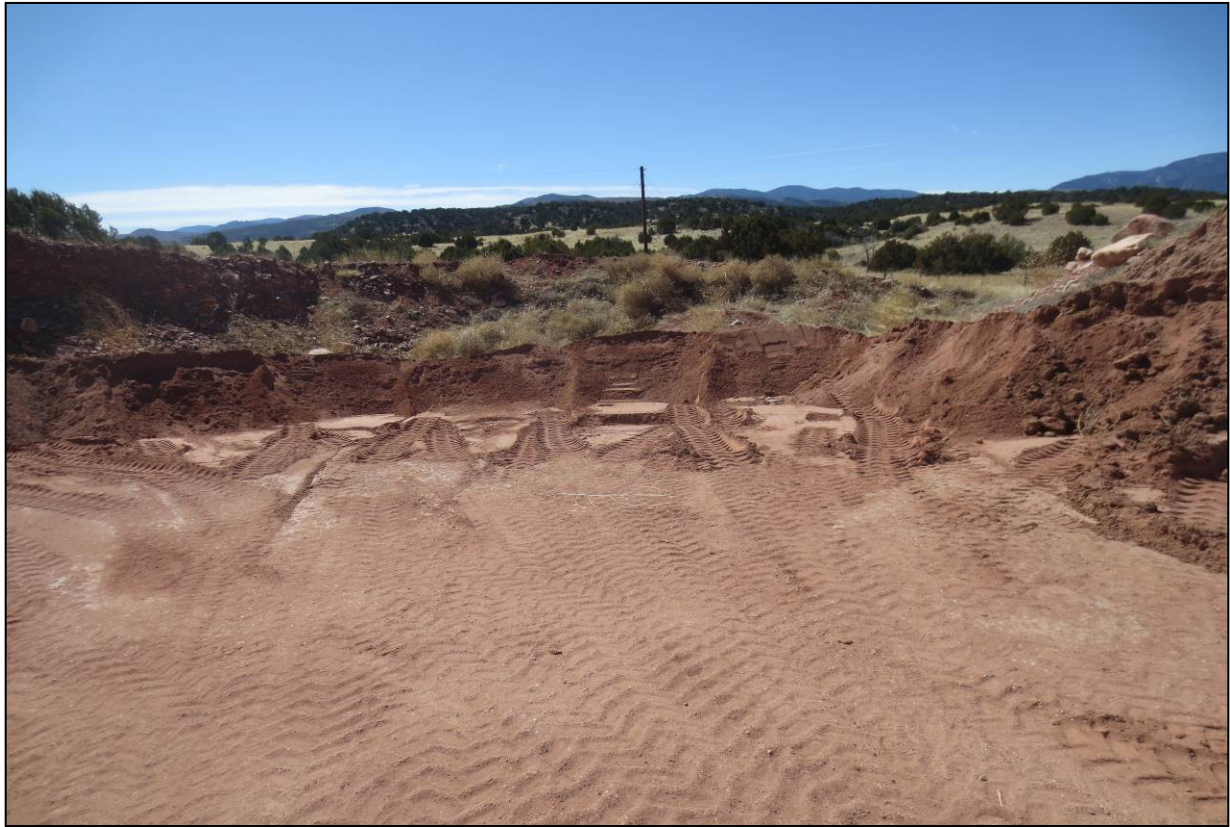
The mining operation was expanding to the south and west. There were several mining faces scattered around the site. The recent mining faces ranged from near vertical to 1.5H:1V. The Operator was expanding the pit deeper in the southwest corner. The operator was in the process of backfilling and grading portions of the pit. Most of the backfilling work was taking place in the northwestern portion of Phase 1 affected land.

**Photo 1:** Recent mining in the southwest corner of phase 1.

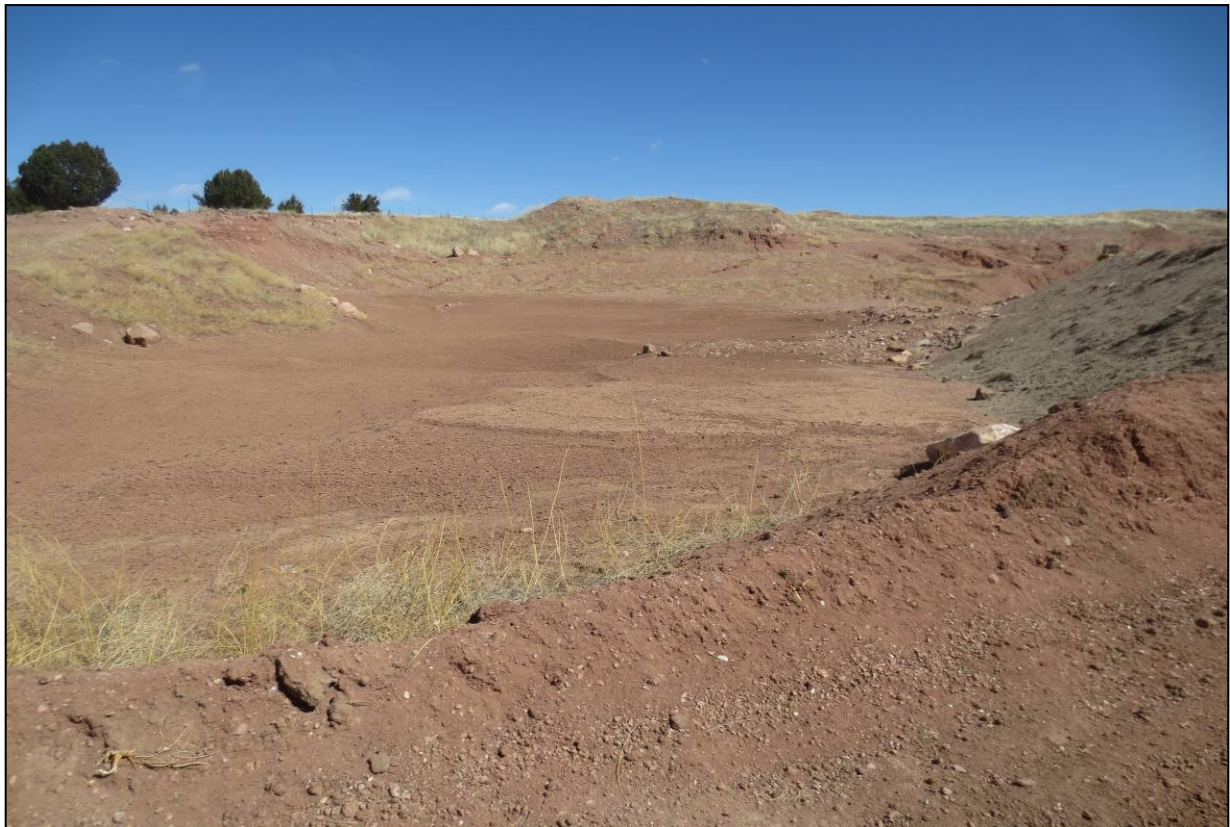
**Photo 2:** Recent backfilling and grading in the northwestern corner of phase 1 affected land.

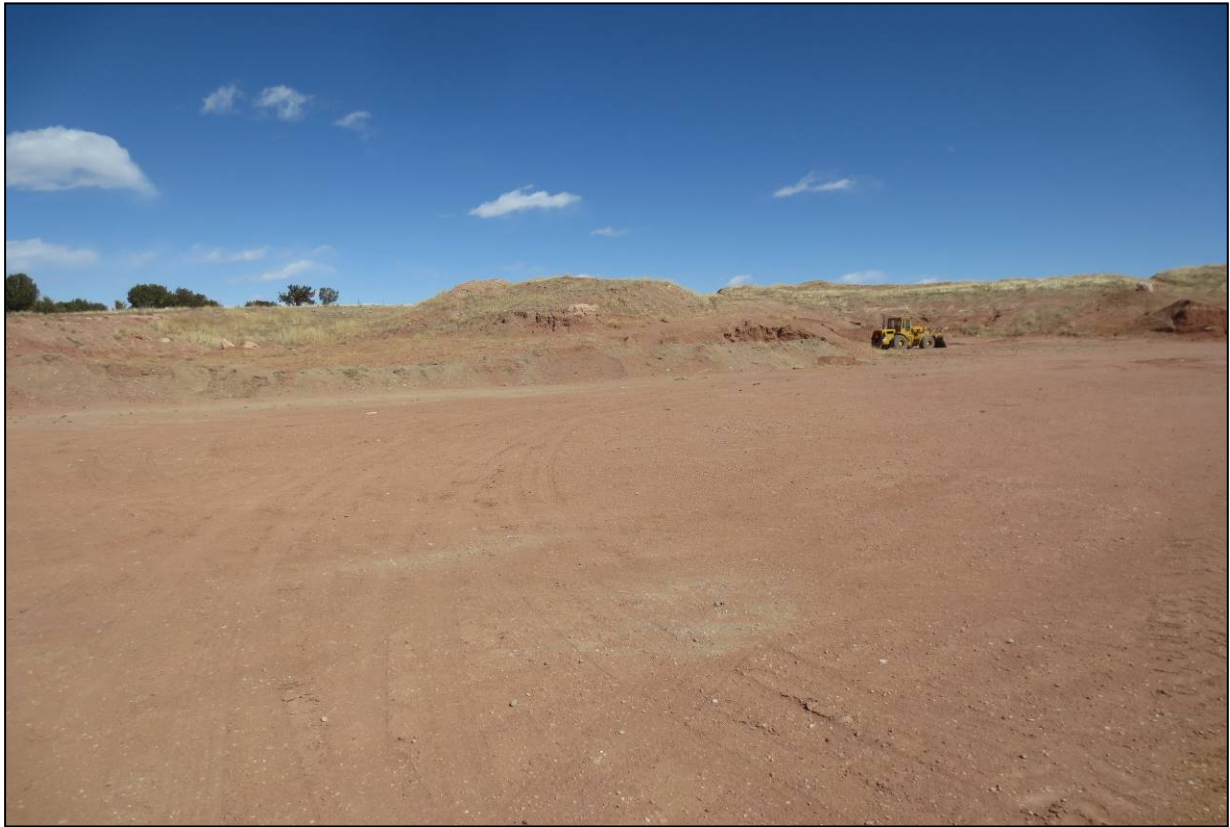
**Photo 3:** Recent backfilling and grading in the northwestern portion of phase 1 affected land.

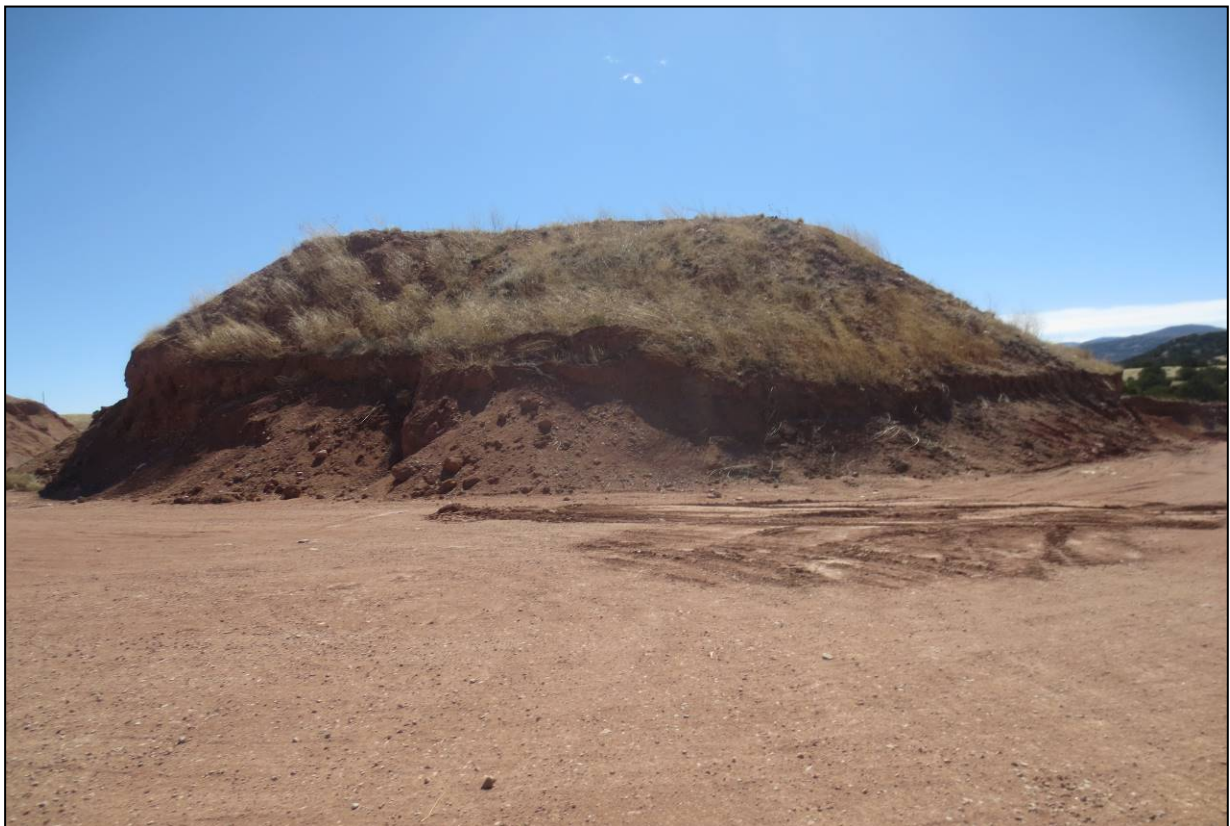
There was adequate topsoil stockpiled on site to conduct the approved reclamation plan. There was a well vegetated topsoil stockpile in the southern portion of phase 1. The topsoil stockpiles had adequate vegetative cover to protect the topsoil from erosion.

**Photo 4:** Topsoil stockpile.
