## Bowie No. 2 2nd Quarter Gob & Pond Reports

Re: Bowie Resources, LLC, Bowie No. 2 Mine  
Coal Mine Waste Banks & Instrumentation Monitoring  
Pond Quarterly Inspections  
Permit C-1996-083

#### Coal Mine Waste Bank Nos. 1, 2, & 3 Inspections - 2nd Quarter 2016

## QUARTERLY POND INSPECTION REPORT

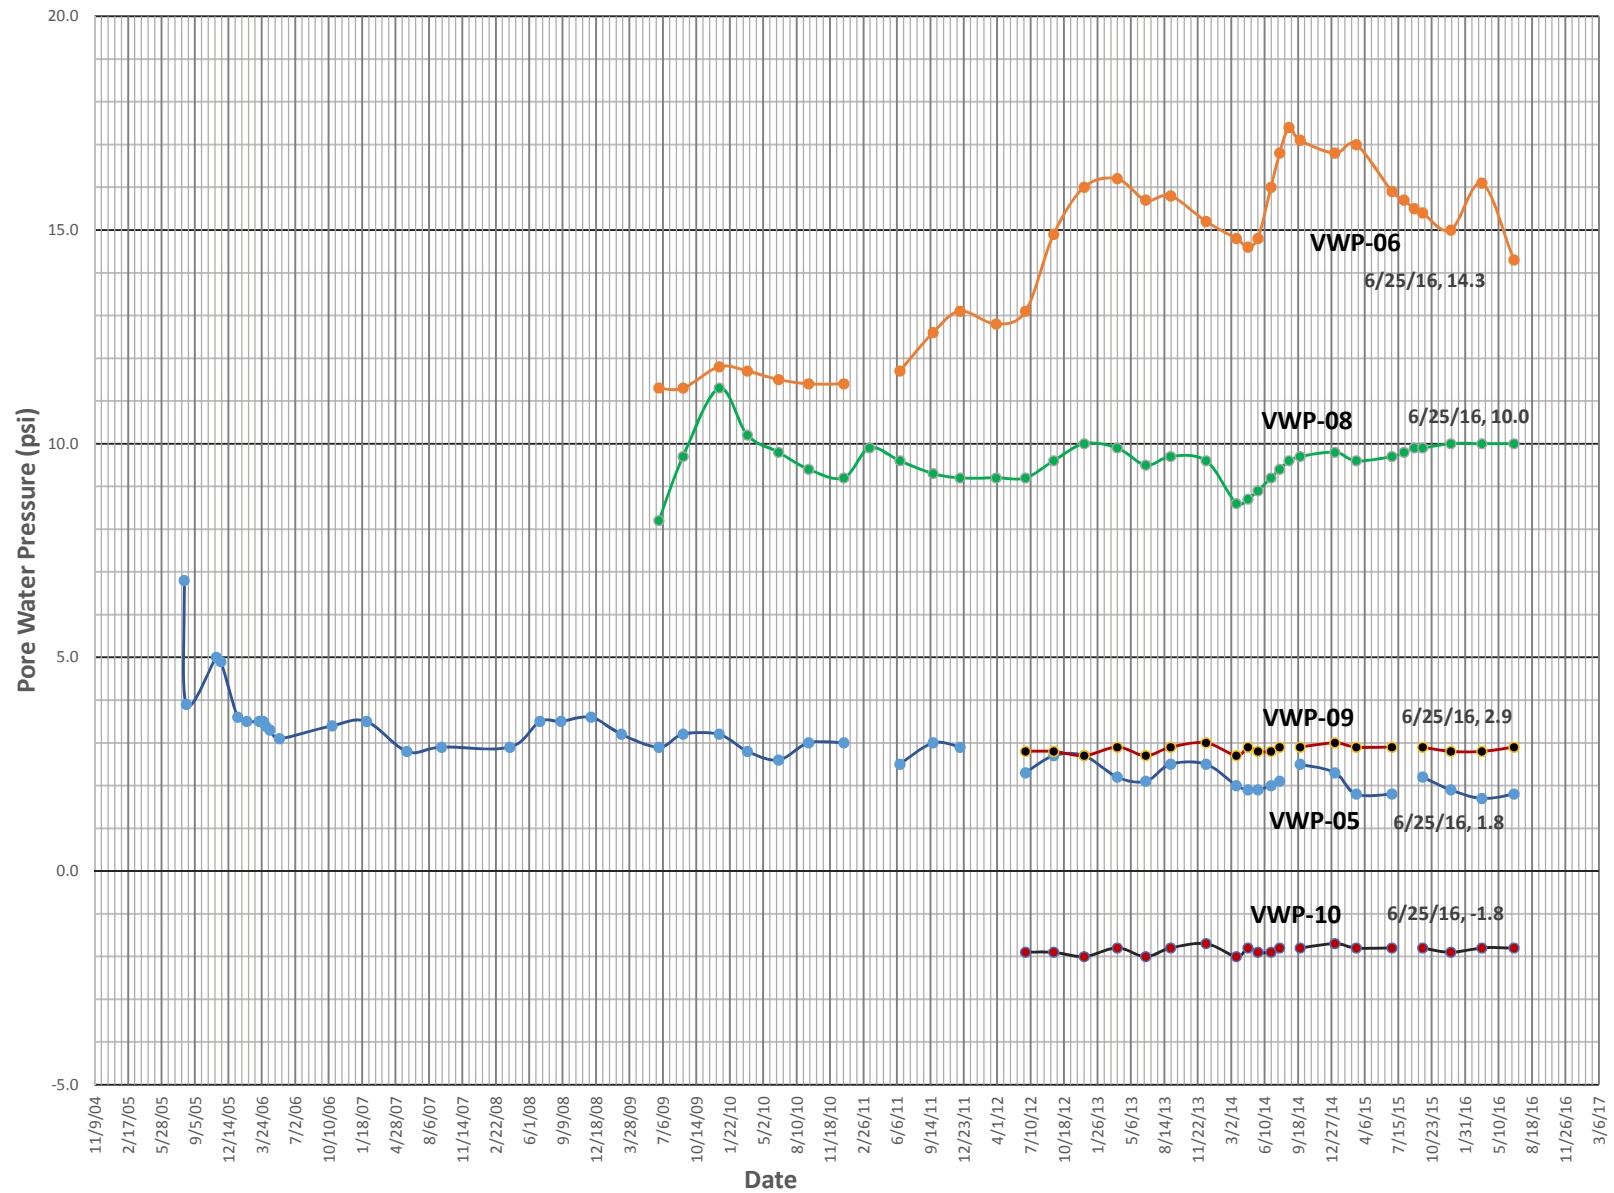
**FIGURE 2**

VWP-05 was installed on August 3, 2005 near the toe of CWDA No. 2 adjacent to the access road/bench. The pore pressures recorded at VWP-05 have shown some seasonal fluctuations; however, the range of pore pressure changes is fairly small. In general, HBET does not believe that the pore pressures in VWP-05 are cause for concern regarding stability of the gob pile.

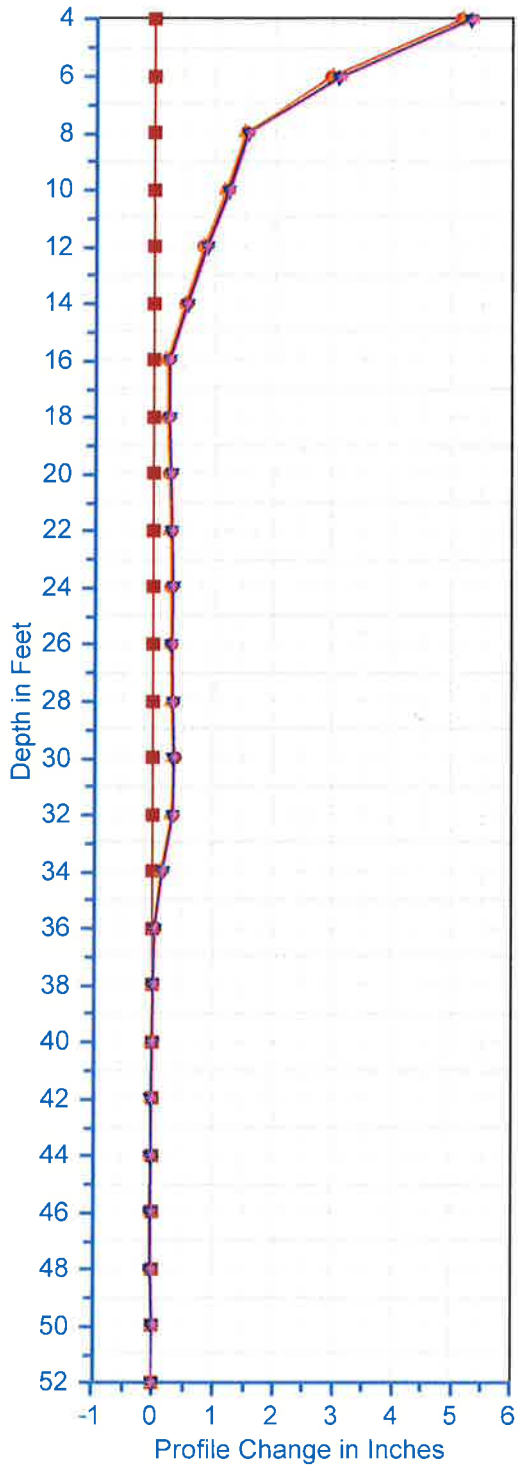
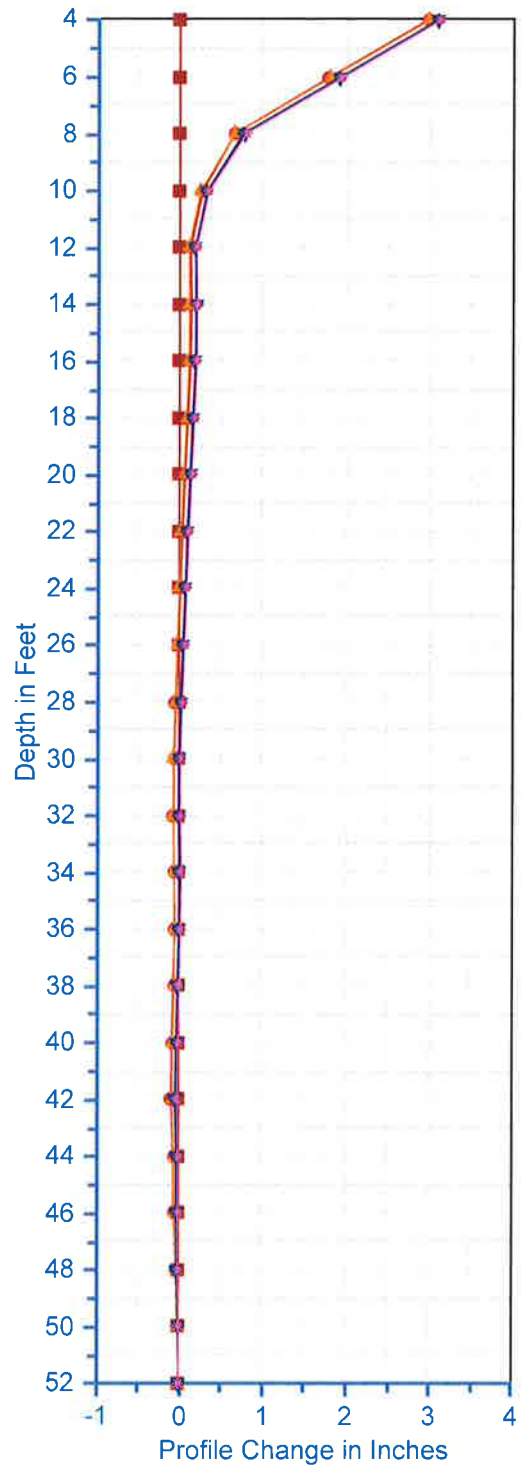
### BOWIE BG05\_4 A

The latest inclinometer readings indicate no major movements since the last quarterly reading. As indicated in the DOWL report, some deflection was observed at BG05-05. However, the movement in the A-axis is zero at the top and bottom with a fairly uniform shift of the data along the length of the instrument. In general, it is unusual to see a fairly uniform shift along the 'middle' of the instrument with no movement at the top along the same axis. In addition, the movement along the B-axis is only in the upper portion of the instrument. Overall, HBET does not believe that the data represents instability in the gob. However, the 3<sup>rd</sup> Quarter 2016 monitoring data may provide additional information regarding the observed deflection.

In general, based upon the results of the recent VWP and inclinometer monitoring data, and upon our observations at the site, HBET does not believe that there is any reduction in the stability of CWDA No. 2. Continued quarterly monitoring of piezometers and inclinometers is recommended.

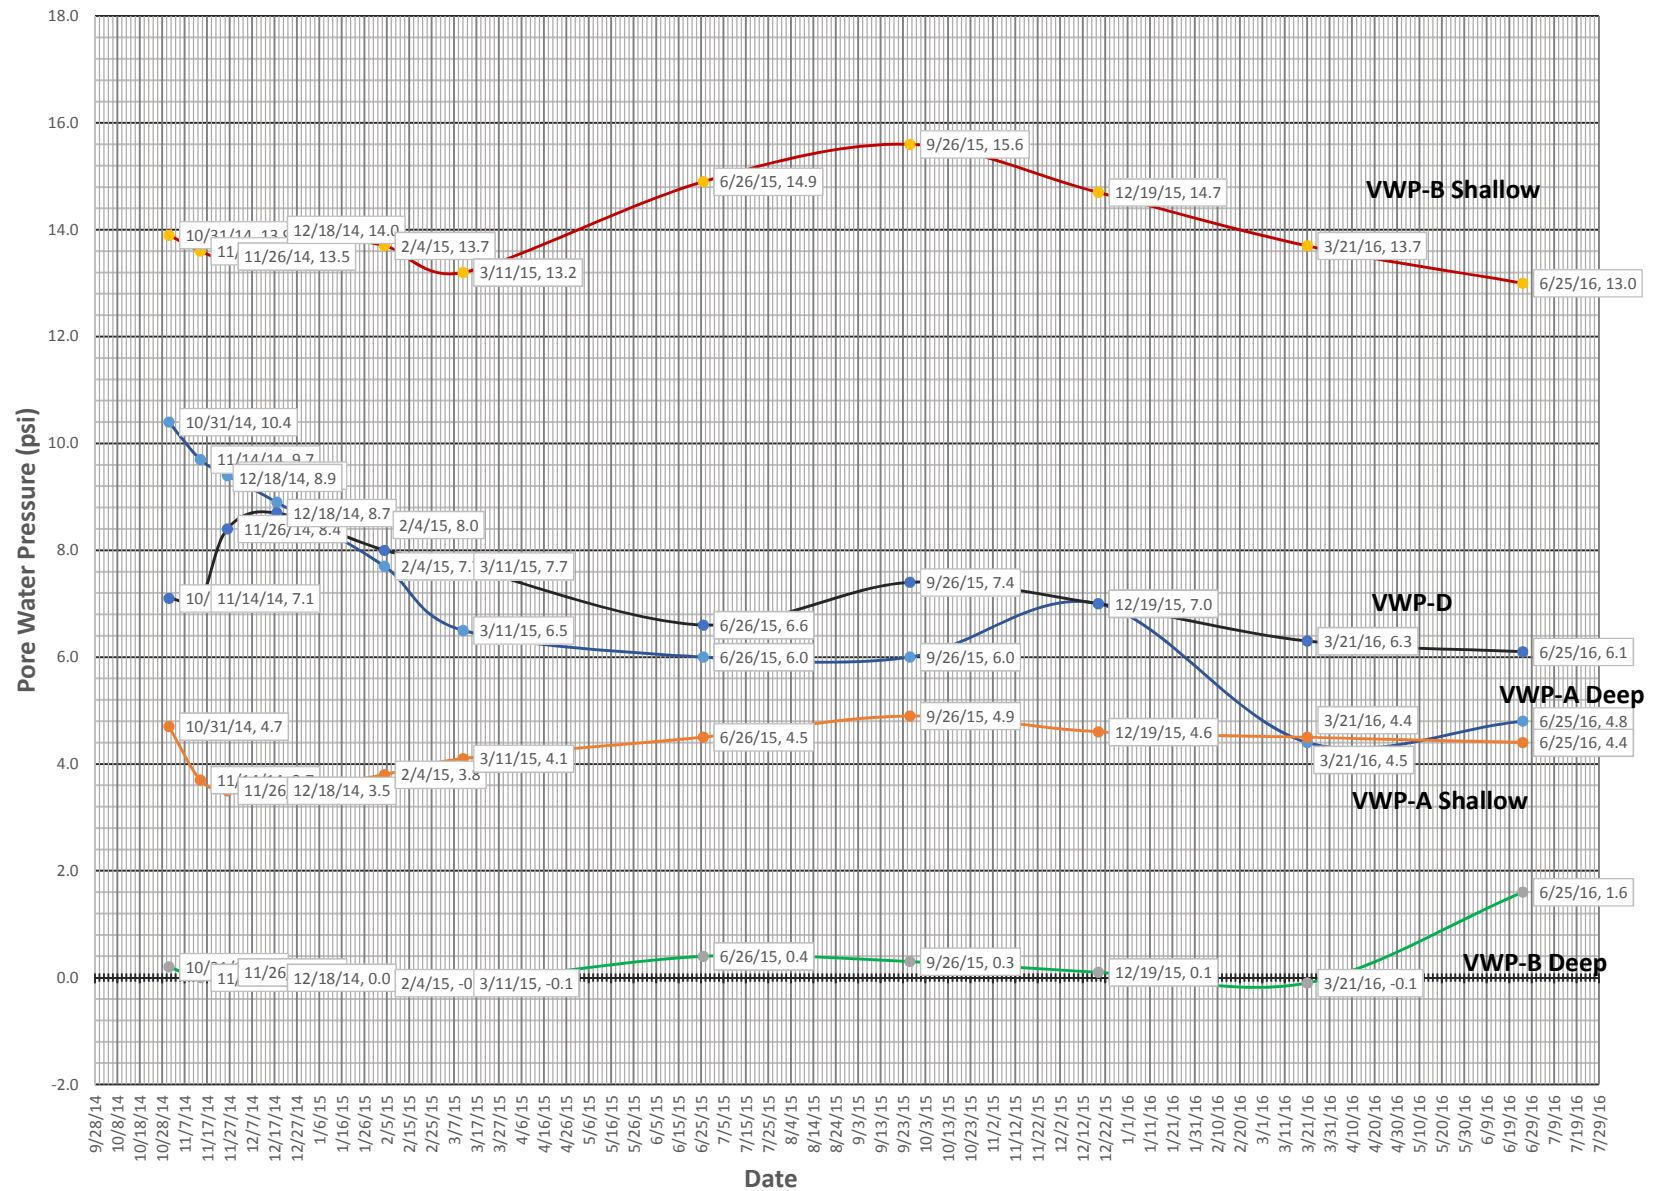
**FIGURE 1**

VWP-A Deep was installed on October 6, 2014 near the northern edge of CWDA No. 3. VWP-A Deep was installed in the foundation soil approximately eight feet below the bottom of the gob. The pore pressures recorded at VWP-A Deep generally decreased since installation until September 2015. Between September and December 2015, the pore pressures increased slightly. However, the pore pressures dropped significantly between December 2015 and March 2016. A slight increase was recorded since March; however, HBET does not believe that the pore pressure changes in VWP-A Deep are cause for concern regarding stability of the gob pile.

VWP-B Deep was installed on October 6, 2014 in the west-central portion of CWDA No. 3. VWP-B Deep was installed in the foundation soil approximately ten feet below the bottom of the gob. Since installation, the pore pressures recorded at VWP-B Deep were fairly constant through March 2016. However a slight increase was recorded between March and June 2016. It is unclear why the pore pressures increased during the last quarter; however, the increase was not significant and HBET does not believe that the pore pressure changes in VWP-B Deep are an indication of instability in CWDA No. 3.

Based upon the results of the most recent VWP monitoring data and upon our observations at the site, HBET does not believe that there is any reduction in the stability of CWDA No. 3. Continued quarterly monitoring of piezometers and inclinometers is recommended.
