MINERALS PROGRAM INSPECTION REPORT
PHONE: (303) 866-3567

MINE NAME: Beeman Pit #1	MINE/PROSPECTING ID#: M-2002-009	MINERAL: Sand and gravel and material for construc	COUNTY: Pueblo
INSPECTION TYPE: Monitoring	INSPECTOR(S): Tyler V. O'Donnell	INSP. DATE: March 15, 2016	INSP. TIME: 16:00
OPERATOR: Martin Marietta Materials, Inc.	OPERATOR REPRESENTATIVE: Julie Mikulas	TYPE OF OPERATION: 112c - Construction Regular Operation	
REASON FOR INSPECTION: Normal I&E Program	BOND CALCULATION TYPE: Complete Bond	BOND AMOUNT: \$62,335.00	
DATE OF COMPLAINT: NA	POST INSP. CONTACTS: None	JOINT INSP. AGENCY: None	
WEATHER: Windy	INSPECTOR'S SIGNATURE:

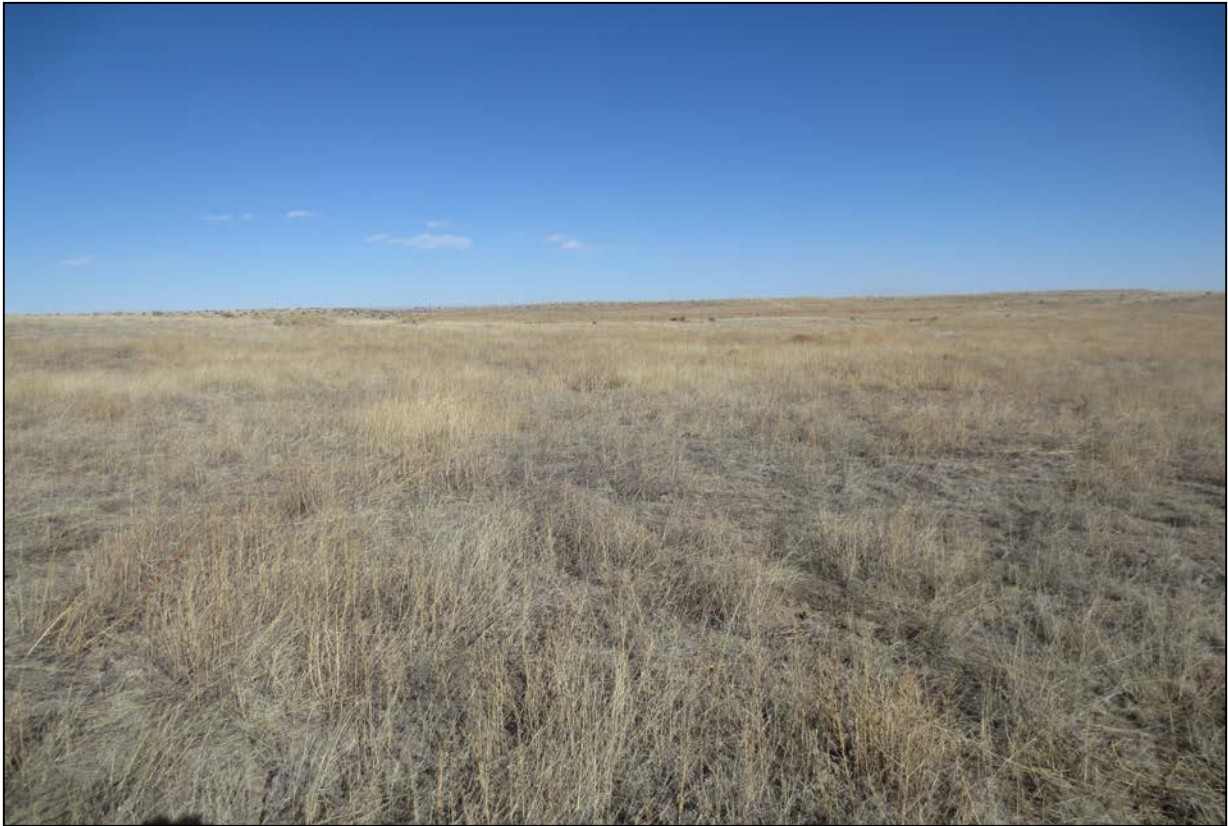
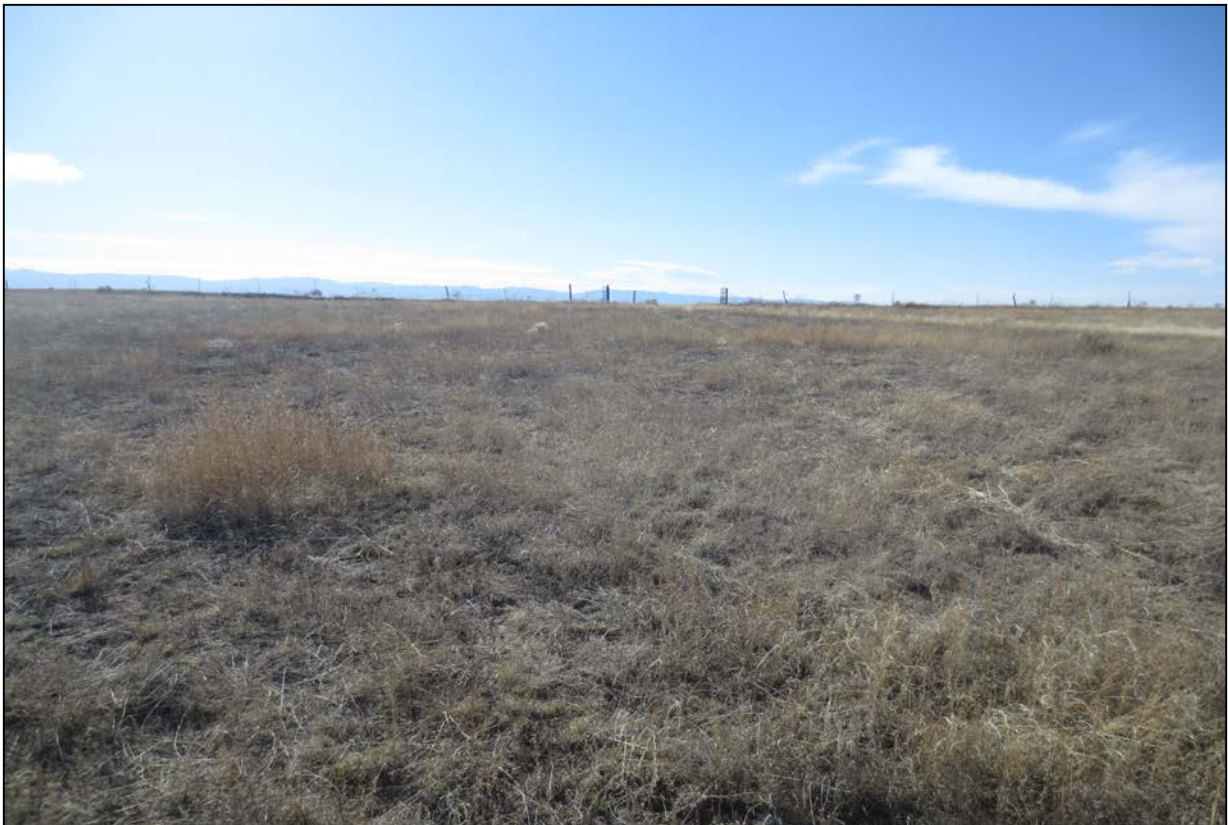
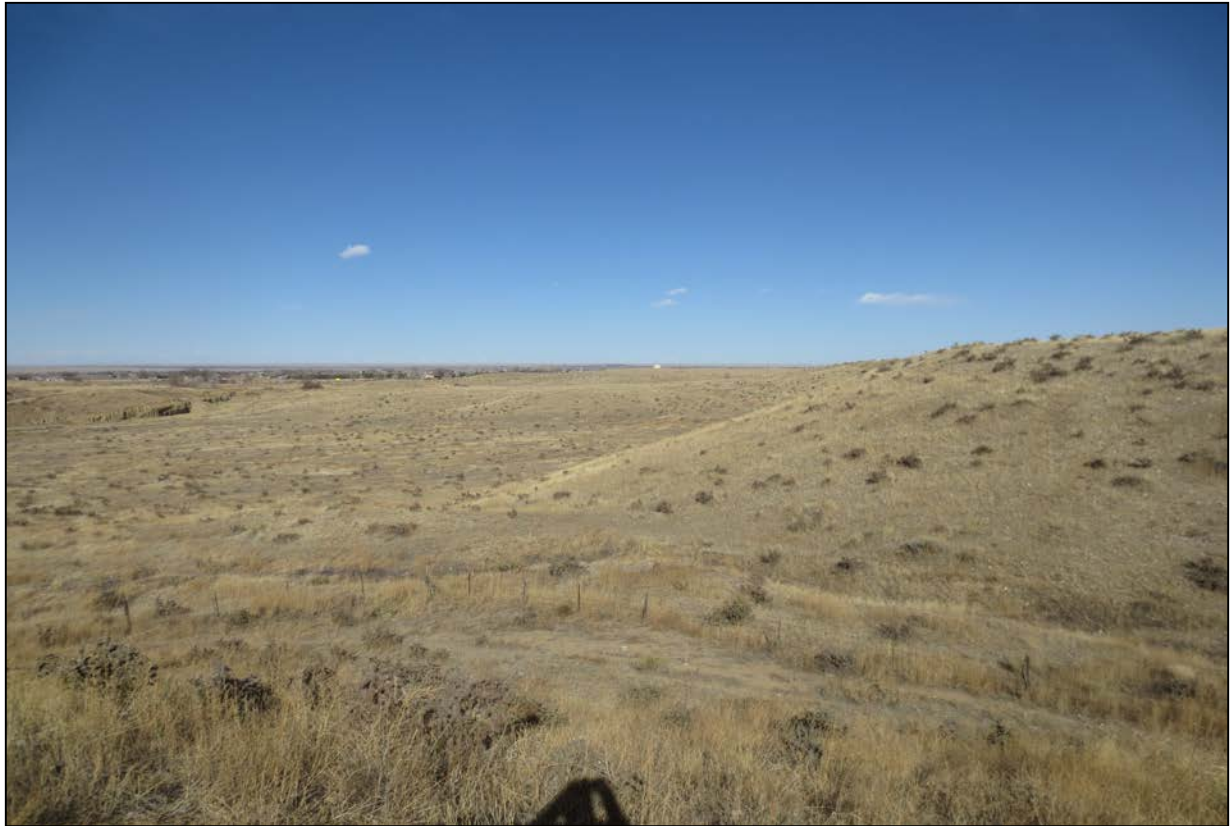
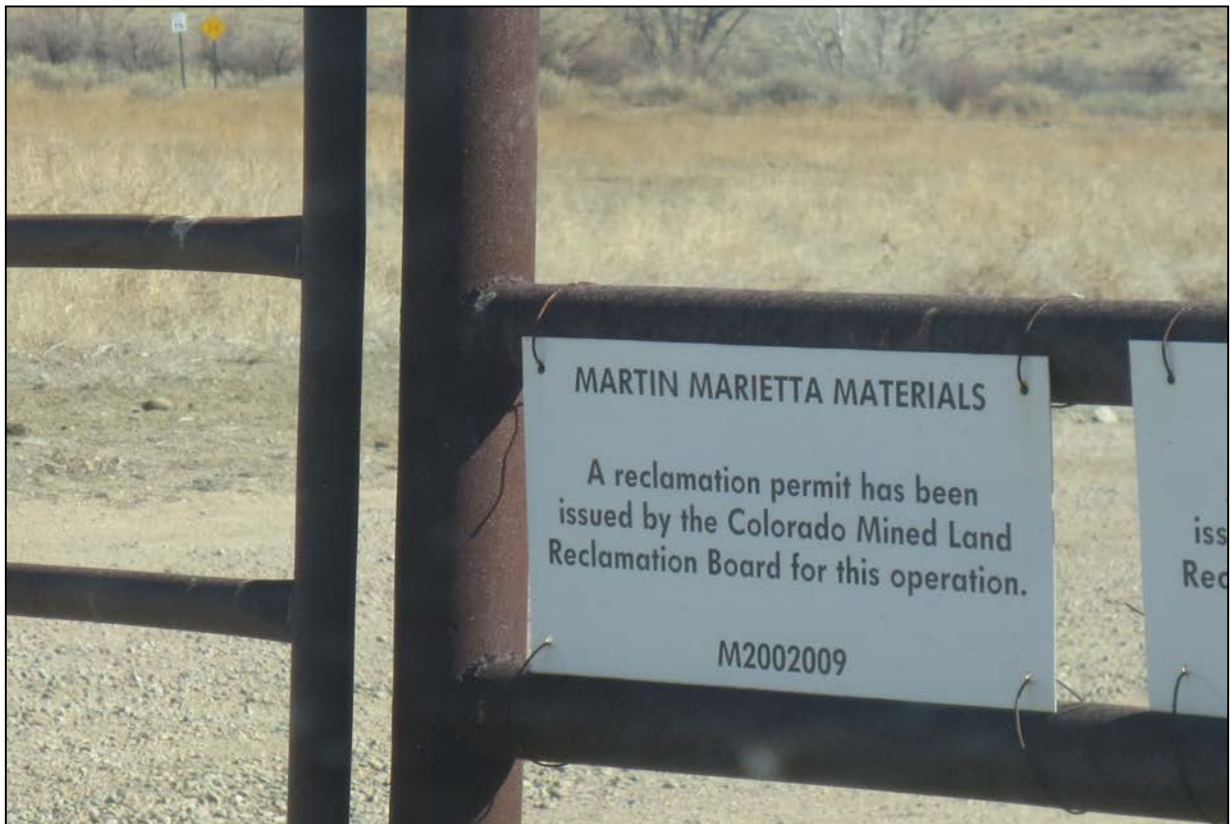
During the inspection, the sky was clear and the ground was dry. No mining equipment was present at the time of the inspection. The mining operation has not started yet. The Site is still being used as rangeland. The Operator's representative stated that mining may begin when the company has a project in the nearby area. The current amount of financial warranty the Operator has on deposit with the State is \$ 62,335. Prior to mining, the Operator will need to notify the Division of the company's intent to mine the site. the Division will recalculate the required financial warranty using updated costs. The Division will provide the Operator an opportunity to comment on the required financial warranty. The required financial warranty maybe adjusted prior to the commencement of the mining operation.

A mine I.D. sign was posted at the entrance to the site. The permit boundary was marked during the inspection.
