**MINERALS PROGRAM INSPECTION REPORT**  
**PHONE: (303) 866-3567**

<b>MINE NAME:</b> Rough Cut Pit	<b>MINE/PROSPECTING ID#:</b> M-2001-033	<b>MINERAL:</b> Sand and gravel	<b>COUNTY:</b> Otero
<b>INSPECTION TYPE:</b> Monitoring	<b>INSPECTOR(S):</b> Amy Eschberger	<b>INSP. DATE:</b> July 13, 2016	<b>INSP. TIME:</b> 10:15
<b>OPERATOR:</b> Rough Cut, L.L.C.	<b>OPERATOR REPRESENTATIVE:</b> Keith Tucker	<b>TYPE OF OPERATION:</b> 112c - Construction Regular Operation	
<b>REASON FOR INSPECTION:</b> Normal I&E Program	<b>BOND CALCULATION TYPE:</b> Complete Bond	<b>BOND AMOUNT:</b> \$193,000.00	
<b>DATE OF COMPLAINT:</b> NA	<b>POST INSP. CONTACTS:</b> None	<b>JOINT INSP. AGENCY:</b> None	
<b>WEATHER:</b> Clear	<b>INSPECTOR'S SIGNATURE:</b>

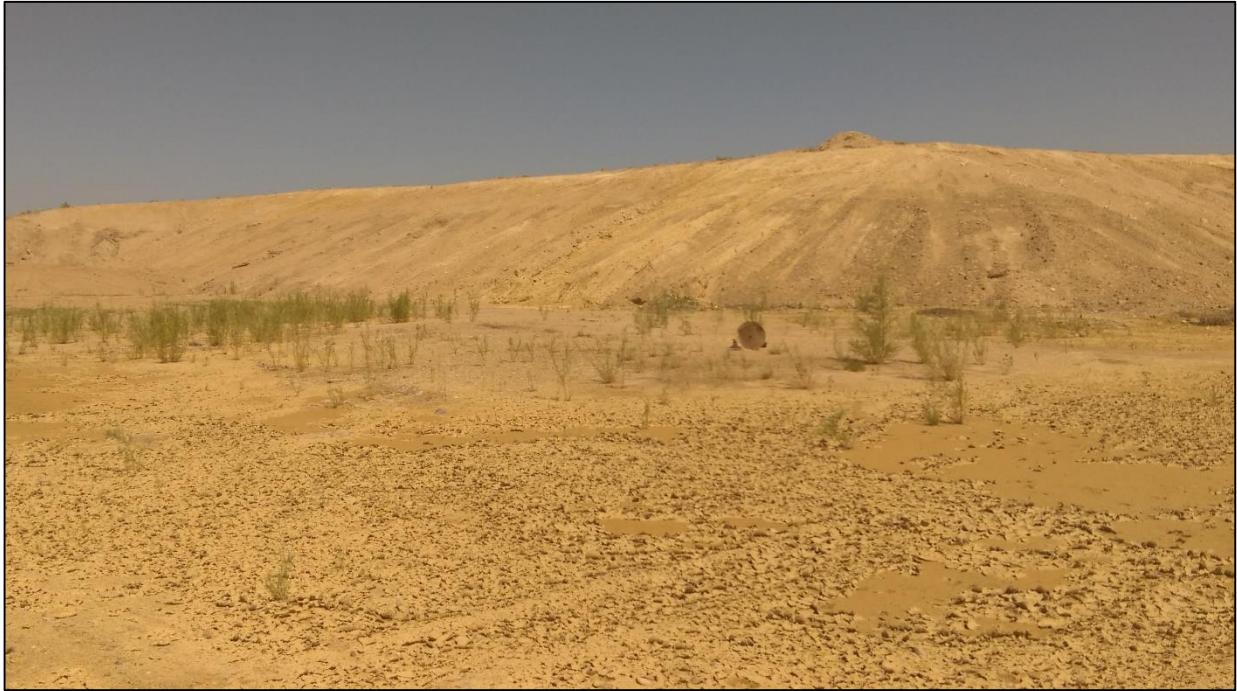
At the time of the inspection, the weather was clear and hot, and the ground was dry. The Division first observed the Phase I pit in the western portion of the permit area. In this phase, the operator had graded all highwalls to slope gradients of 3H:1V or flatter (**Photos 1-4**). In the January 13, 2016 inspection report, the Division had estimated the highwall in this phase to be approximately 1,647 feet in length. Because this highwall has been graded to the approved slope gradient, the Division will no longer require reclamation costs in the bond estimate for grading this highwall. Additional work in this phase included reseeded the southern 15 acres (**Photo 5**). Because grasses have not yet established in this area, the Division must still hold reclamation costs for seeding this area. However, the estimated failure rate for revegetation of this area has been reduced in the Division's bond estimate. During the last inspection, the northeastern portion of this phase was being used for storage of equipment and excess parts/junk. Since then, the operator has removed some of the equipment and graded the cement rock stockpile located in this area to 3H:1V slopes (**Photos 6 and 7**). Mr. Tucker indicated that the operation will move the equipment storage area to a location south of the current storage area. If all goes according to planned, this northeastern area will be backfilled, retopsoiled, and seeded this fall. Portions of this area have already been graded. Because this portion of the permit area has not yet been retopsoiled or seeded, the Division must still hold reclamation costs for these tasks. However, the Division was able to reduce costs for grading in the bond estimate.

**Photo 1.** View looking north in Phase 1 pit, showing highwall has been graded to 3H:1V.

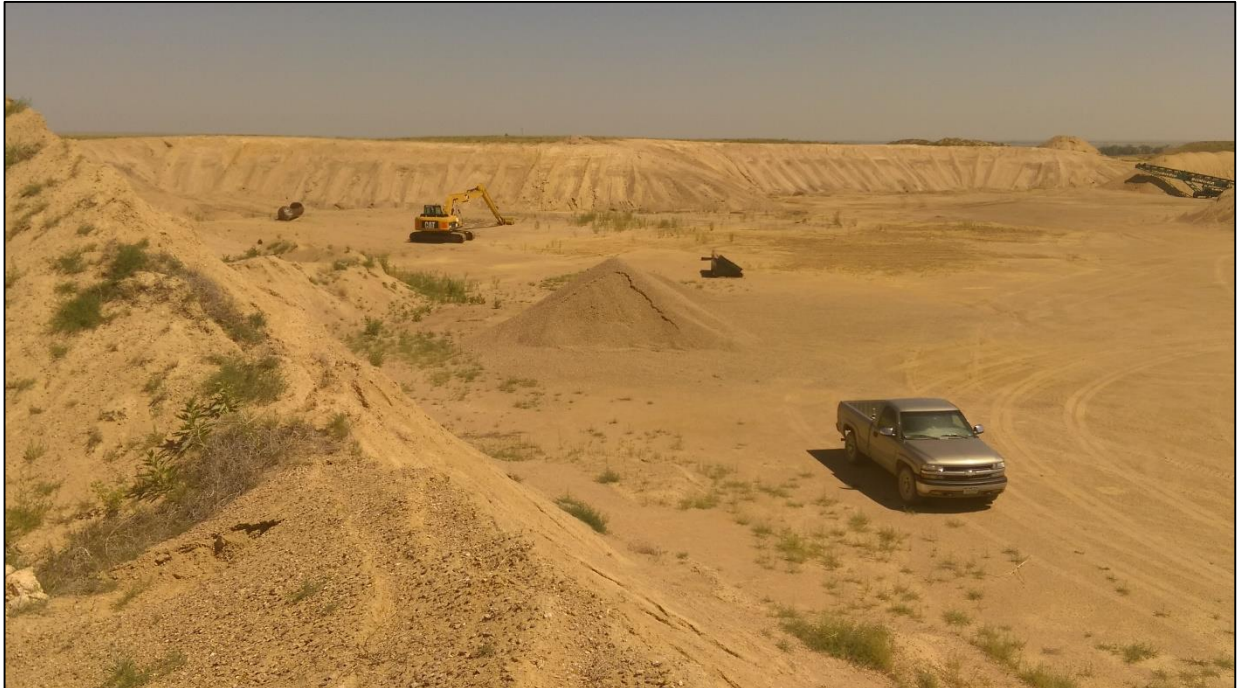
**Photo 2.** View looking north in Phase 1 pit (from western edge), showing highwalls (in background) have been graded to 3H:1V.

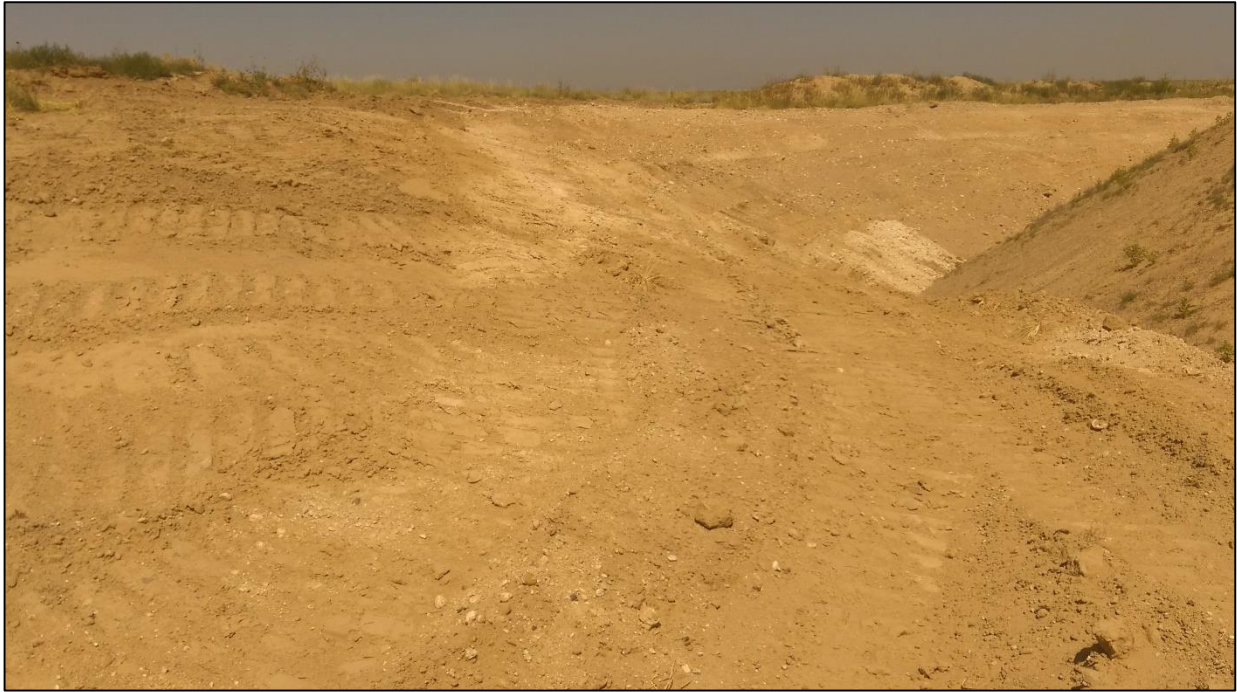
**Photo 3.** View looking north across western highwall in Phase 1 pit (behind stockpiles), showing this highwall has been graded to 3H:1V.

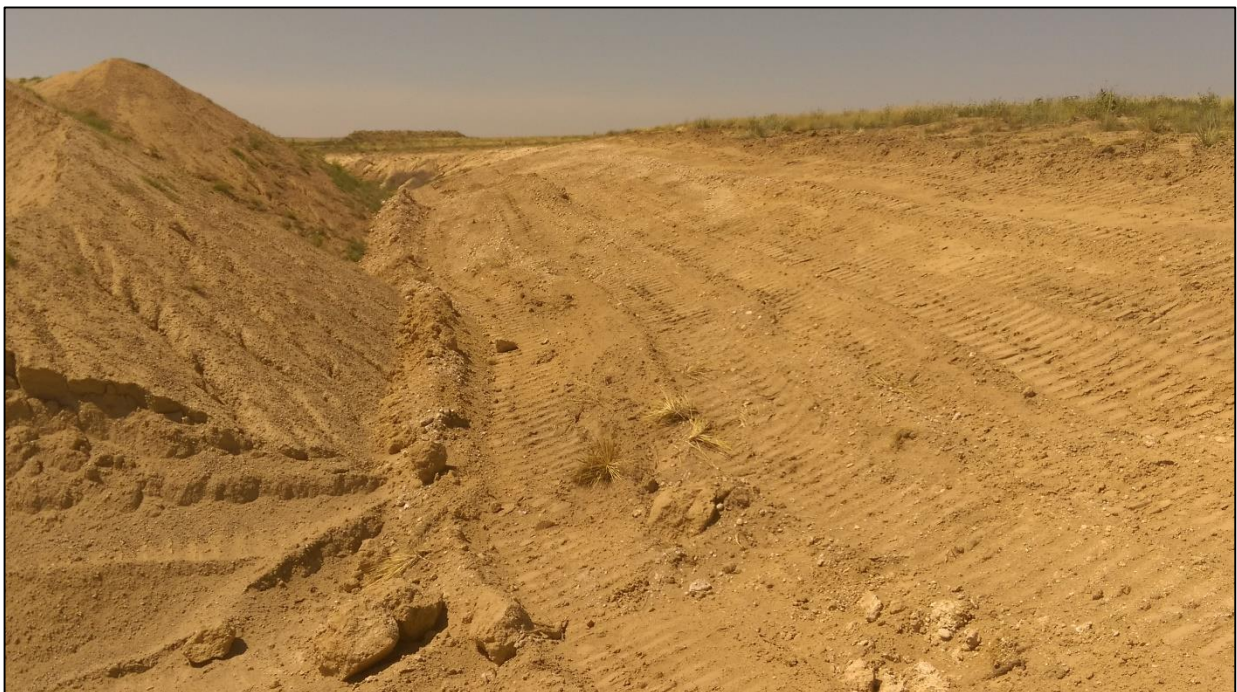
**Photo 4.** View looking south across western highwall in Phase 1 pit (behind stockpiles), showing this highwall has been graded to 3H:1V.

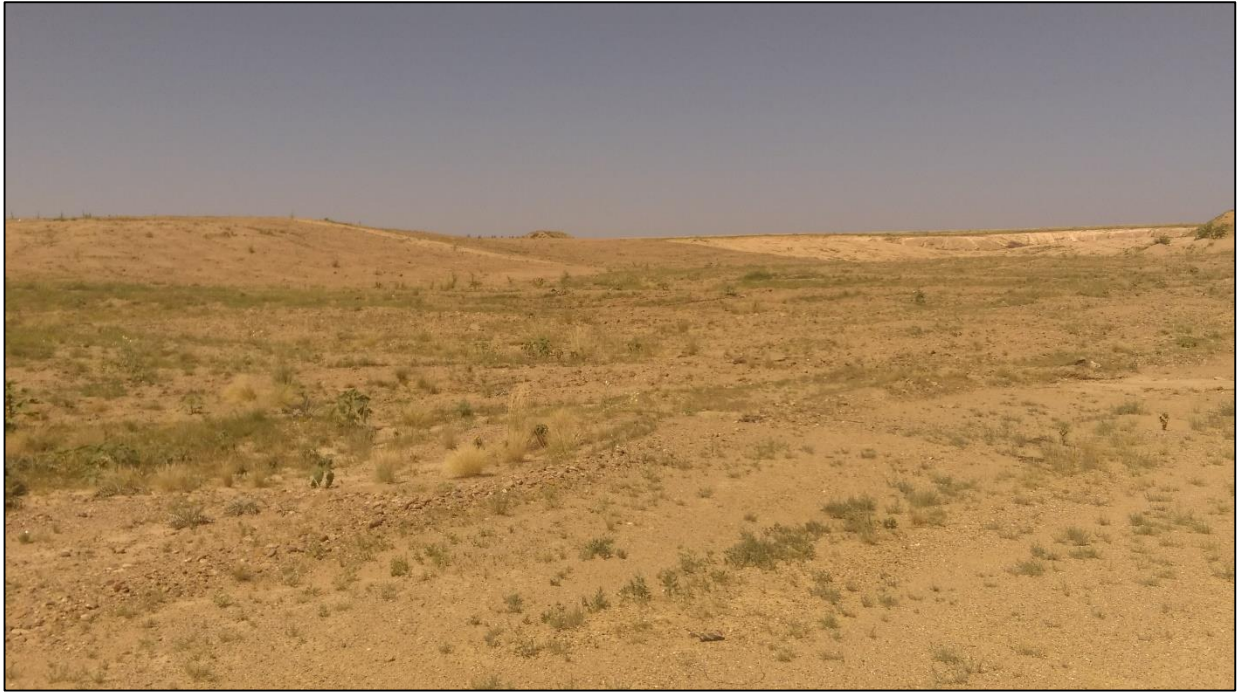
**Photo 5.** View looking southwest across southern portion of Phase 1 pit which has been graded, retopsoiled, and recently reseeded.

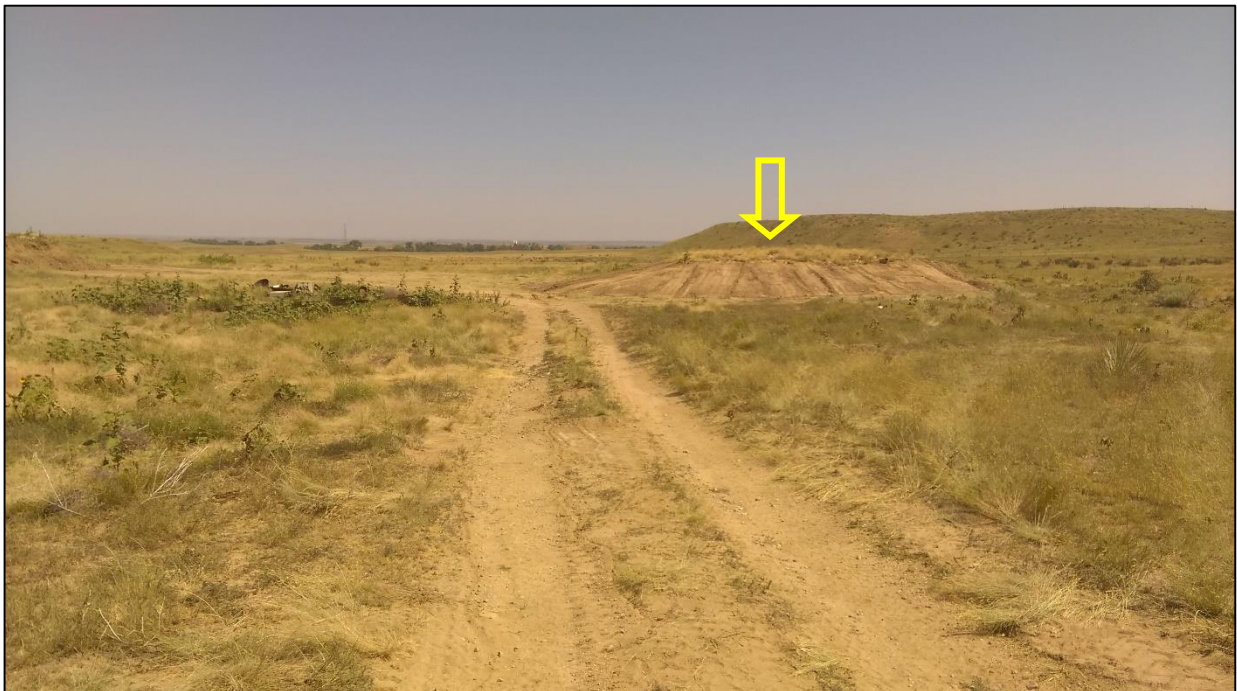
**Photo 6.** View looking north across northeastern portion of Phase 1 pit that was used for stockpiling equipment. Some of equipment has been removed and cement rock stockpile (at right; indicated) has been graded to 3H:1V.

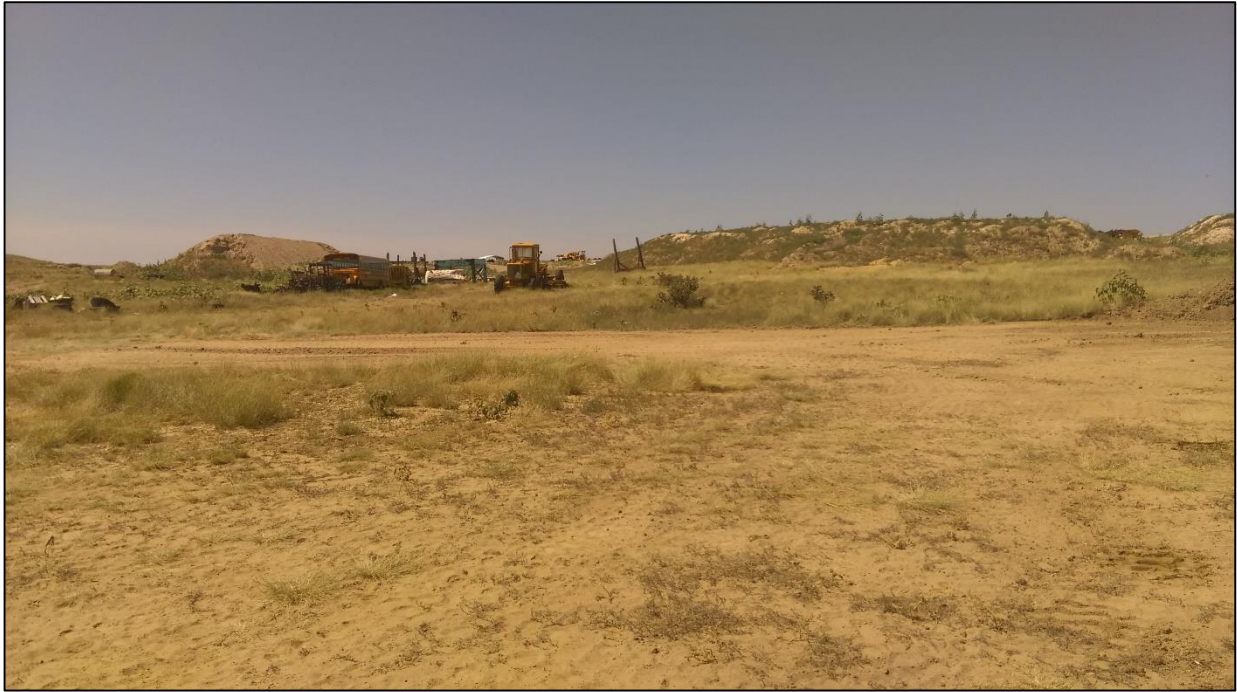
**Photo 7.** View looking south across northeastern portion of Phase 1 pit that was used for stockpiling equipment. Some of equipment has been removed. This area will be reclaimed in the near future.

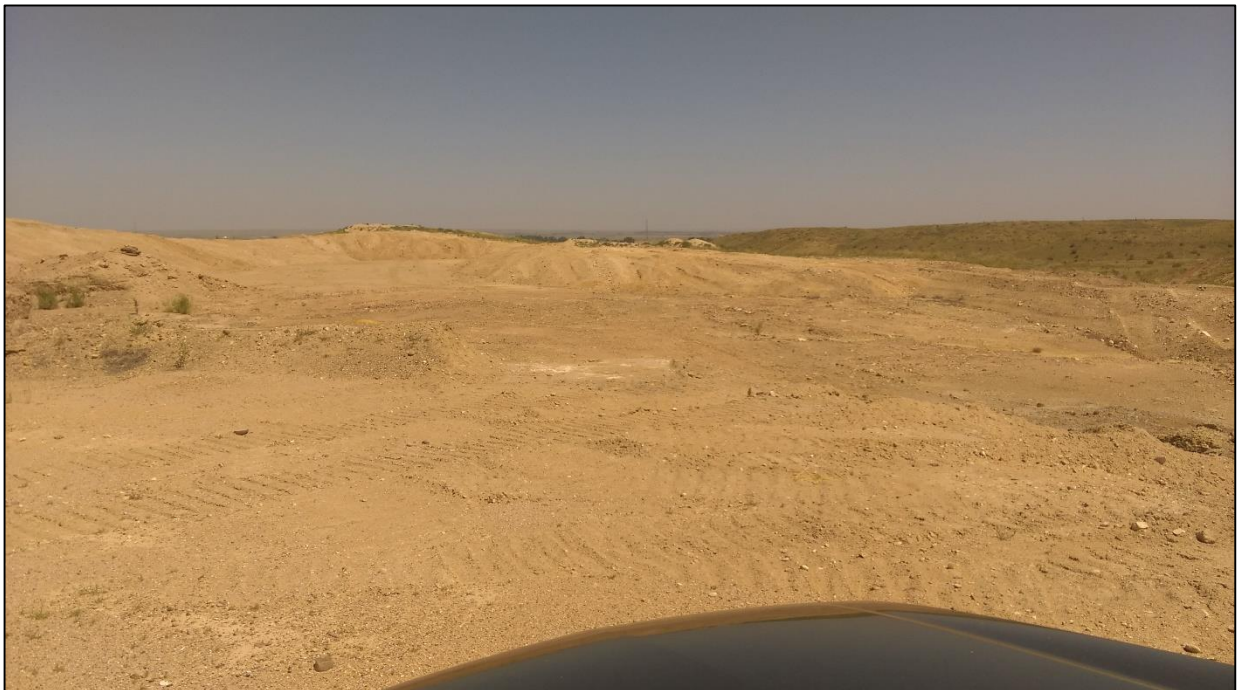
The Division next observed the Phase 2 pit in the central portion of the permit area. The operator had also graded the highwalls in this phase to 3H:1V or flatter (**Photos 8**). In the January 13, 2016 inspection report, the Division had estimated the highwall in this phase to be approximately 1,974 feet in length. Because this highwall has been graded to the approved slope gradient, the Division will no longer require reclamation costs in the bond estimate for grading this highwall. In the northeastern portion of this phase, the operator had completed grading work, including removing the berm around the edge of the ridge (**Photo 9**). The overburden/topsoil stockpile that was located at the eastern edge of this area had been knocked down and spread out over the adjacent disturbed land (**Photo 10**). Mr. Tucker indicated this area would be seeded this fall. The eastern 8.25 acres that was retopsoiled in 2013 will also be seeded this fall. Because grasses have not yet established in these areas, the Division must still hold reclamation costs for the eastern and northeastern portions of this phase. However, the grading and retopsoiling costs for this phase can be reduced to account for work completed. At the southern edge of this phase where the small batch plant operated years ago, a very small asphalt stockpile remains. Mr. Tucker indicated that this stockpile would be removed in the next day or so, and the area would be retopsoiled, and seeded this fall.

**Photo 8.** View looking north in Phase 2 pit, showing highwalls have been graded to 3H:1V.

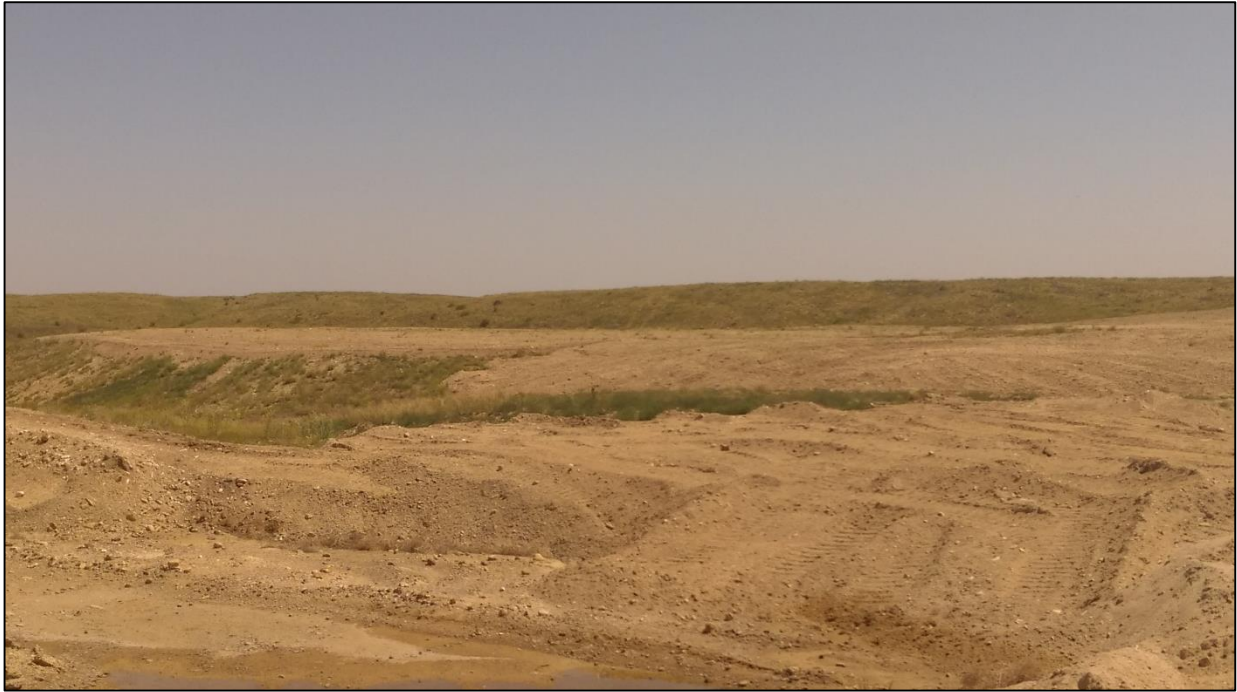
**Photo 9.** View looking northeast in Phase 2 pit, showing northeastern portion has been graded out to near flat (including berms that had lined the ridge edge).

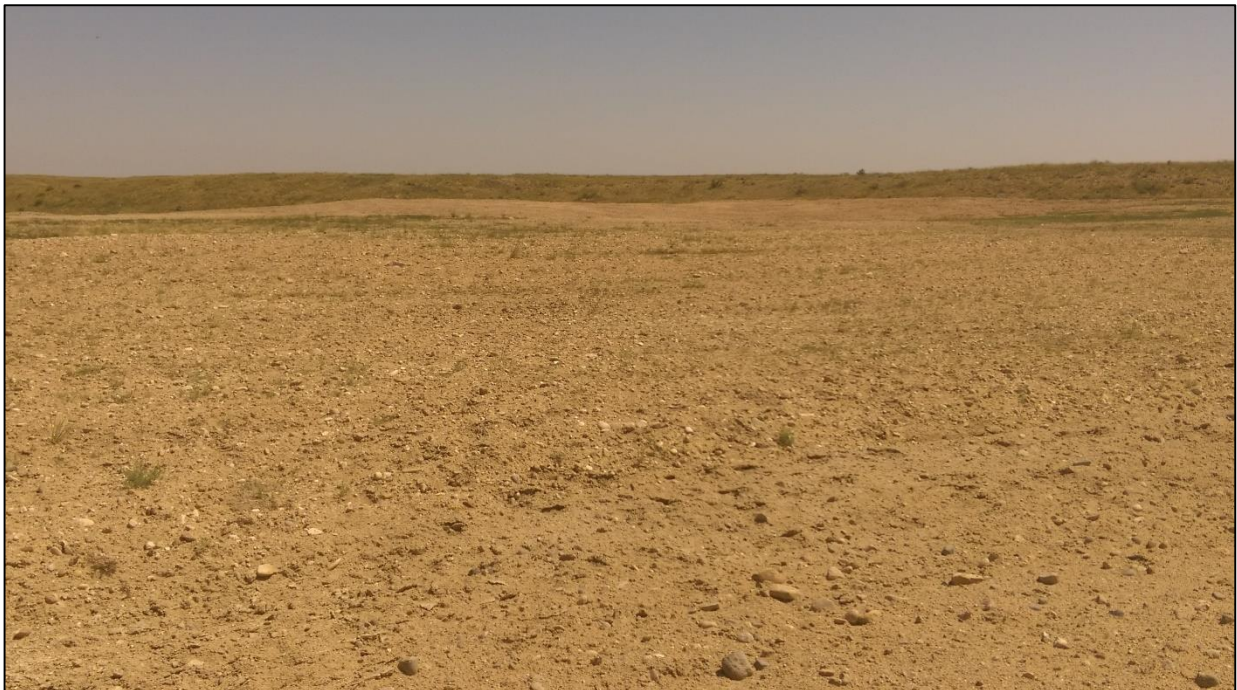
**Photo 10.** View looking east in Phase 2 pit, showing eastern portion where overburden/topsoil stockpile has been knocked over and spread across adjacent land for reclamation.

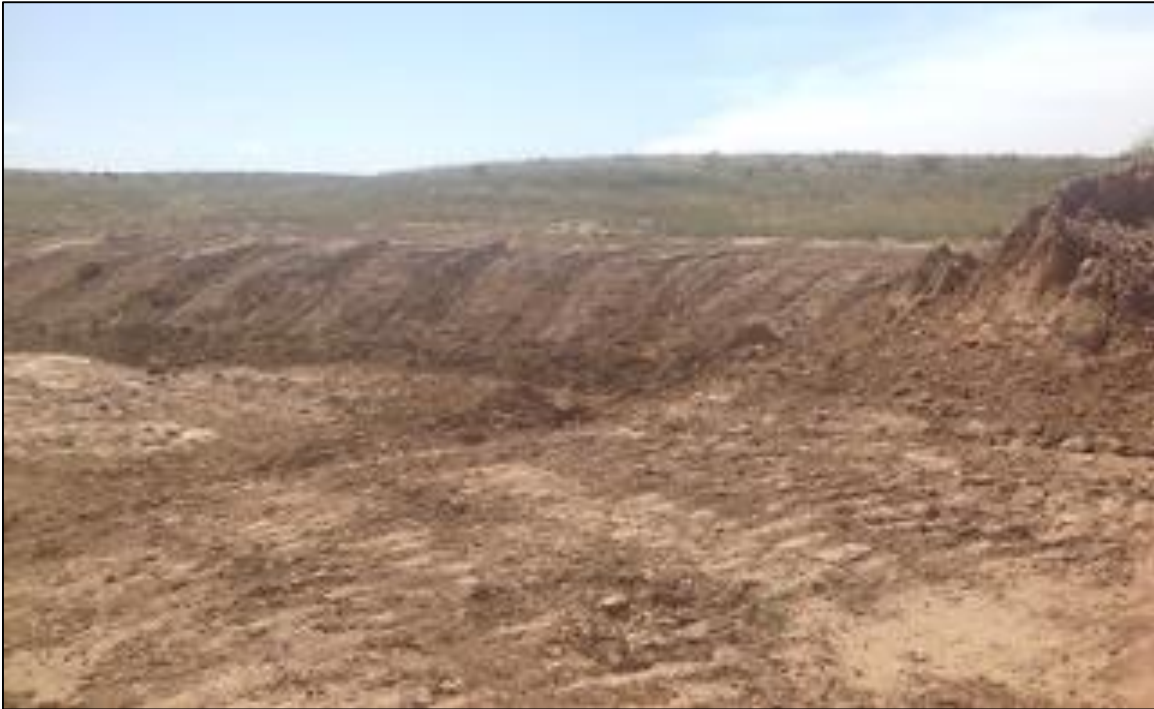
The Division did not observe the small Phase 3 pit during the inspection. However, Mr. Tucker later emailed photos showing reclamation work completed in this phase. Total disturbance in this phase consists of only 1.5 acres. In the January 13, 2016 inspection report, the Division estimated the highwall in this phase to be approximately 520 feet in length. Since then, it appears that the operator has graded this highwall to the required 3H:1V slope gradient (**Photos 11 and 12**). Therefore, the Division will no longer require reclamation costs in the bond estimate for grading this highwall. However, the bond estimate must still include costs for ripping the 0.5 acre stockpile area, and retopsoiling and revegetating the 1.5 acres disturbed in this phase.

**Photo 11.** View looking west in Phase 3 pit, showing western highwall graded to 3H:1V.  
Photo was provided by Keith Tucker via email on July 15, 2016.

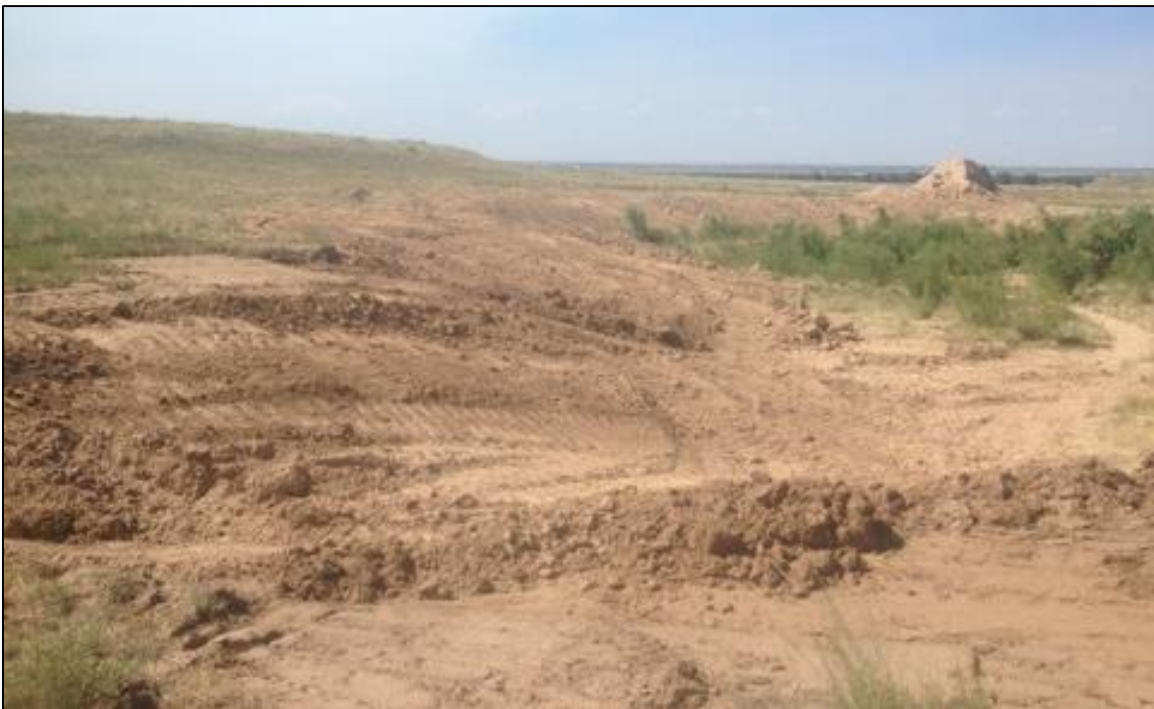
**Photo 12.** View looking south in Phase 3 pit, showing eastern highwall graded to 3H:1V.  
Photo was provided by Keith Tucker via email on July 15, 2016.
