**MINERALS PROGRAM INSPECTION REPORT**  
**PHONE: (303) 866-3567**

<b>MINE NAME:</b> Toltec No 2	<b>MINE/PROSPECTING ID#:</b> M-1984-039	<b>MINERAL:</b> Silver, gold, copper,	<b>COUNTY:</b> San Juan
<b>INSPECTION TYPE:</b> Monitoring	<b>INSPECTOR(S):</b> Lucas J. West, Russ Means	<b>INSP. DATE:</b> June 29, 2016	<b>INSP. TIME:</b> 12:40
<b>OPERATOR:</b> Wilbur F Benham	<b>OPERATOR REPRESENTATIVE:</b> None	<b>TYPE OF OPERATION:</b> 110(2) - Hard Rock Limited Impact	
<b>REASON FOR INSPECTION:</b> Normal I&E Program	<b>BOND CALCULATION TYPE:</b> None	<b>BOND AMOUNT:</b> \$3,000.00	
<b>DATE OF COMPLAINT:</b> NA	<b>POST INSP. CONTACTS:</b> None	<b>JOINT INSP. AGENCY:</b> None	
<b>WEATHER:</b> Clear	<b>INSPECTOR'S SIGNATURE:</b>

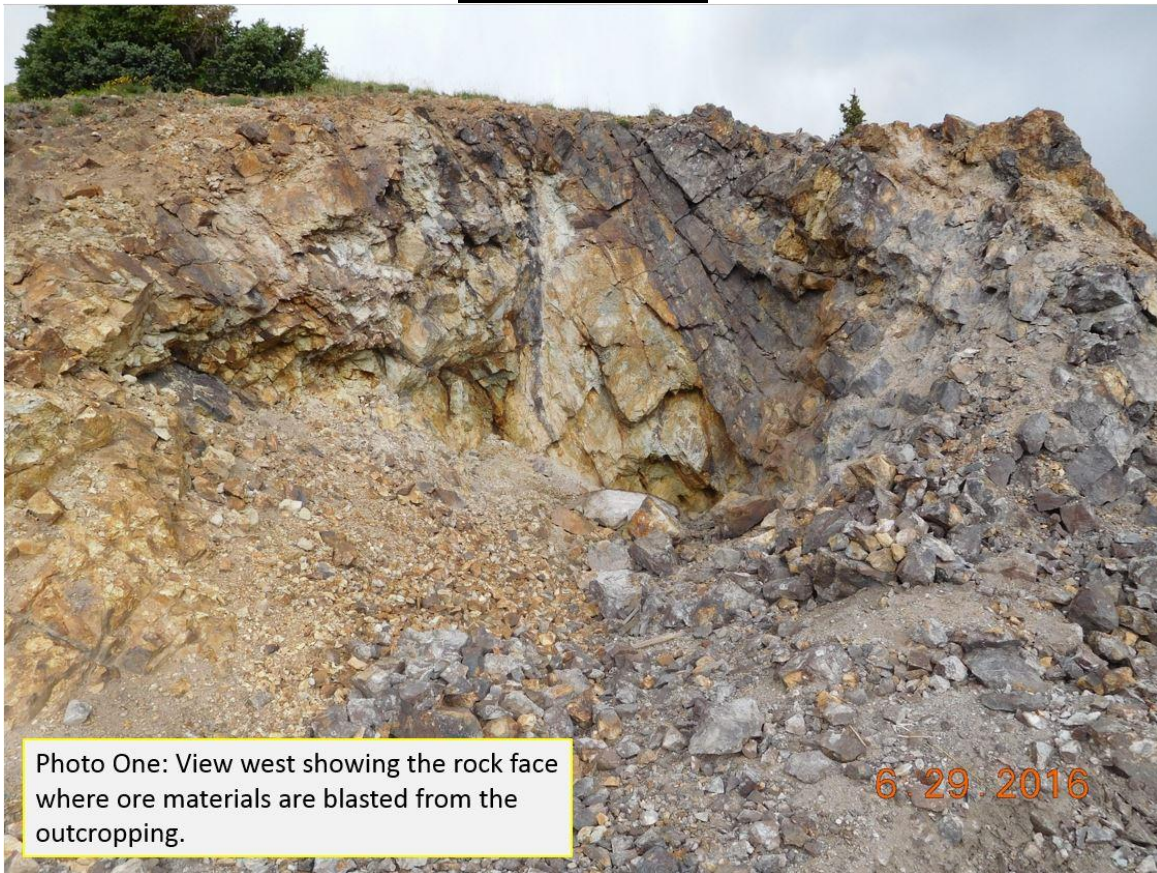
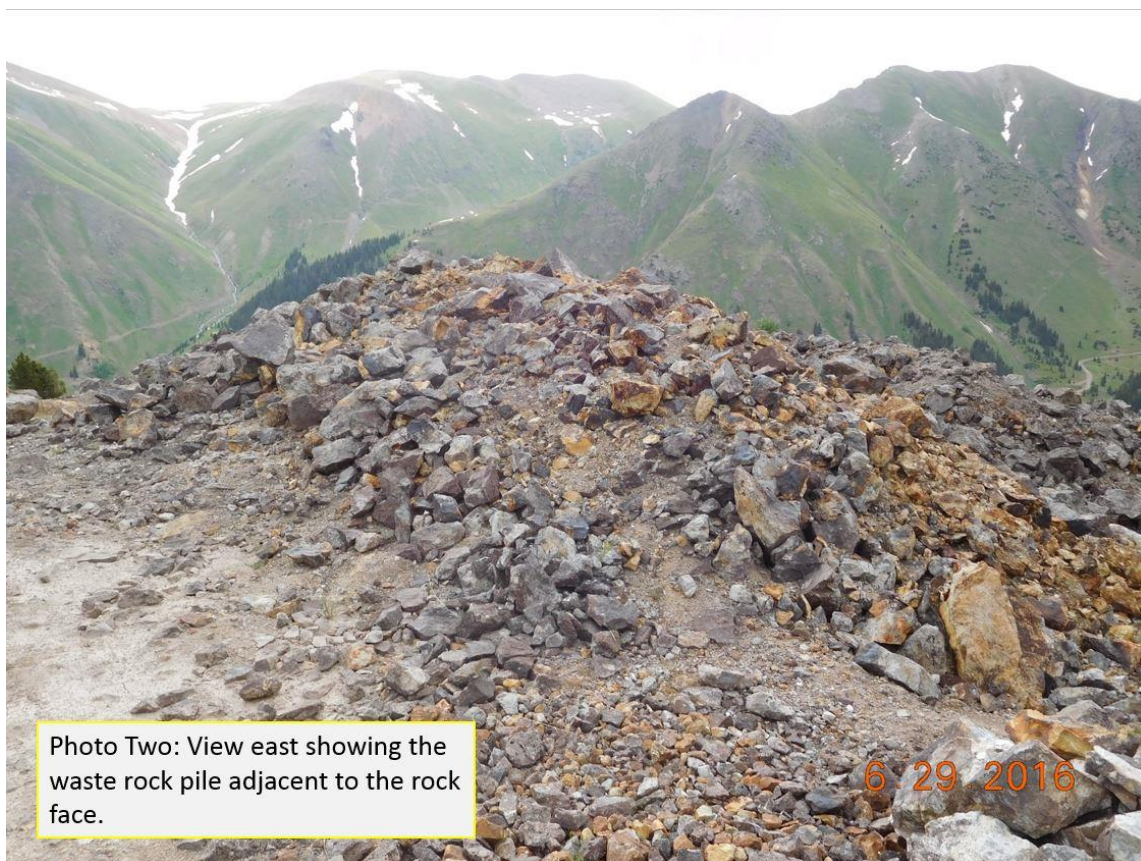
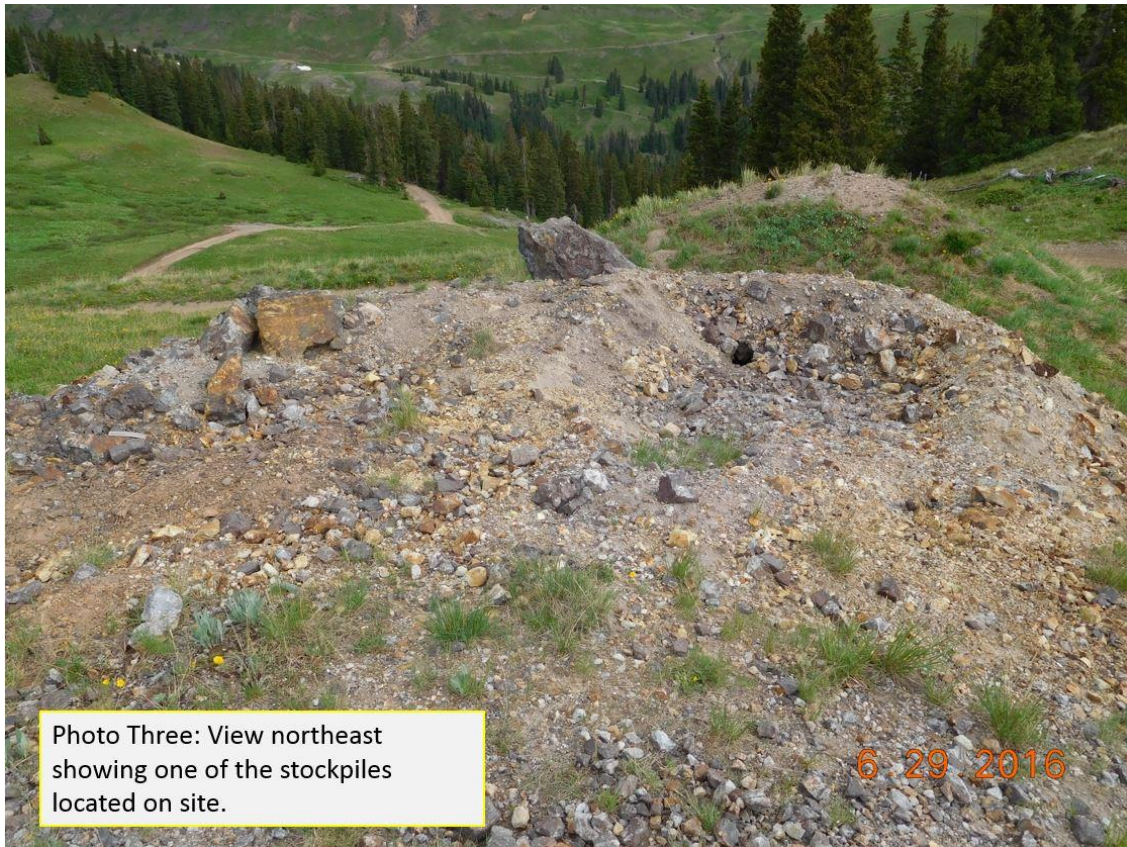
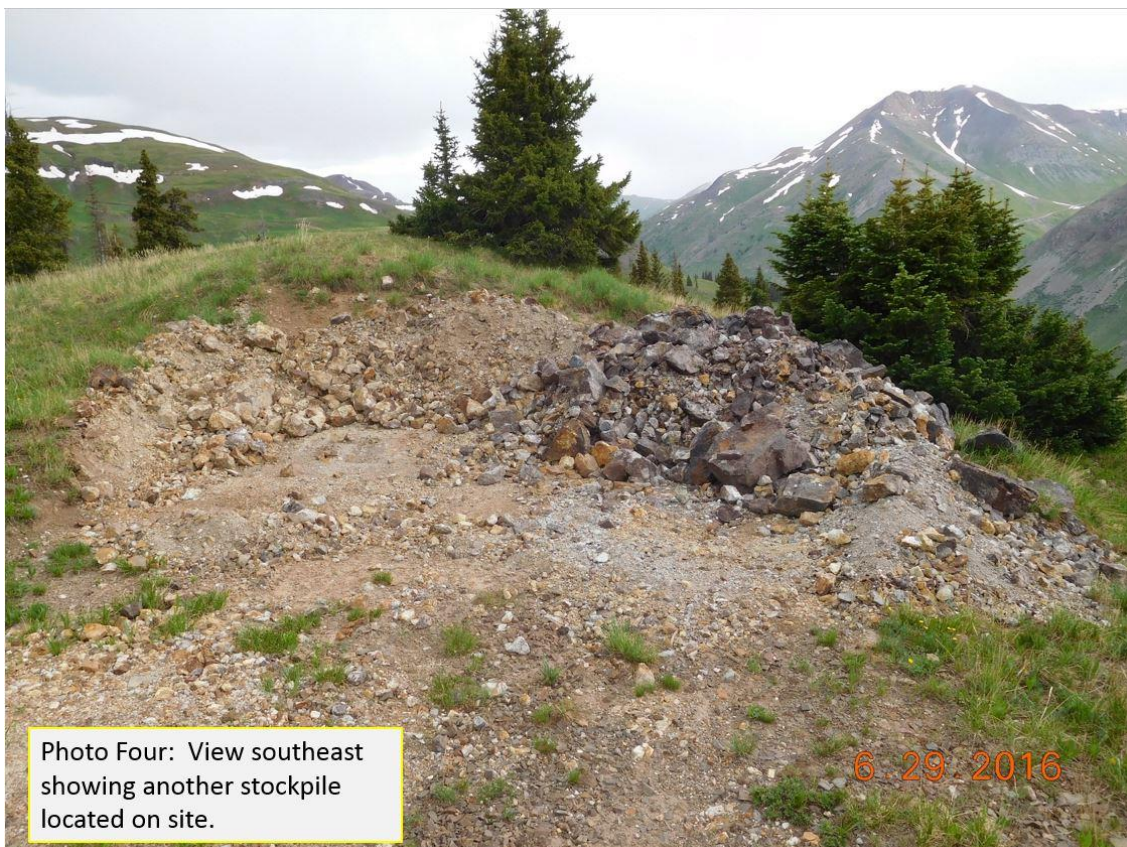
The site was not active during the inspection and no equipment was observed on site. No proper mine identification sign was posted, however a "No Trespassing" sign was observed. The condition of the site has remained unchanged from the Division's previous inspection dated October 2016. The operator suffered an injury during the last mining season and no activity has taken place since. Photo One shows the main area of activity that is the rock face where ore is blasted from and sorted into the stockpiles on site. The stockpiles were noted to be in the same condition as the previous inspection as well. Photos Two, Three and Four show the various stockpiles. The site appears to be stable, exhibits positive drainage and is free from trash and debris. No Noxious weeds were noted during this inspection. No new problems or possible violations were observed at this time.
