MINERALS PROGRAM INSPECTION REPORT
PHONE: (303) 866-3567

MINE NAME: Native/Pierre Mine	MINE/PROSPECTING ID#: M-1977-321	MINERAL: Clay (general)	COUNTY: Pueblo
INSPECTION TYPE: Monitoring	INSPECTOR(S): Tyler V. O'Donnell	INSP. DATE: March 16, 2016	INSP. TIME: 08:00
OPERATOR: Summit Brick & Tile Co.	OPERATOR REPRESENTATIVE: Mat Welte	TYPE OF OPERATION: 110c - Construction Limited Impact	
REASON FOR INSPECTION: Normal I&E Program	BOND CALCULATION TYPE: Complete Bond	BOND AMOUNT: \$6,500.00	
DATE OF COMPLAINT: NA	POST INSP. CONTACTS: None	JOINT INSP. AGENCY: None	
WEATHER: Clear	INSPECTOR'S SIGNATURE:

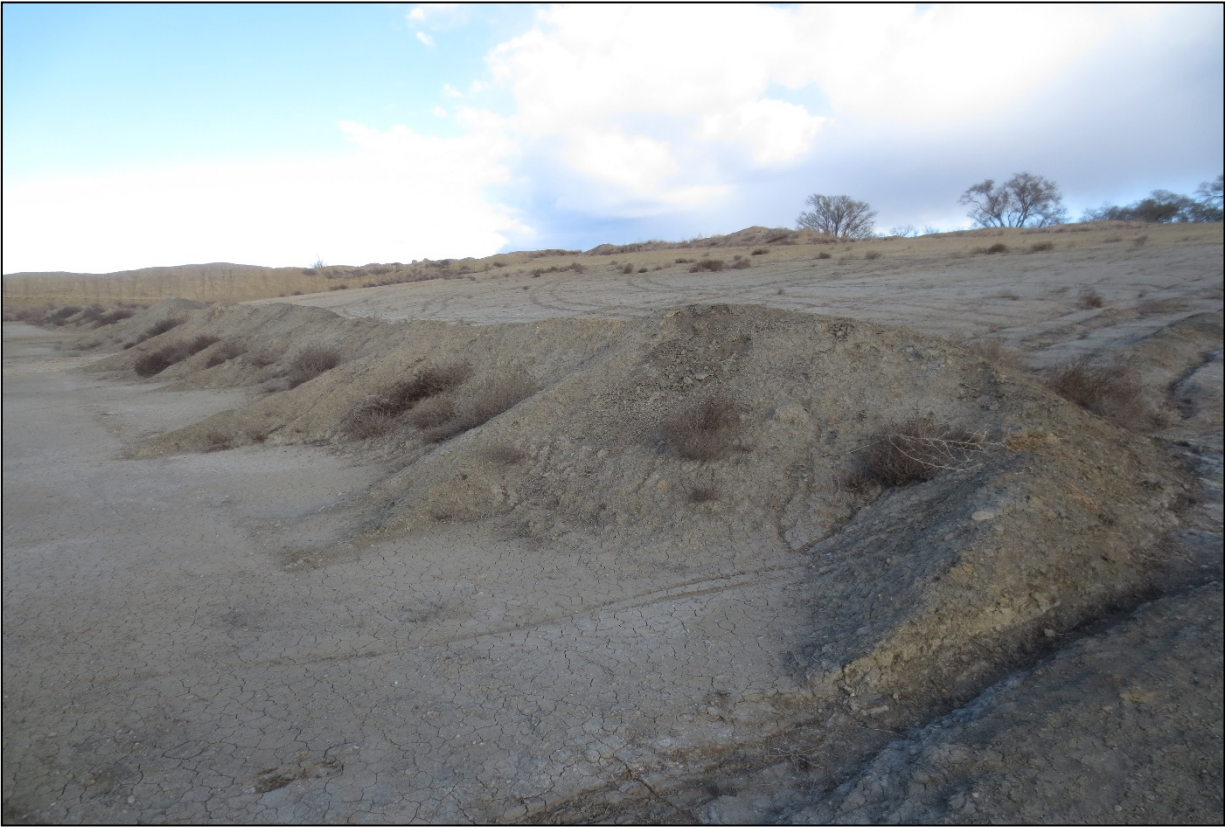
The mining operation was expanding to the north. It appears that the Operator is mining the northern portion of the site at a 3H:1V or flatter. The Operator was in the process of backfilling with waste brick and other waste materials from the brick plant, as approved in the reclamation plan. Most of the backfilling work was taking place in the southern portion of the affected land.

Photo 1: Active mining face along the northern boundary.

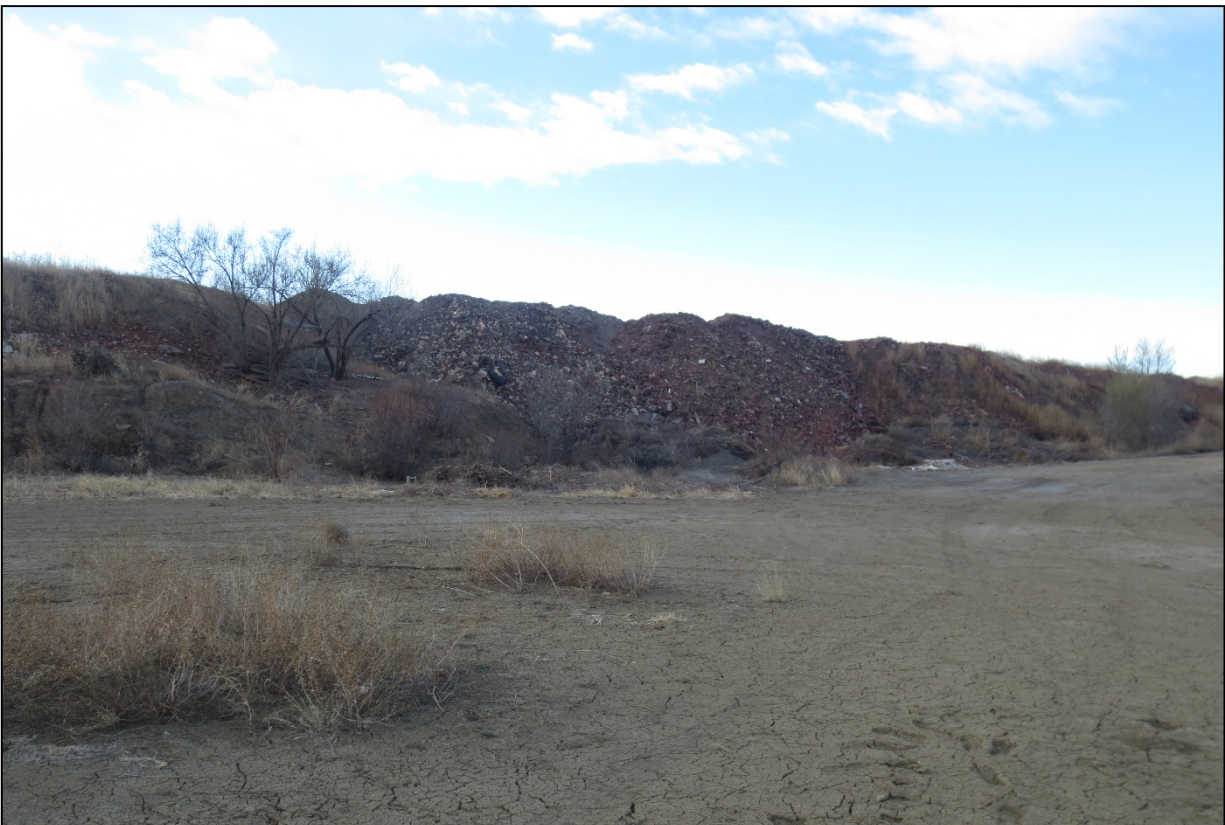
Photo 2: Active backfilling of waste brick and other materials.

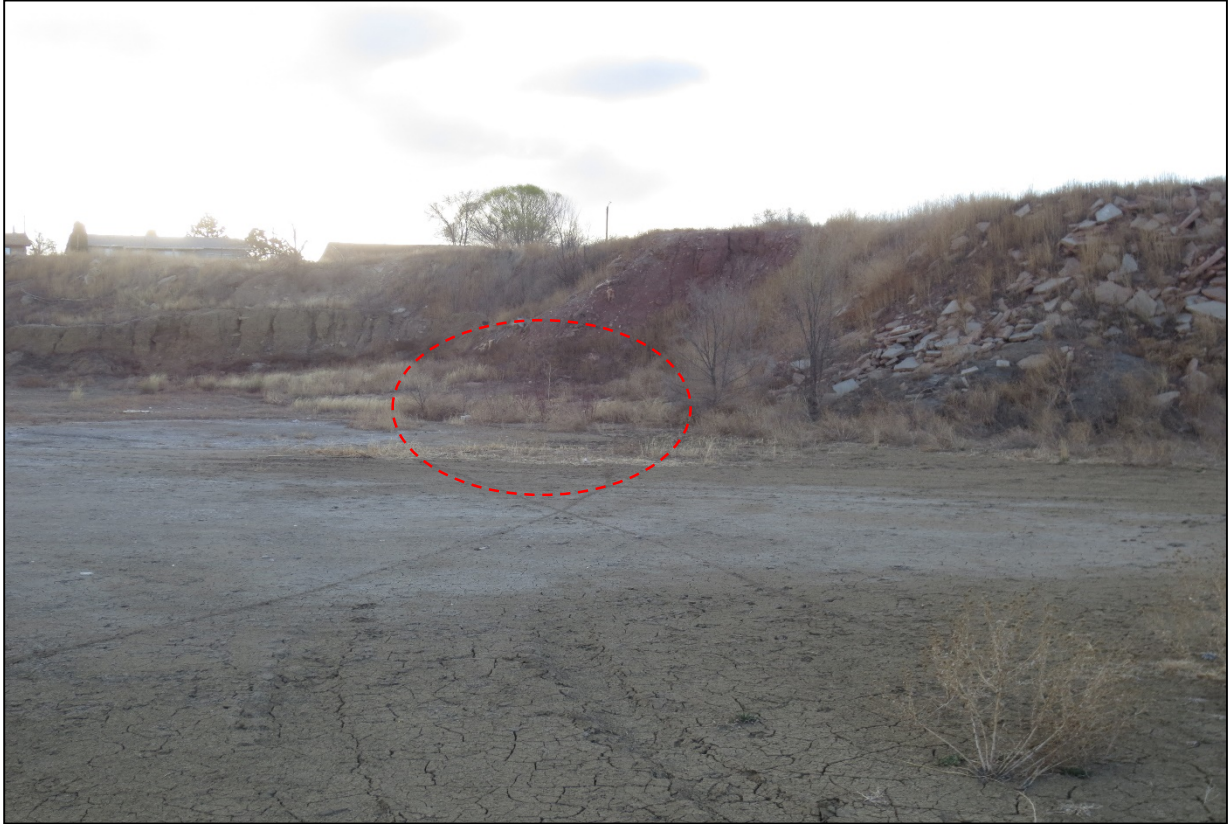
There was some plant growth throughout the affected lands. The growth in the affected areas appeared to be volunteer vegetation, comprised primarily of annual weeds, and native grasses. There were a few juvenile Tamarisk trees beginning to establish in a hand full of low laying areas around the southern portion of the site. Due to the limited number of tamarisk trees observed, the Division will not cite a problem for failure to control noxious weeds. However, the Operator is encouraged to continue to monitor and treat noxious weeds as they appear in the permit boundary. If the population of tamarisk increases the Division may cite a problem during a future inspection.

Photo 3: Tamarisk trees circled in the red dashed line.

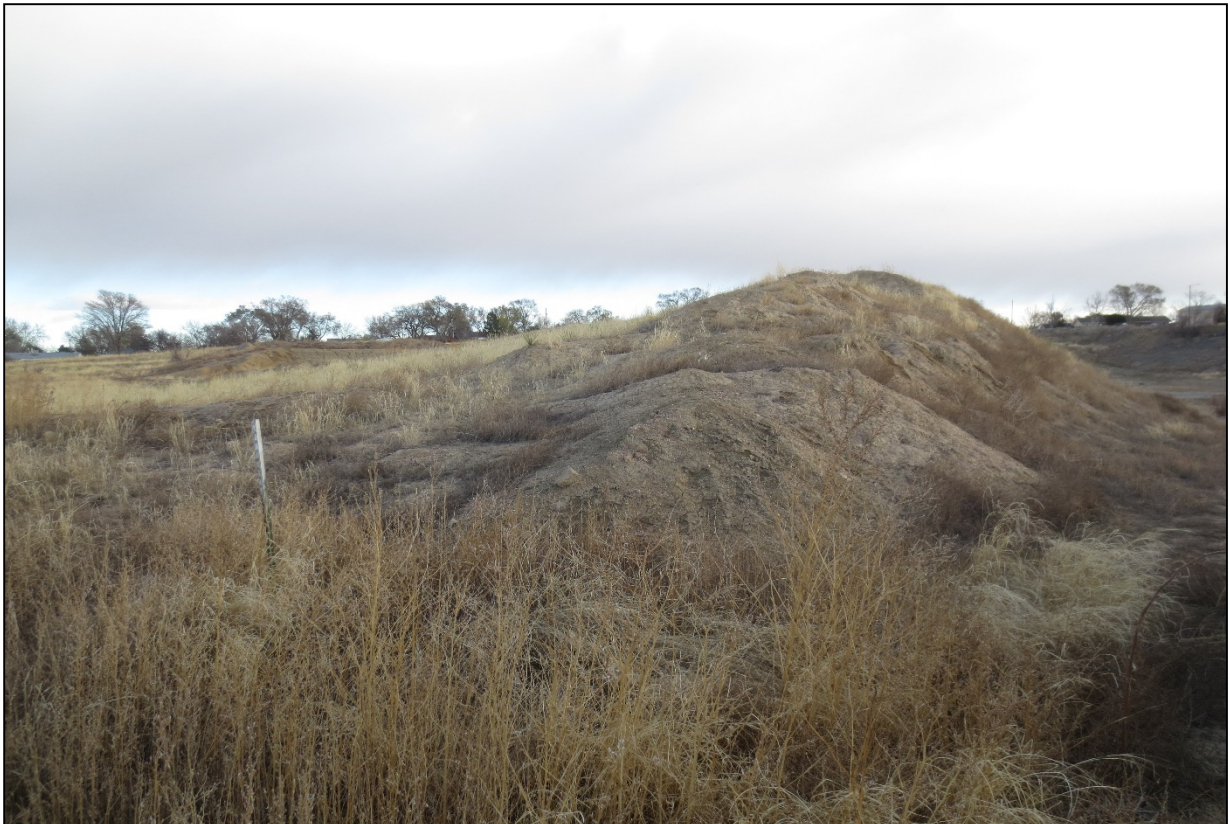
There was adequate topsoil stockpiled on site to conduct the approved reclamation plan. There were two partially vegetated topsoil stockpiles within the affected lands, one in the southwest corner and the other in the northeast corner of the site. The topsoil stockpiles had adequate vegetative cover to protect topsoil from erosion.

Photo 4: Topsoil stockpile in the southwestern corner of the affected land.
