COLORADO DIVISION OF RECLAMATION, MINING AND SAFETY
MINERALS PROGRAM INSPECTION REPORT
PHONE: (303) 866-3567

MINE NAME: Connell Carr Pit	MINE/PROSPECTING ID#: M-2014-001	MINERAL: Sand and gravel	COUNTY: Weld
INSPECTION TYPE: Monitoring	INSPECTOR(S): Peter S. Hays	INSP. DATE: June 8, 2016	INSP. TIME: 10:00
OPERATOR: Connell Resources, Inc.	OPERATOR REPRESENTATIVE: Kevin Anderson	TYPE OF OPERATION: 112c - Construction Regular Operation

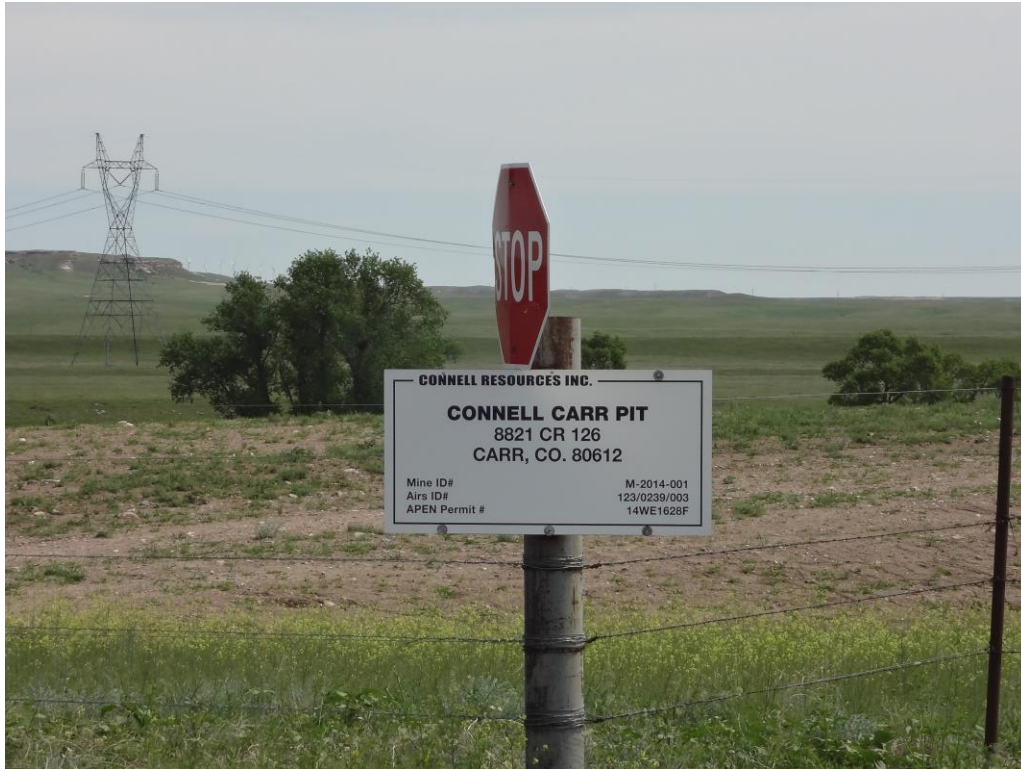
Connell Carr Pit sign

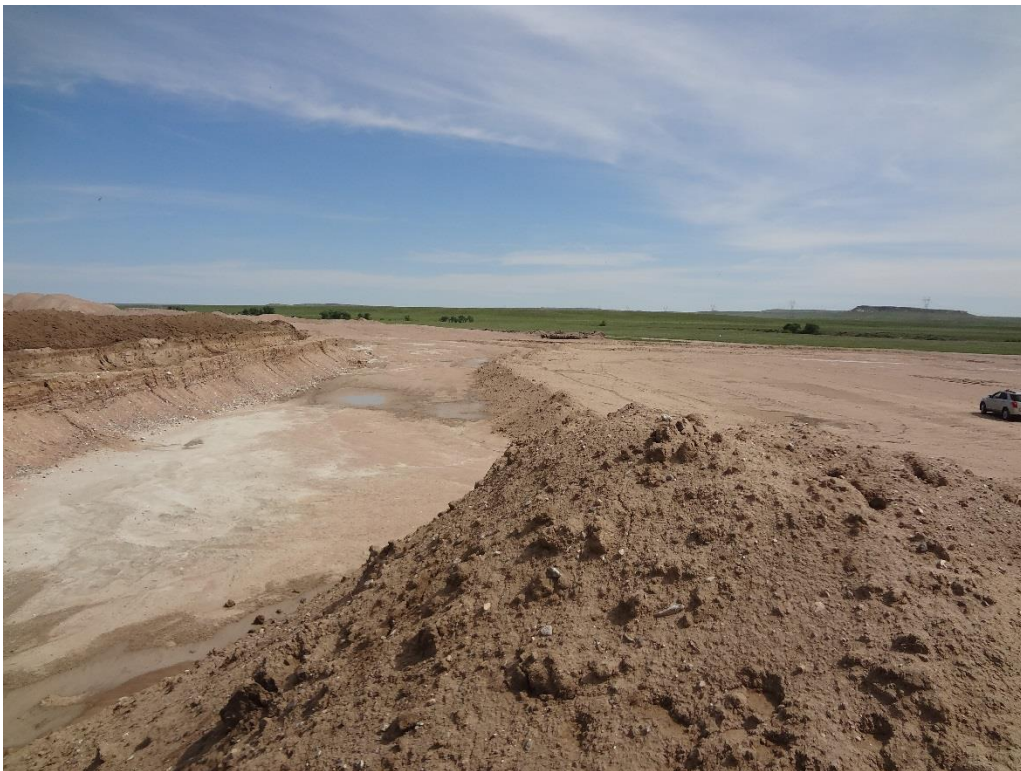
Looking north from south end of site at concurrent reclamation
